Appendix G

## Natural Environment Report and Existing Natural Features Technical Memo

# Natural Environment Report Kennedy Road from Major Mackenzie Drive to Elgin Mills Road Markham, Ontario

Prepared For: Regional Municipality of York

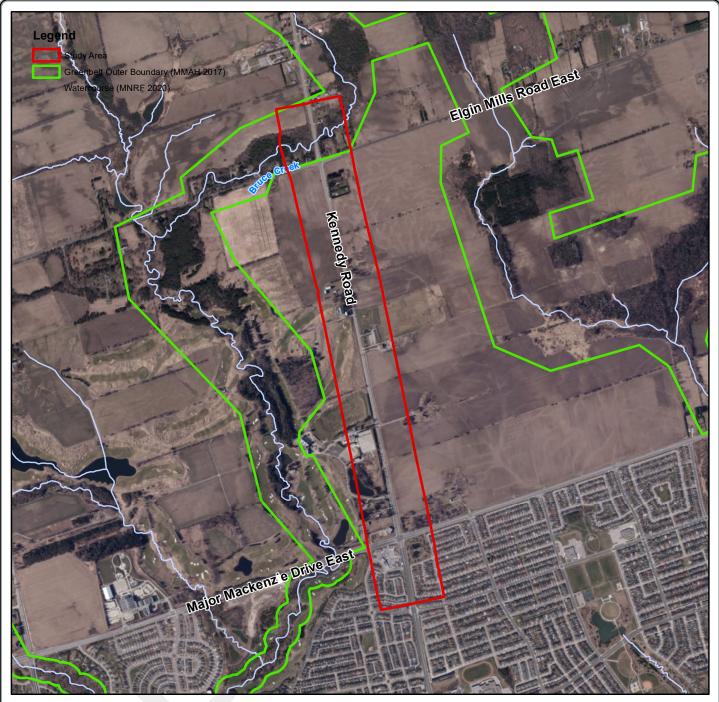
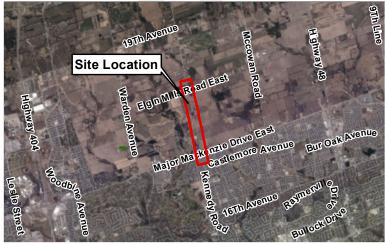
Site Location Figure					
Kennedy Road Natural Environment Report					
BEACON Project: 220329 Last Revised: June 2021					
Client: Regional Prepared by: BD Municipality of York Checked by: CG					
N 1:20,000 Inset Map:1:120,000		ap:1:120,000			
Contains information licensed under the Open Government License– Ontario Orthoimagery Baselayer: 2020 (FBS)

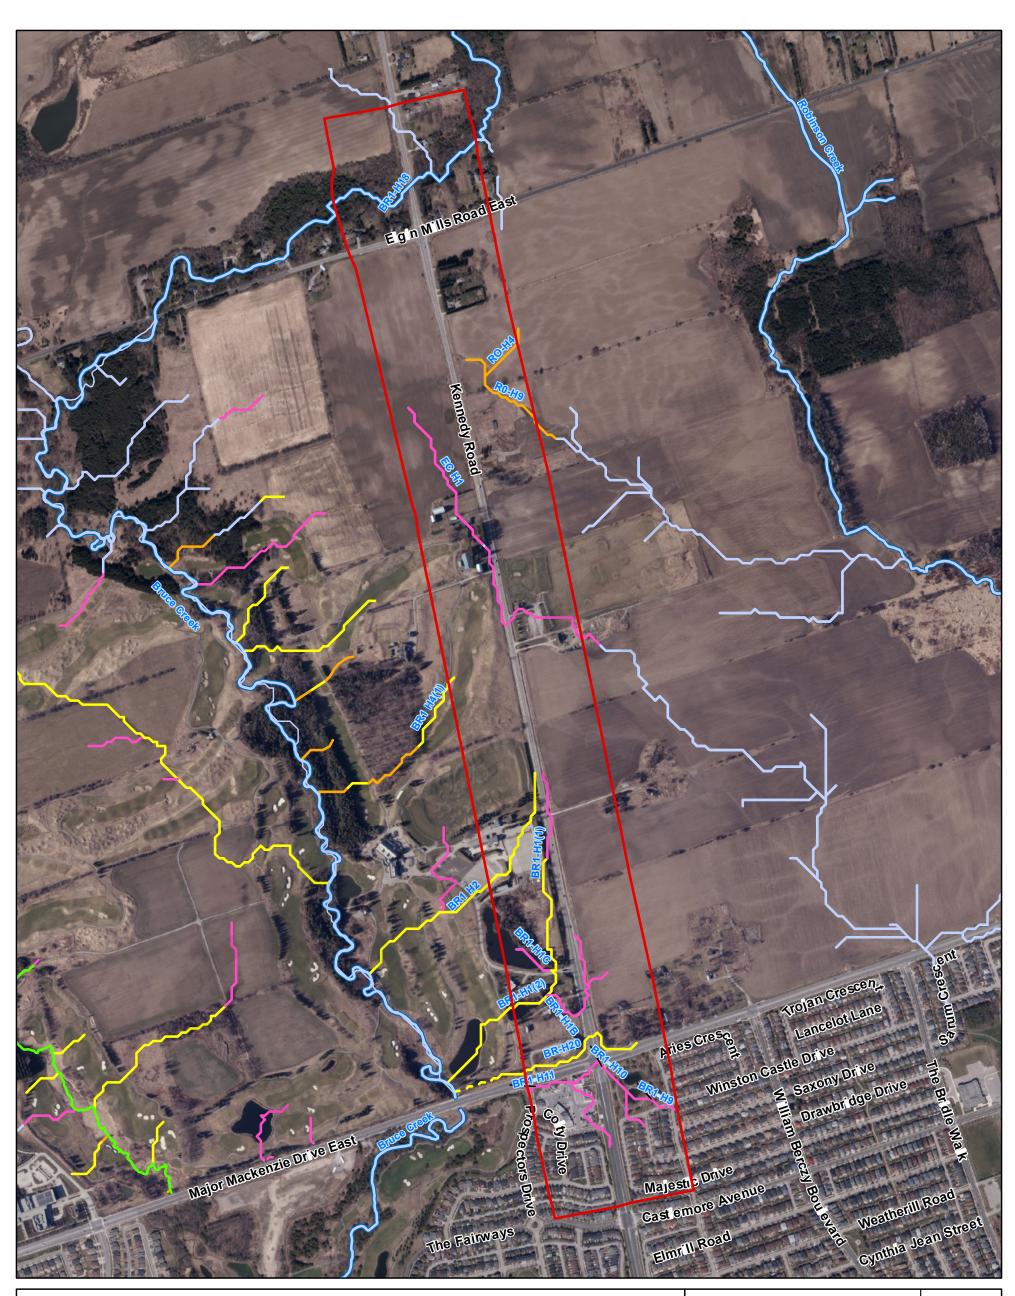
Legend		Aquatic Existing Condition	ns Figure 2
Subject Lands	Thermal Regime		
Headwater Drainage Features Assessment	Cold	Kennedy Road Natural Enviro	imental Report
Unclassified			t: 220329
Conservation			: August 2021
Mitigation		Client: Regional Prepare	
— No Management Required		Municipality of York Checke	l by: CG
Protection			0 400 m
Maintain / Replicate Terrestrial Linkage	Contains information licensed under the Ope		
Watercourse (MNRF 2019)		Ontario Orthoimagery Basela	er: 2020

Management recommendations for the FUA HDFs were addressed in the SWS Phase 1 and 2 analyses. Assessments were initially reported in the Phase 1 Characterization Report (2015) and further reviewed and revised, where required, through the Phase 2 reports and Agency consultation. The SWS Phase 1 Characterization Report provided recommendations, including those HDFs where the recommendations for "No Management" were made. Within the Subject Lands a total of ten features in the Bruce Creek Subcatchment, two features in the Robinson Creek Subcatchment (**Figure 2**). Most appear to be fed by tile drain outlets from the adjacent golf course and agricultural fields. Note that H18 is the upper reaches of Bruce Creek (**see Figure 2**).

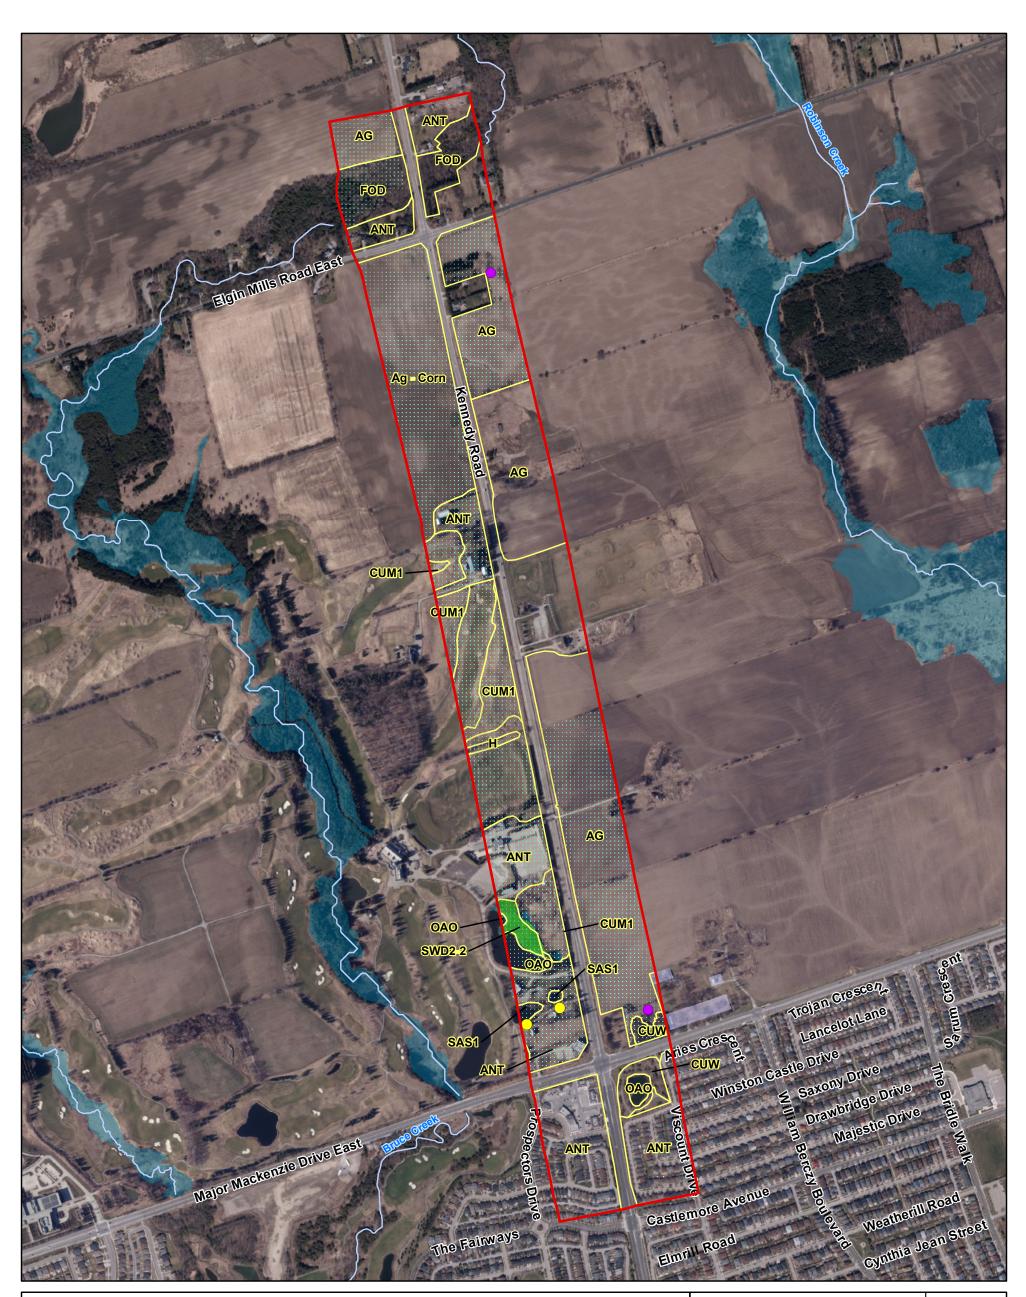
Terrest	trial Exis	sting	Conditions	Figure 3	
Kenr	Kennedy Road Natural Environmental Report				
Project: 220329 Last Revised: June 2021					
Client: Regional Prepared by: BD Municipality of York Checked by: CG					
N	1:9,100	0 L	200 I	400 m	
Contains			der the Open Goverr ery Baselayer: 2020

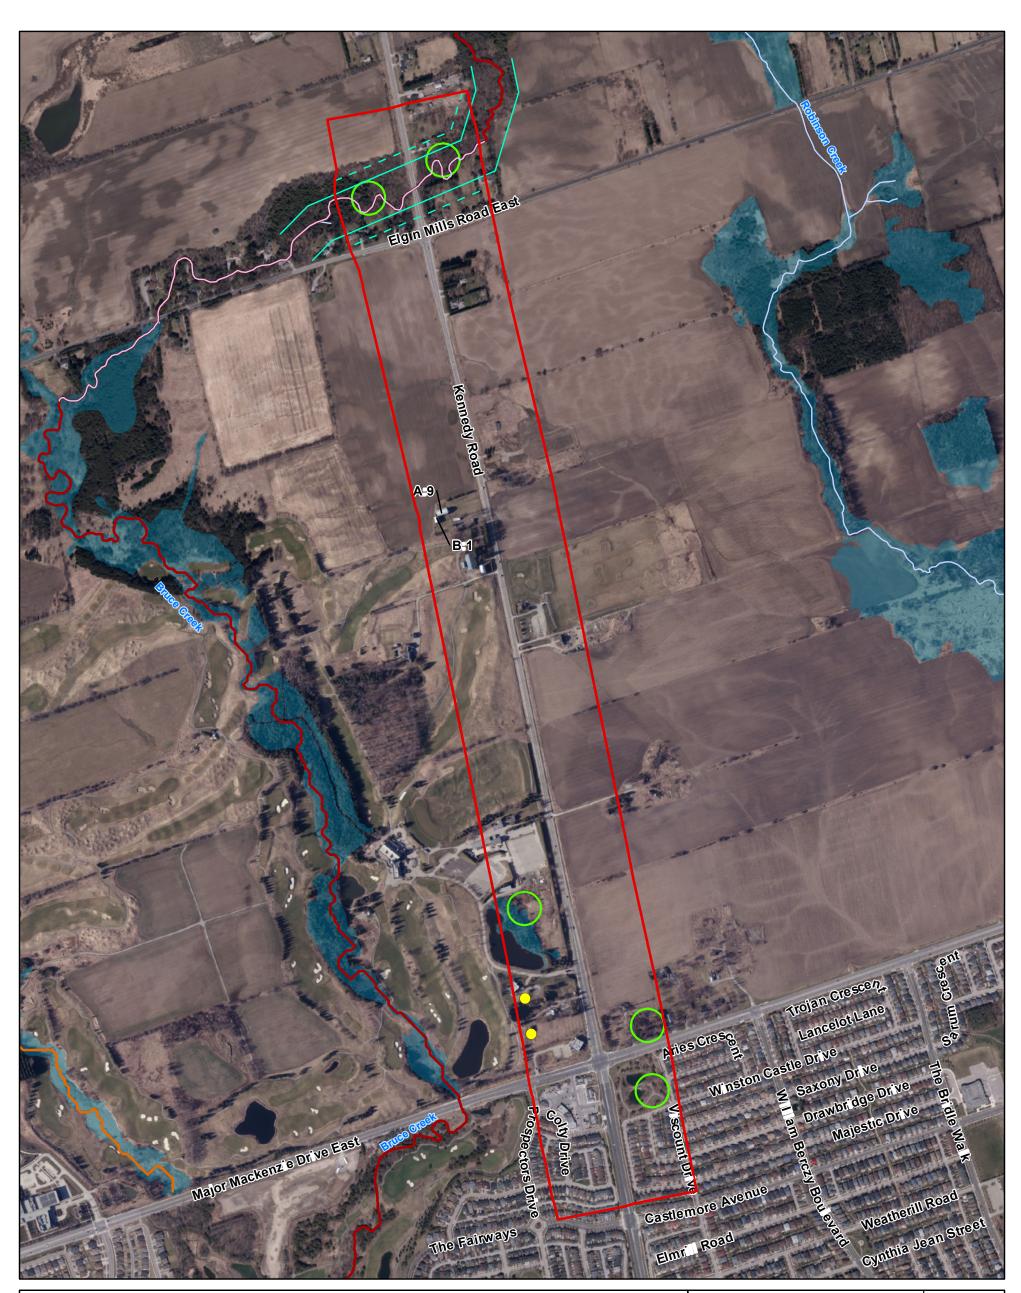
Figure 4

#### Legend Species at Risk Habitat Subject Lands **Regulated Redside Dace Habitat** Potential Bat Habitat - Contributing Habitat Kennedy Road Natural Environmental Report Watercourse (MNRF 2019) Occupied Habitat Provincially Significant Wetland (MNRF 2020) Meander Belt BEACON **Butternut Locations** $\bigcirc$ Meander Belt + 30 m \_ \_ Last Revised: June 2021 Building Code: Number of Nesting B3: Barn Swallow (2013) **Client: Regional** Municipality of York 0 1:9,100 A Contains information licensed under the Open Government License-

Barn Swallows are designated threatened under the provincial ESA and are provided species and habitat protection under Section 9 and 10 of this legislation. This species builds their mud nests on any available ledges, vents or windowsills. Nests can also be built on vertical walls with rough surfaces (e.g., brick or wooden walls) under an overhang for overhead protection (MNRF 2017b). Barn Swallows require access to suitable open habitat for foraging and mud for nest building (Heagy *et al.* 2014); as such, nesting individuals are typically found within 200 m of grasslands, wetlands, riparian habitats and waterbodies (MECP 2019). Habitat for this species has been confirmed among the numerous buildings on the farms along Warden Avenue within the Subject Lands. Pre-construction nest surveys for Barn Swallow will be completed for any structures/buildings that will be affected by proposed works to determine permitting expectations (refer to **Figure 4**).
