Appendix G

## Natural Environment Report and Existing Natural Features Technical Memo

# Natural Environment Report Kennedy Road from Major Mackenzie Drive to Elgin Mills Road Markham, Ontario

Prepared For: Regional Municipality of York

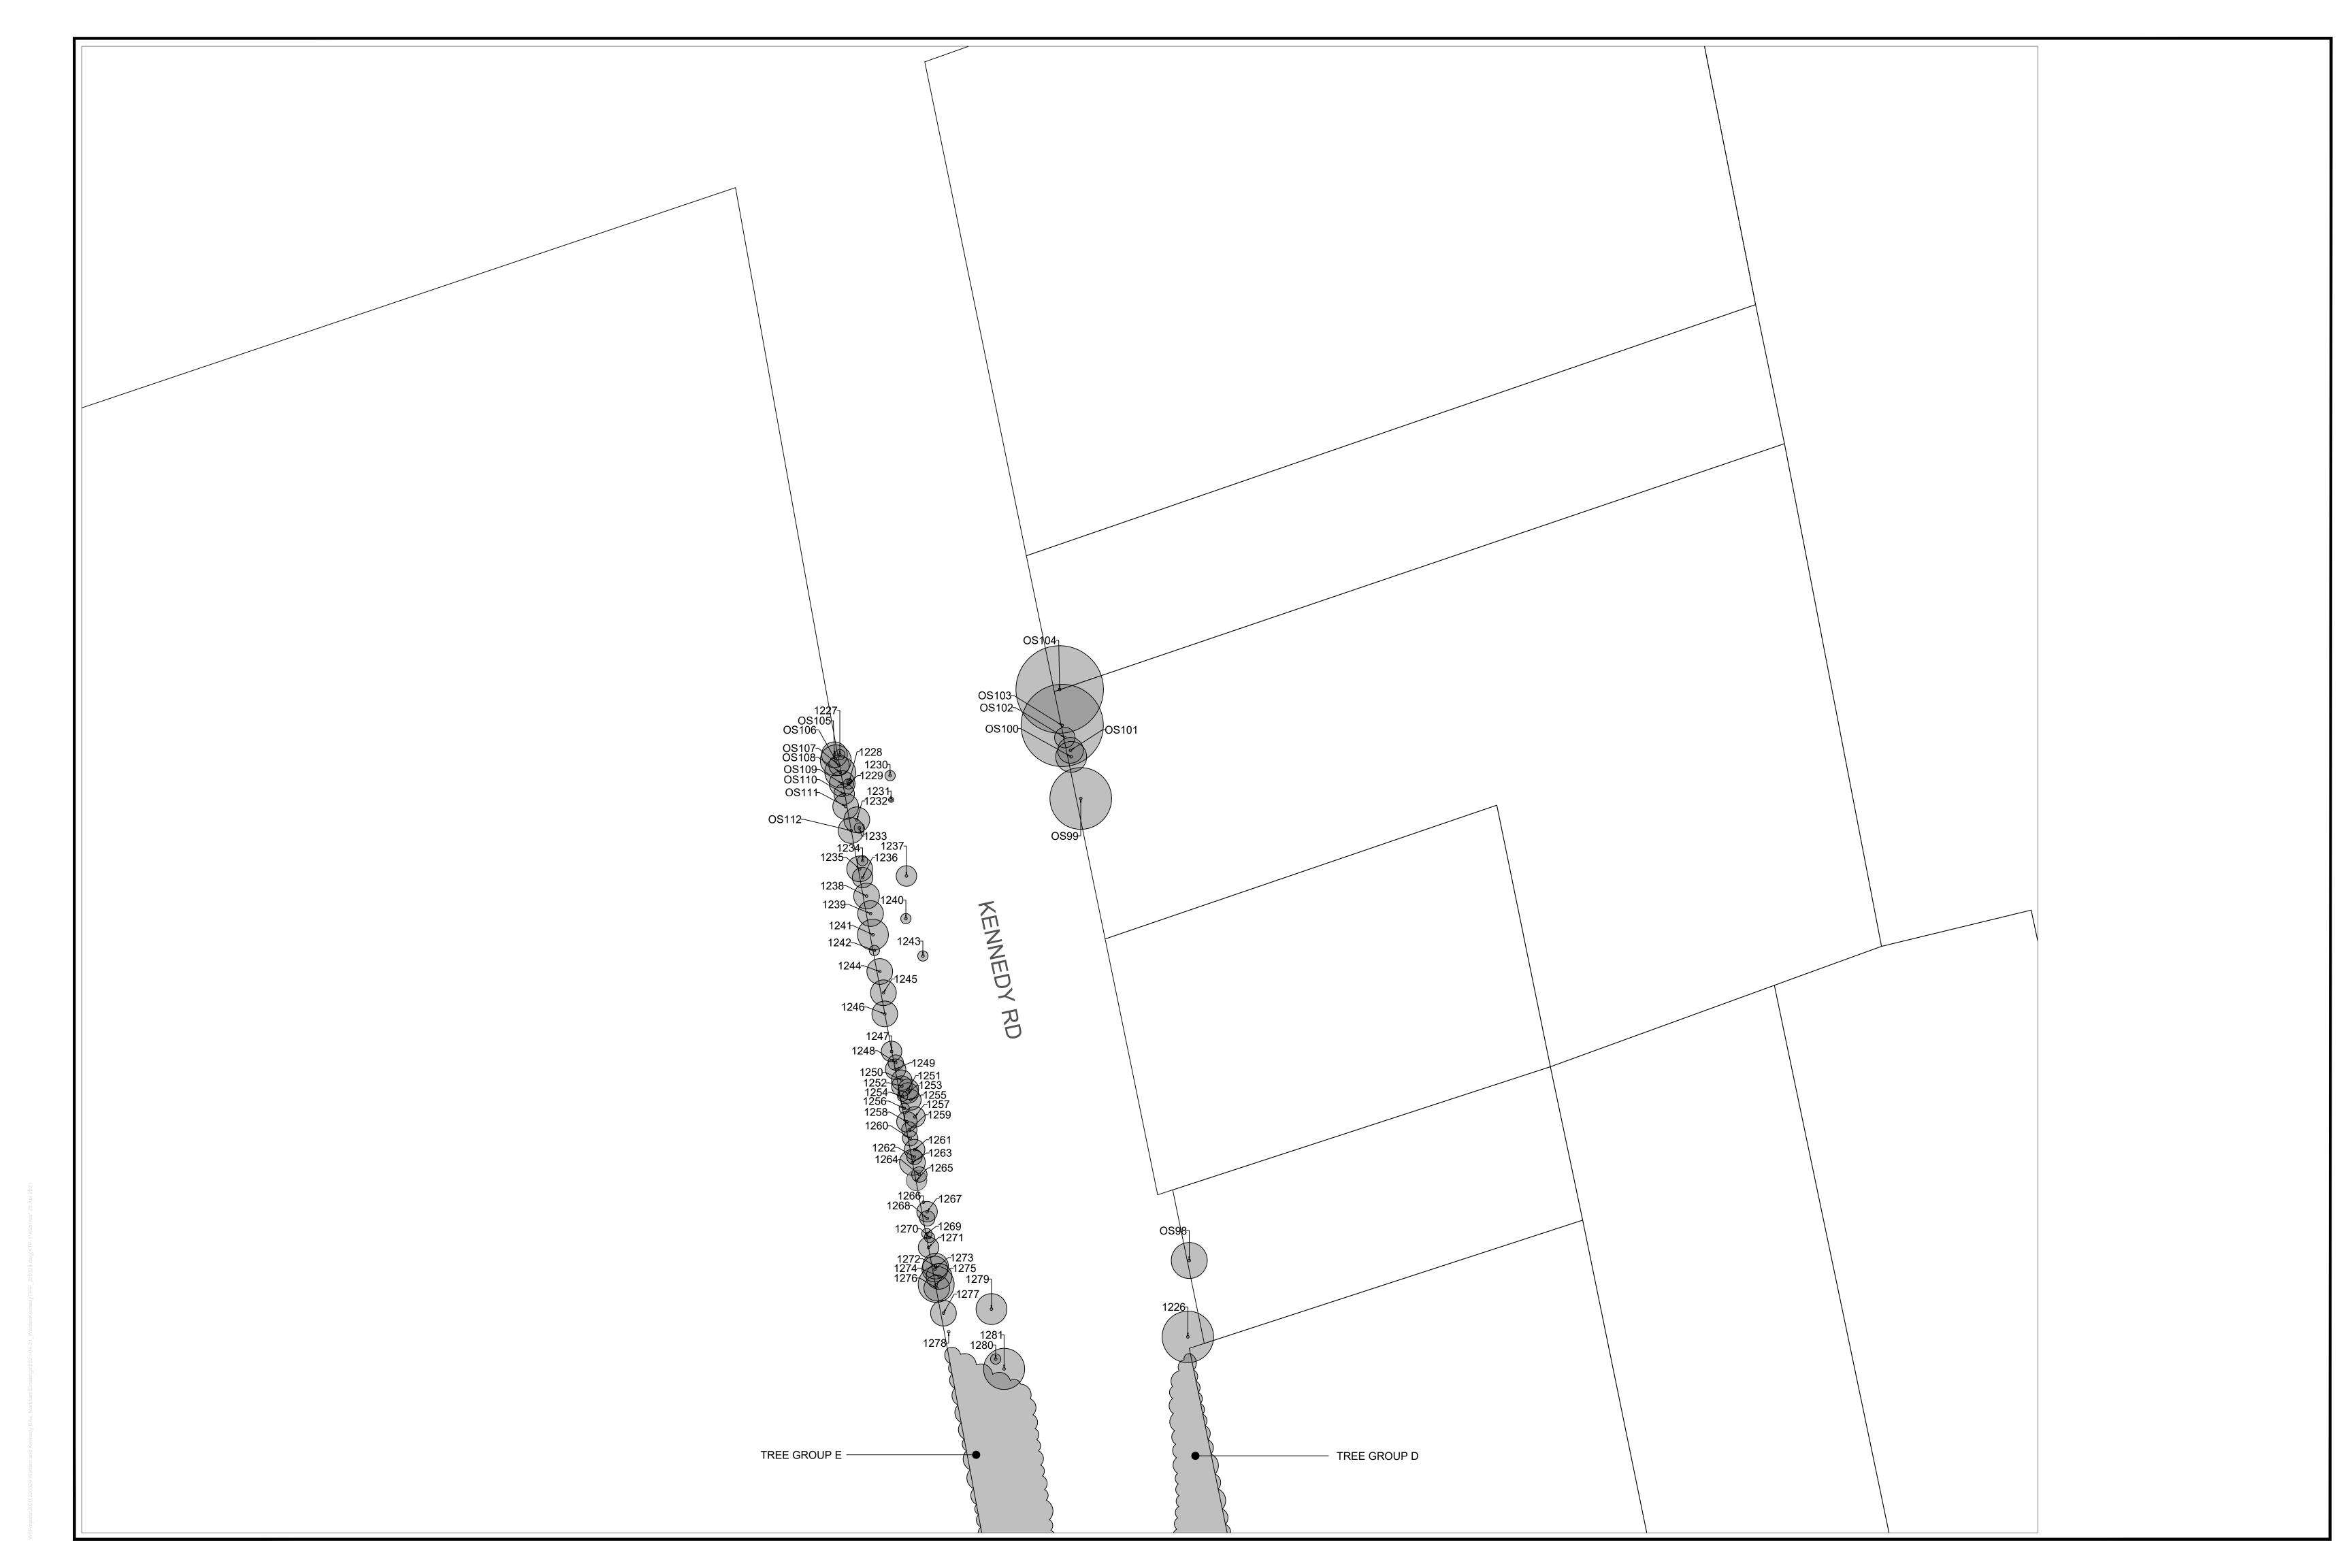
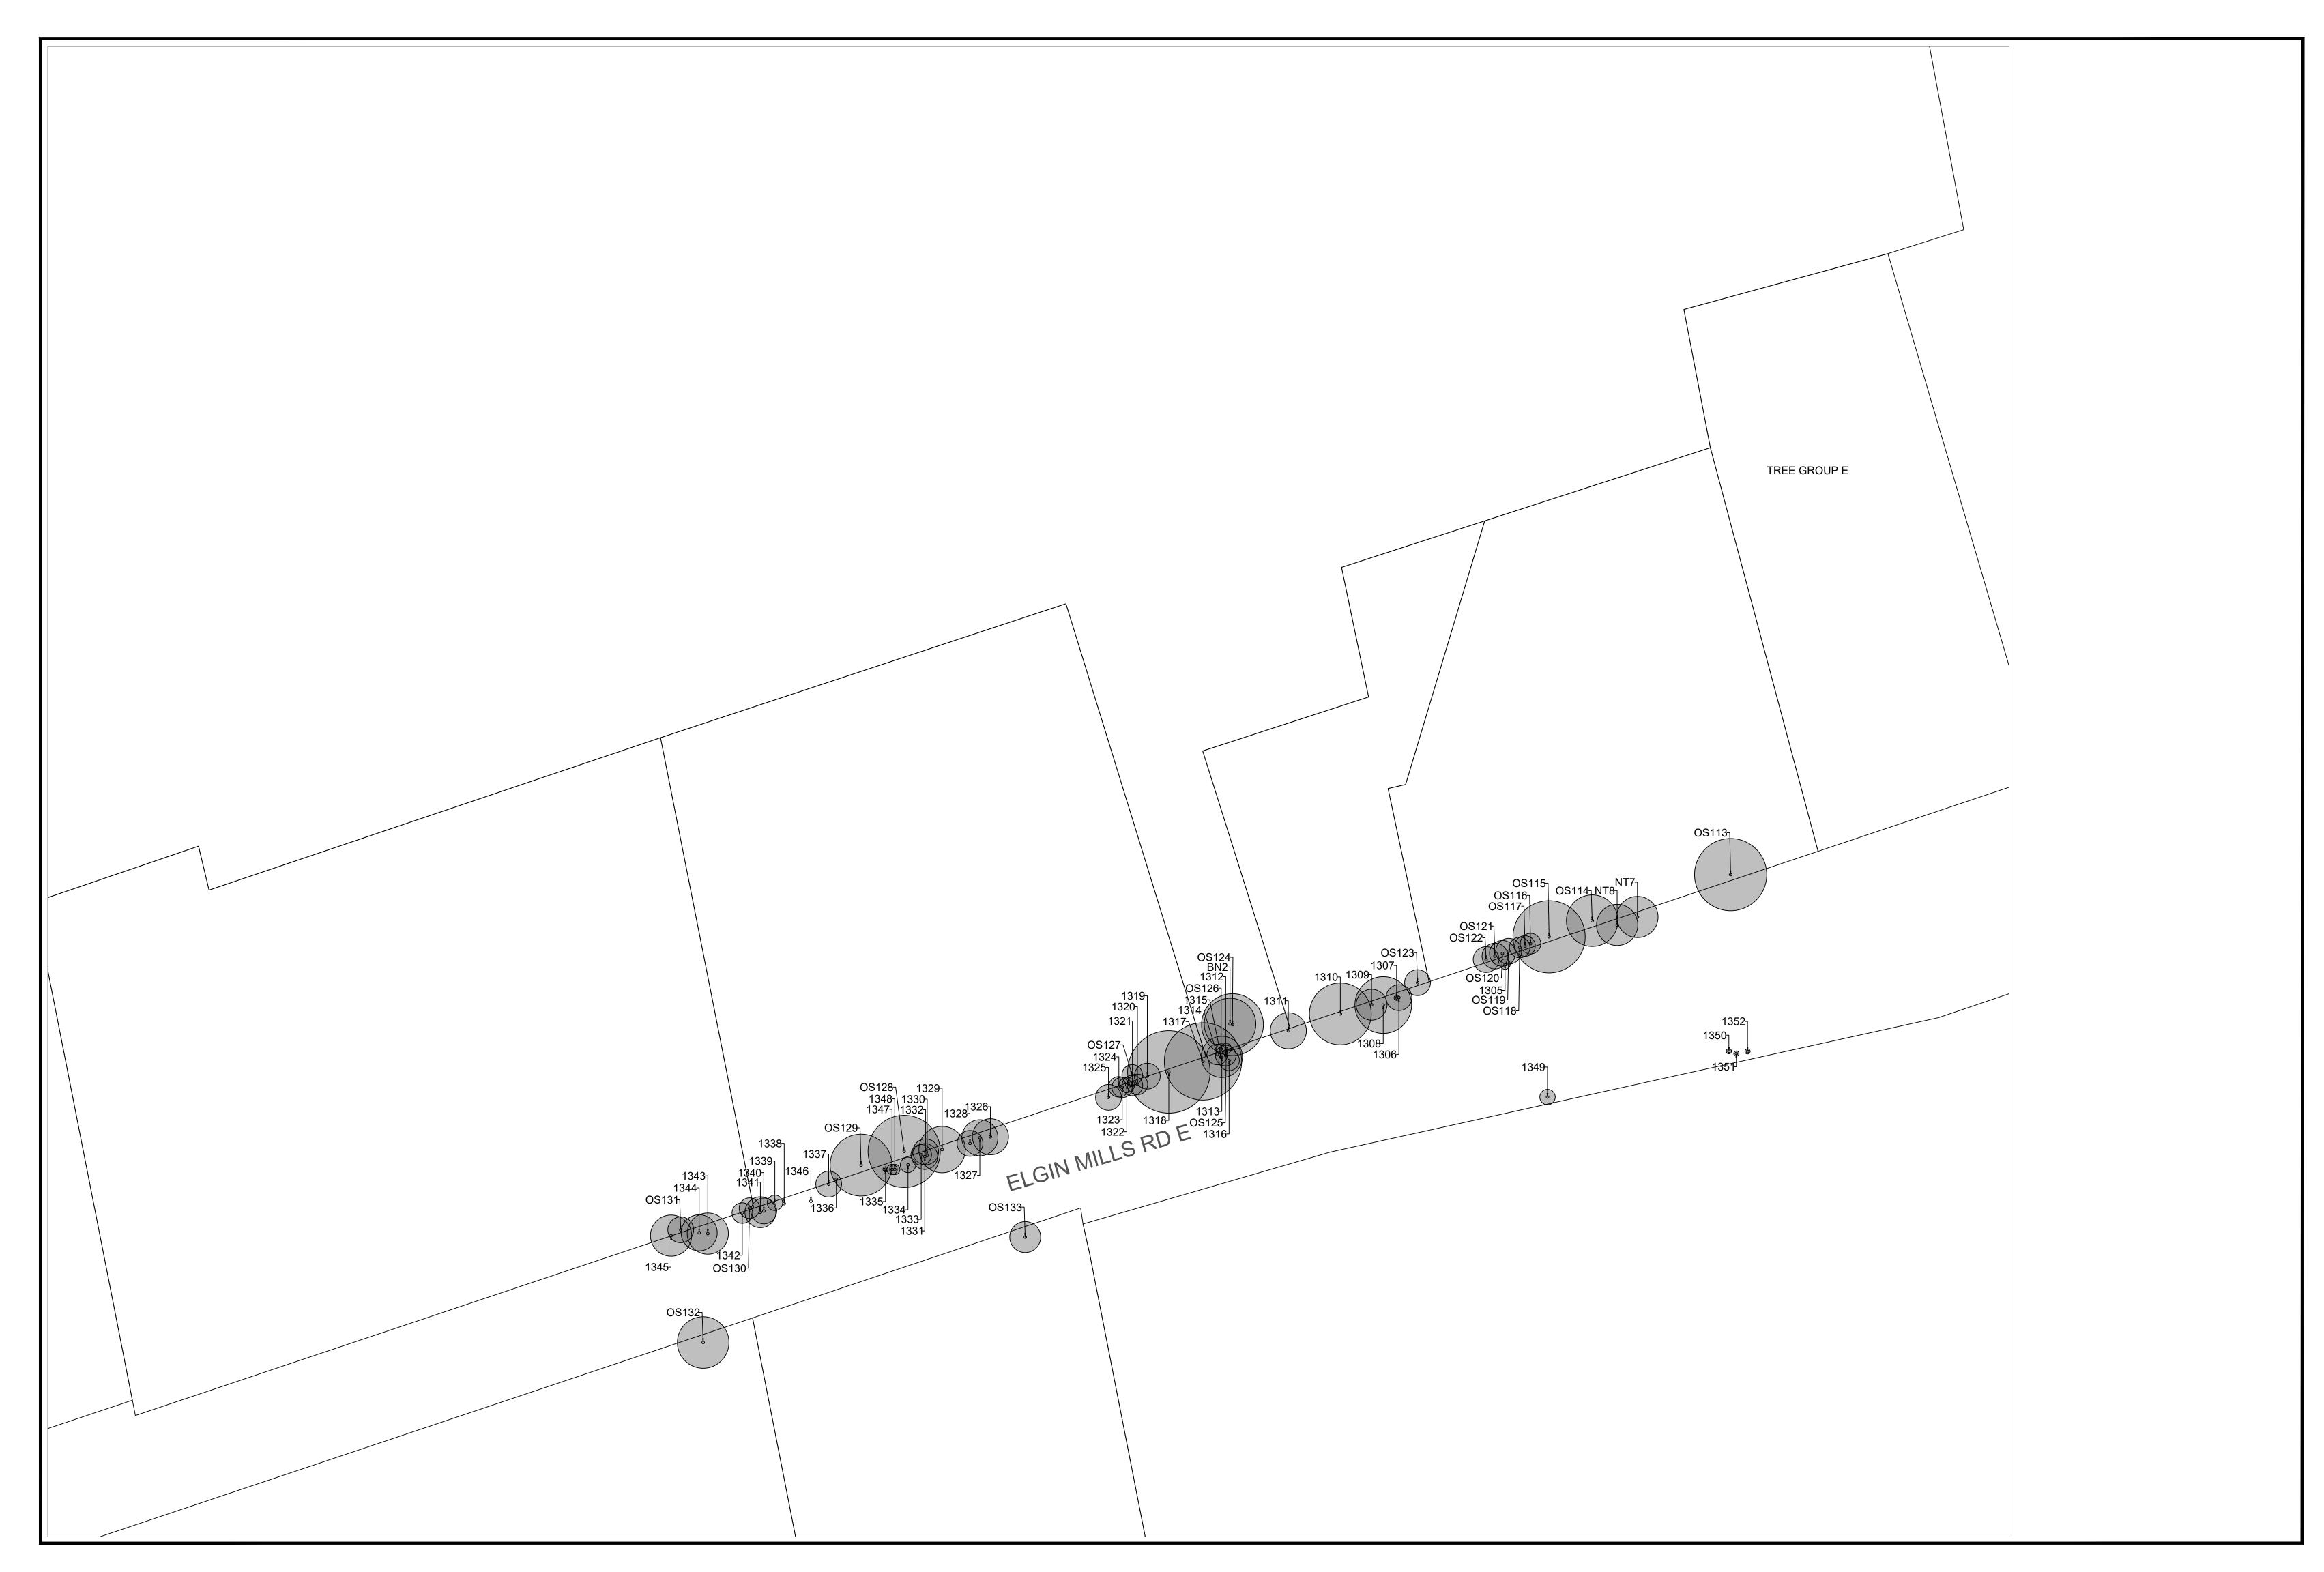
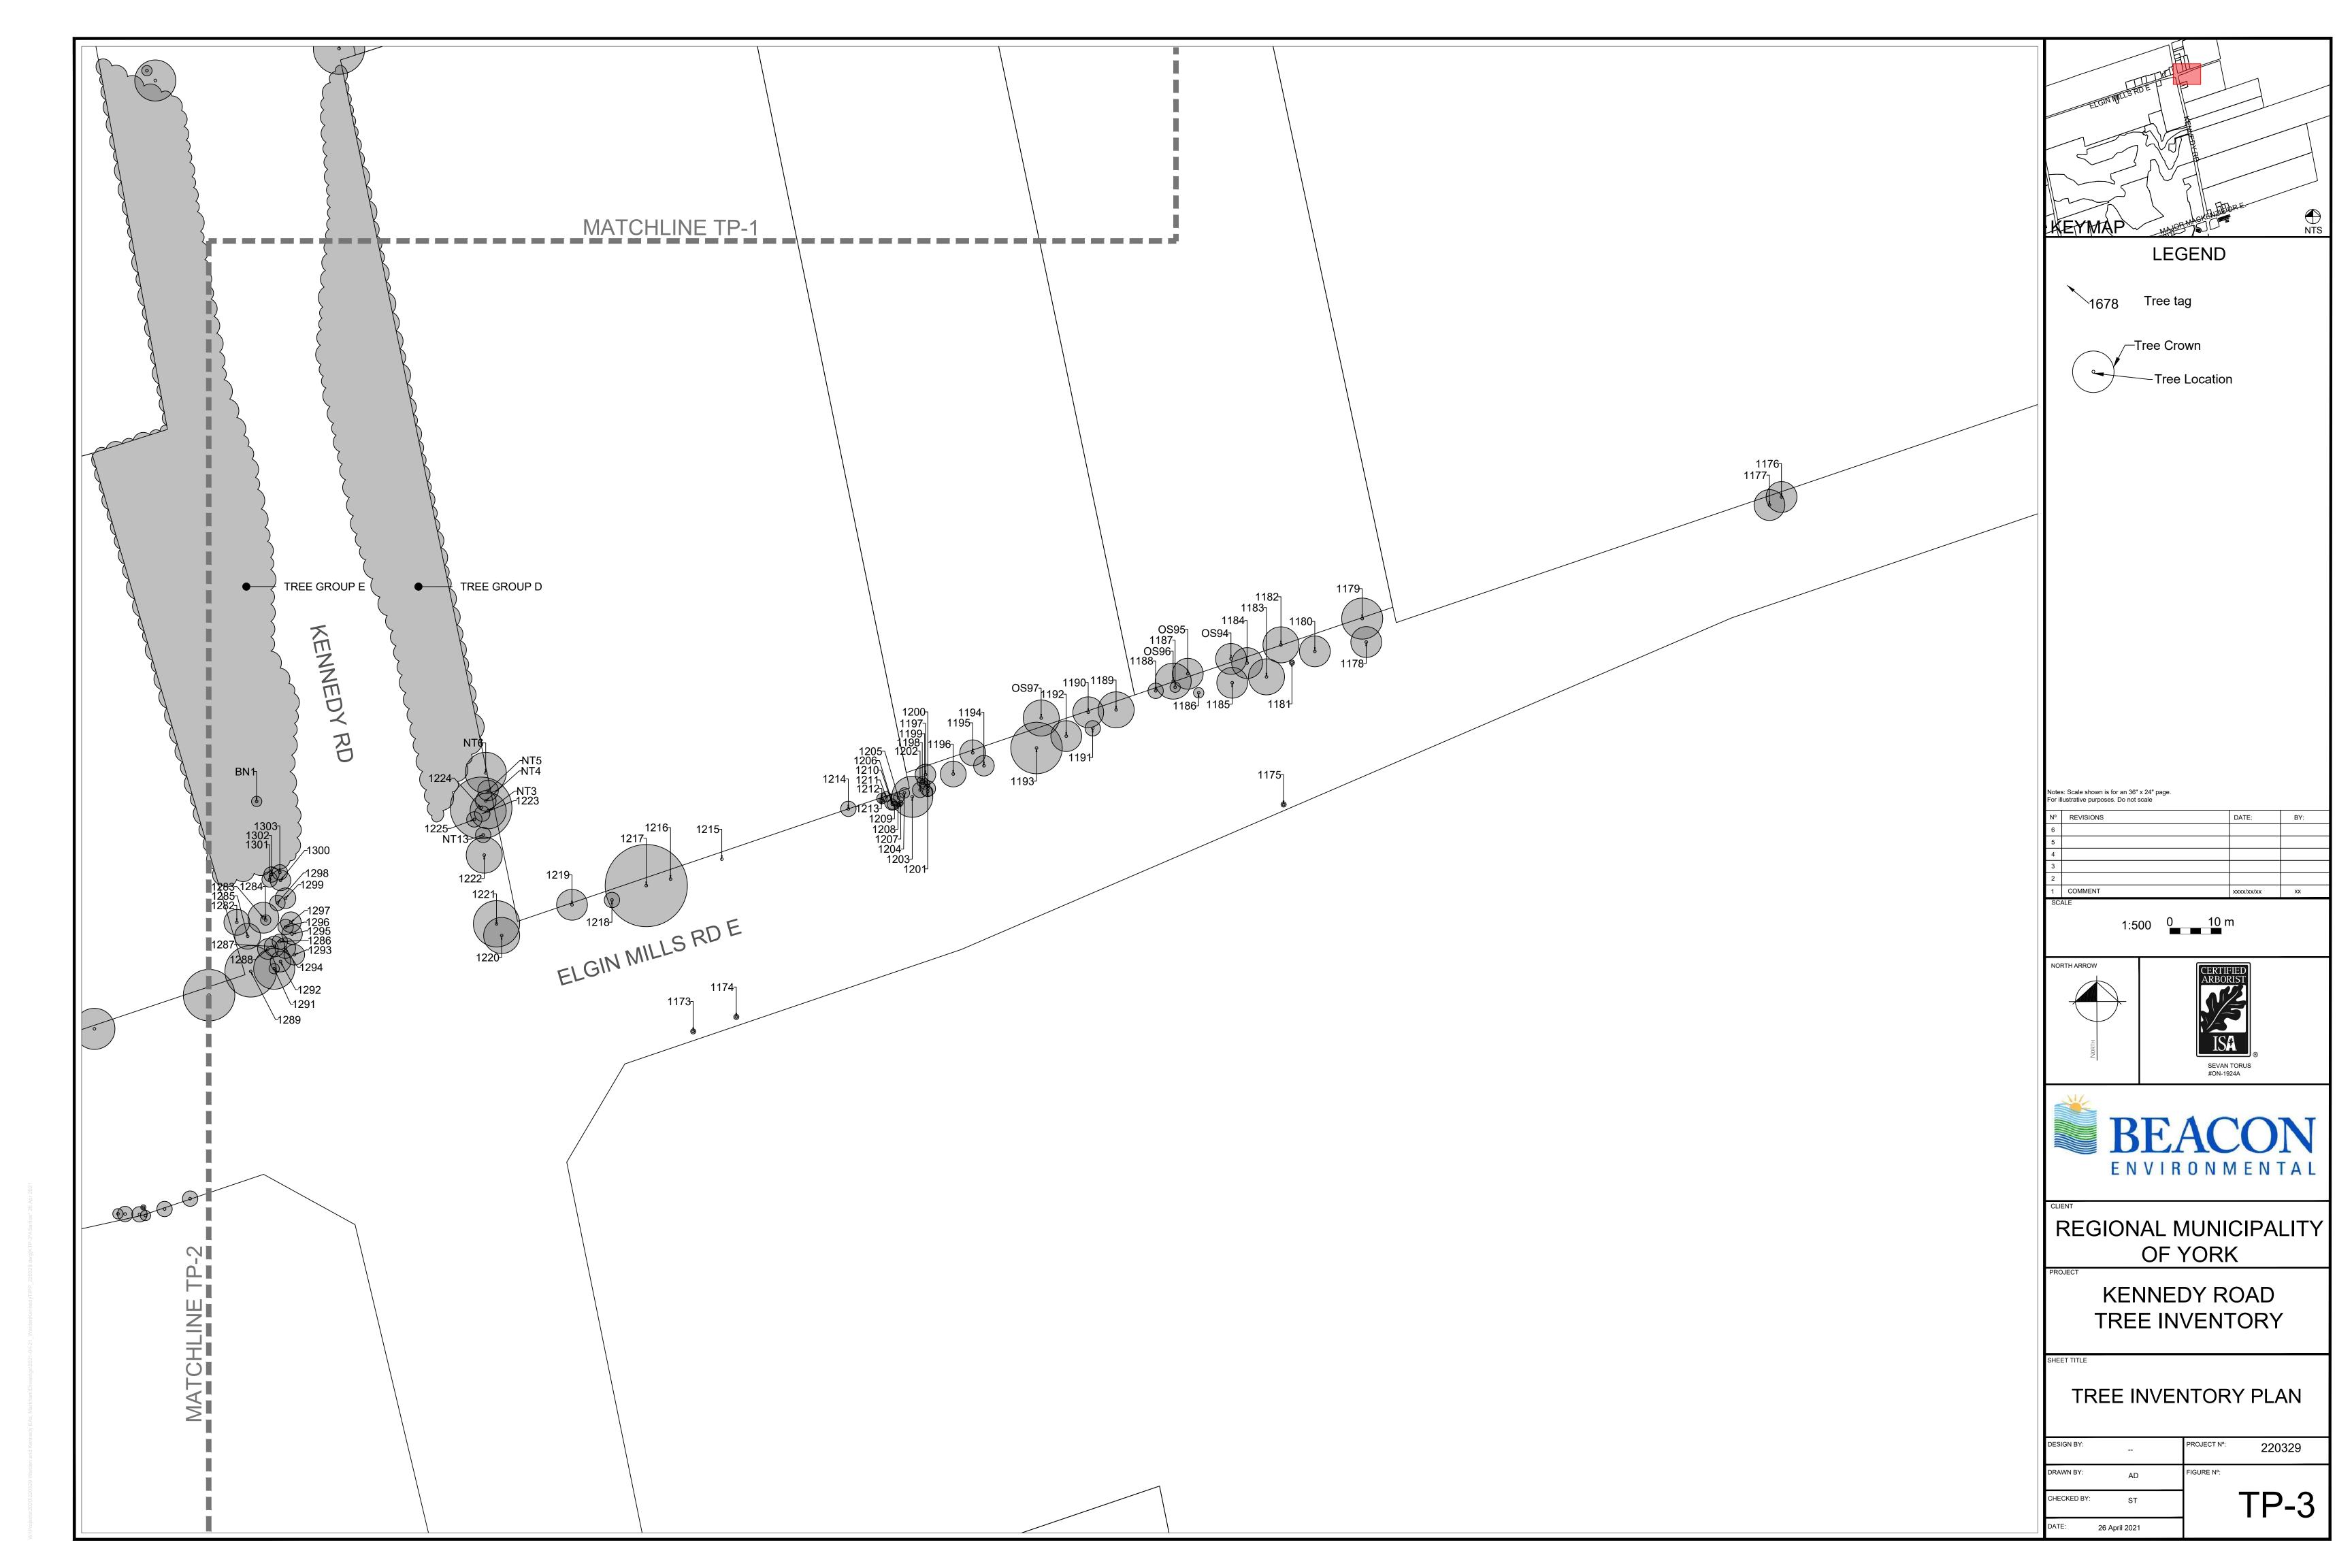
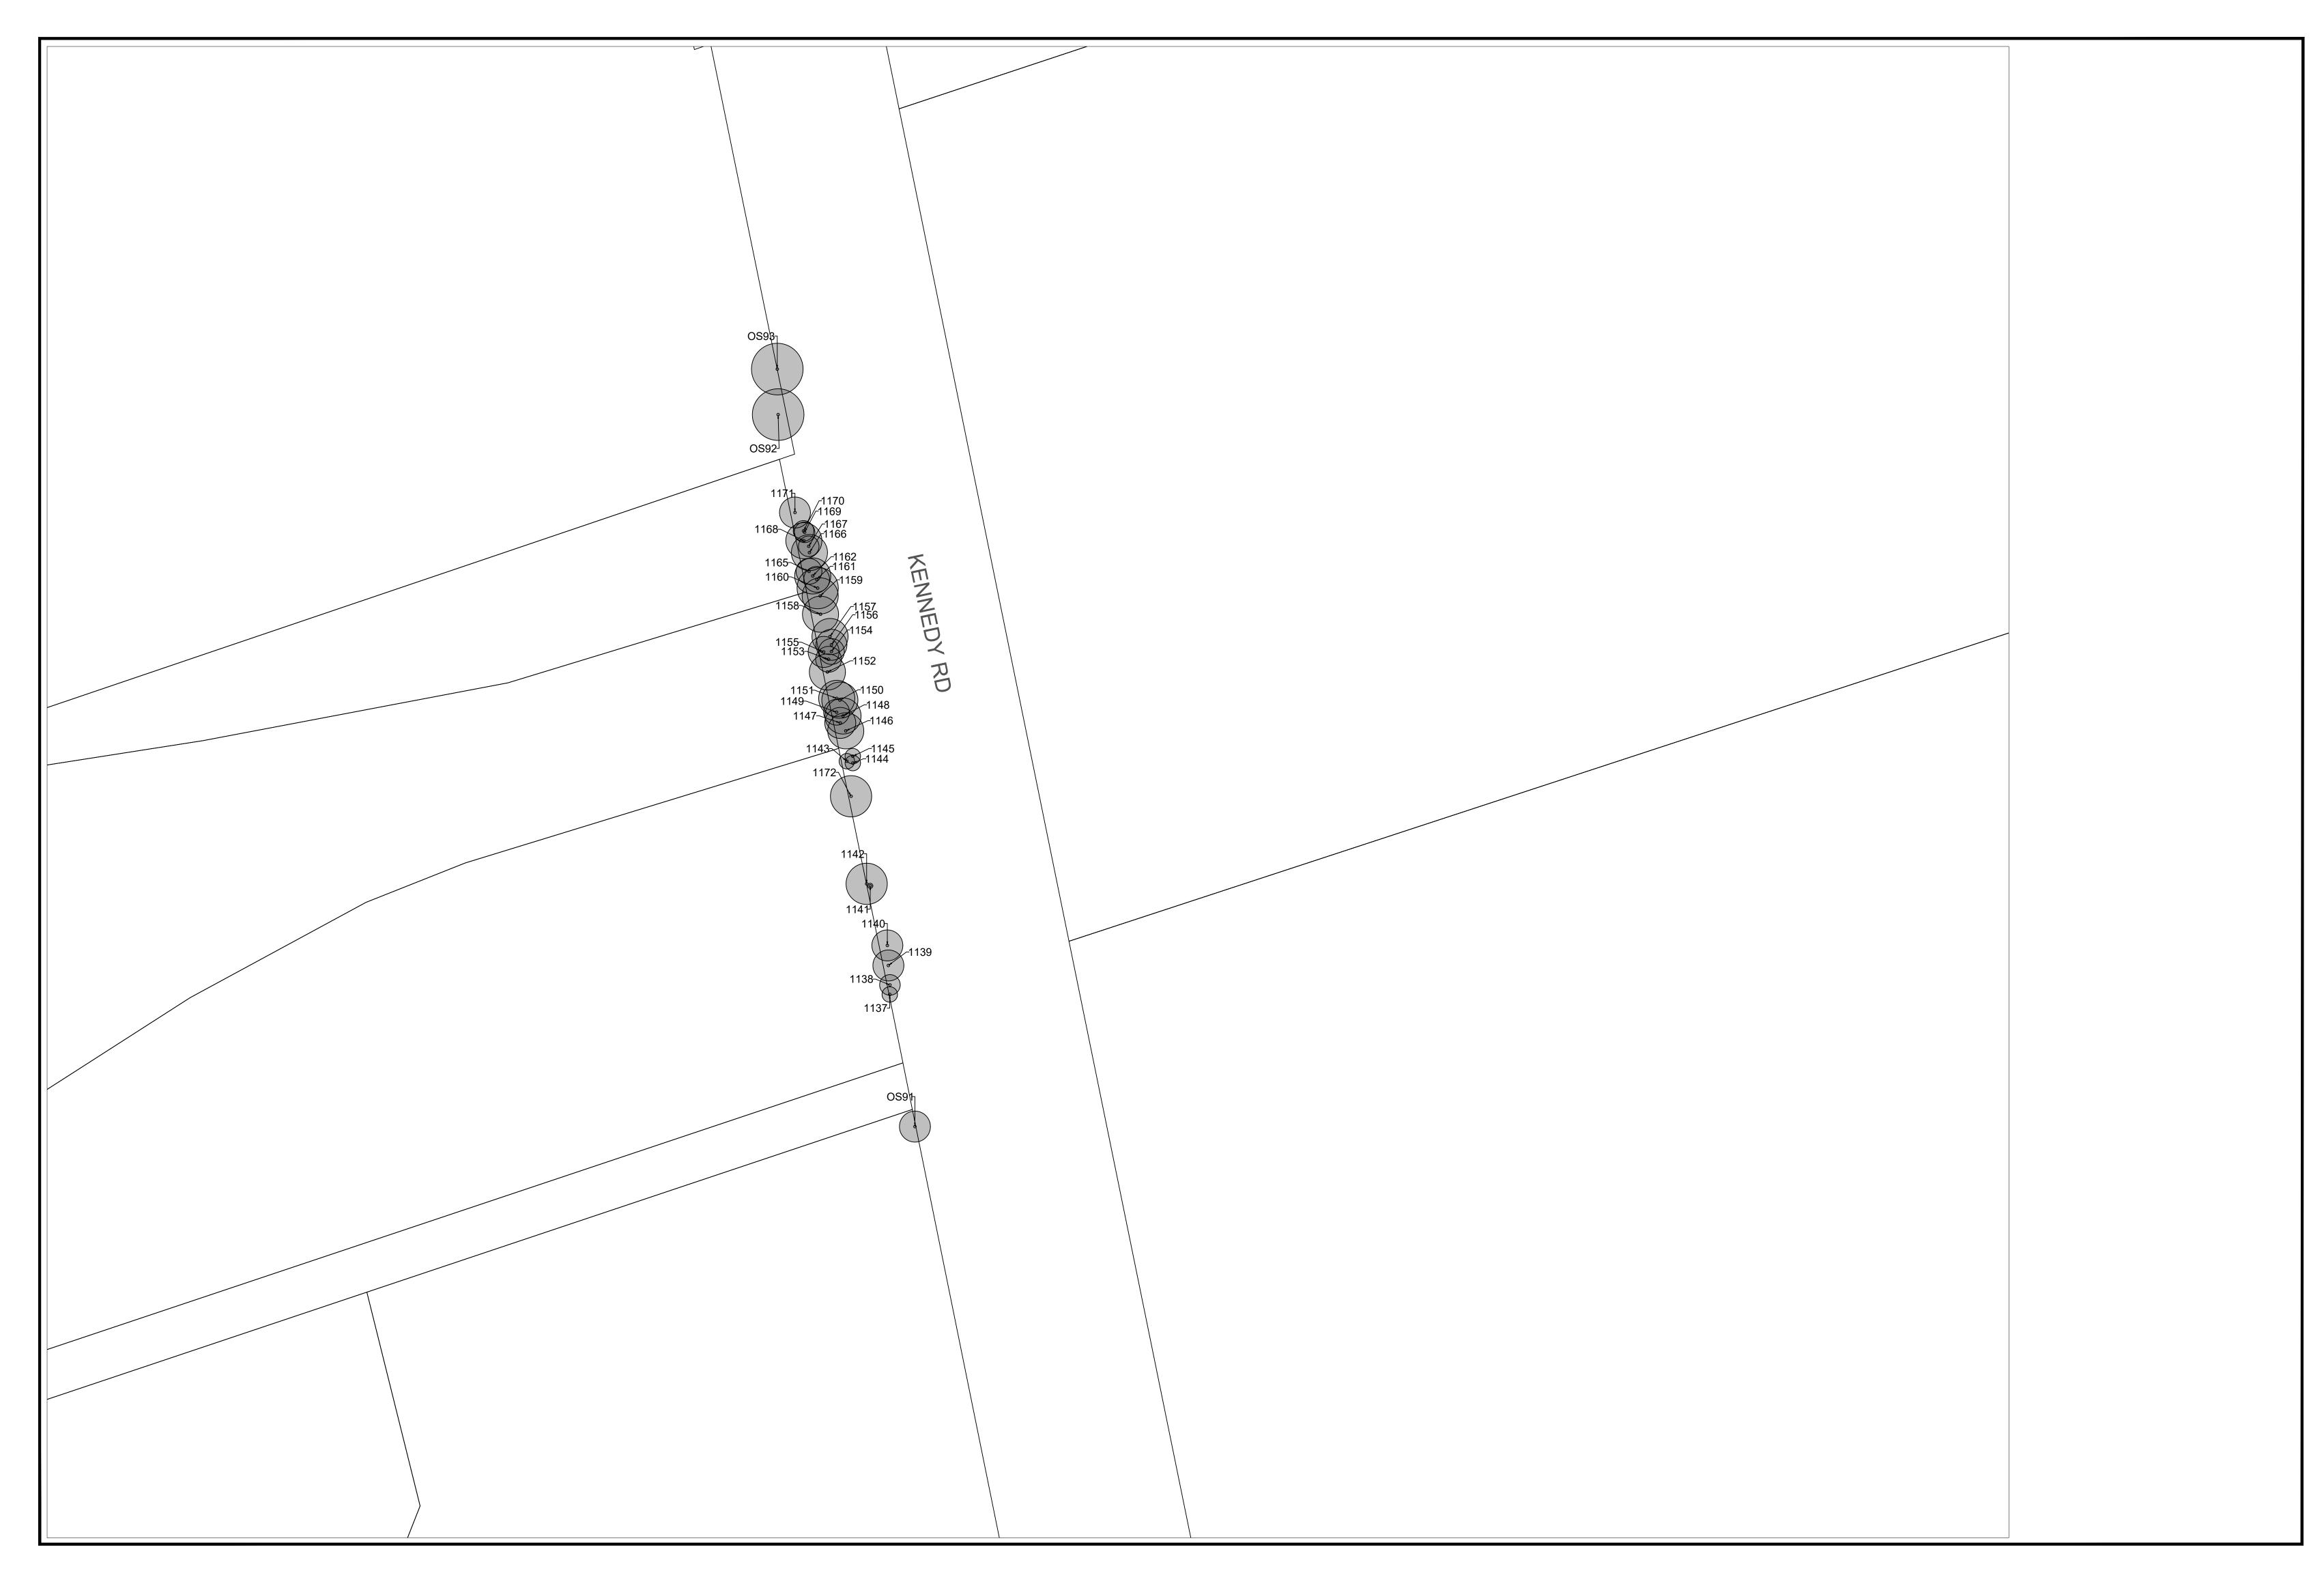
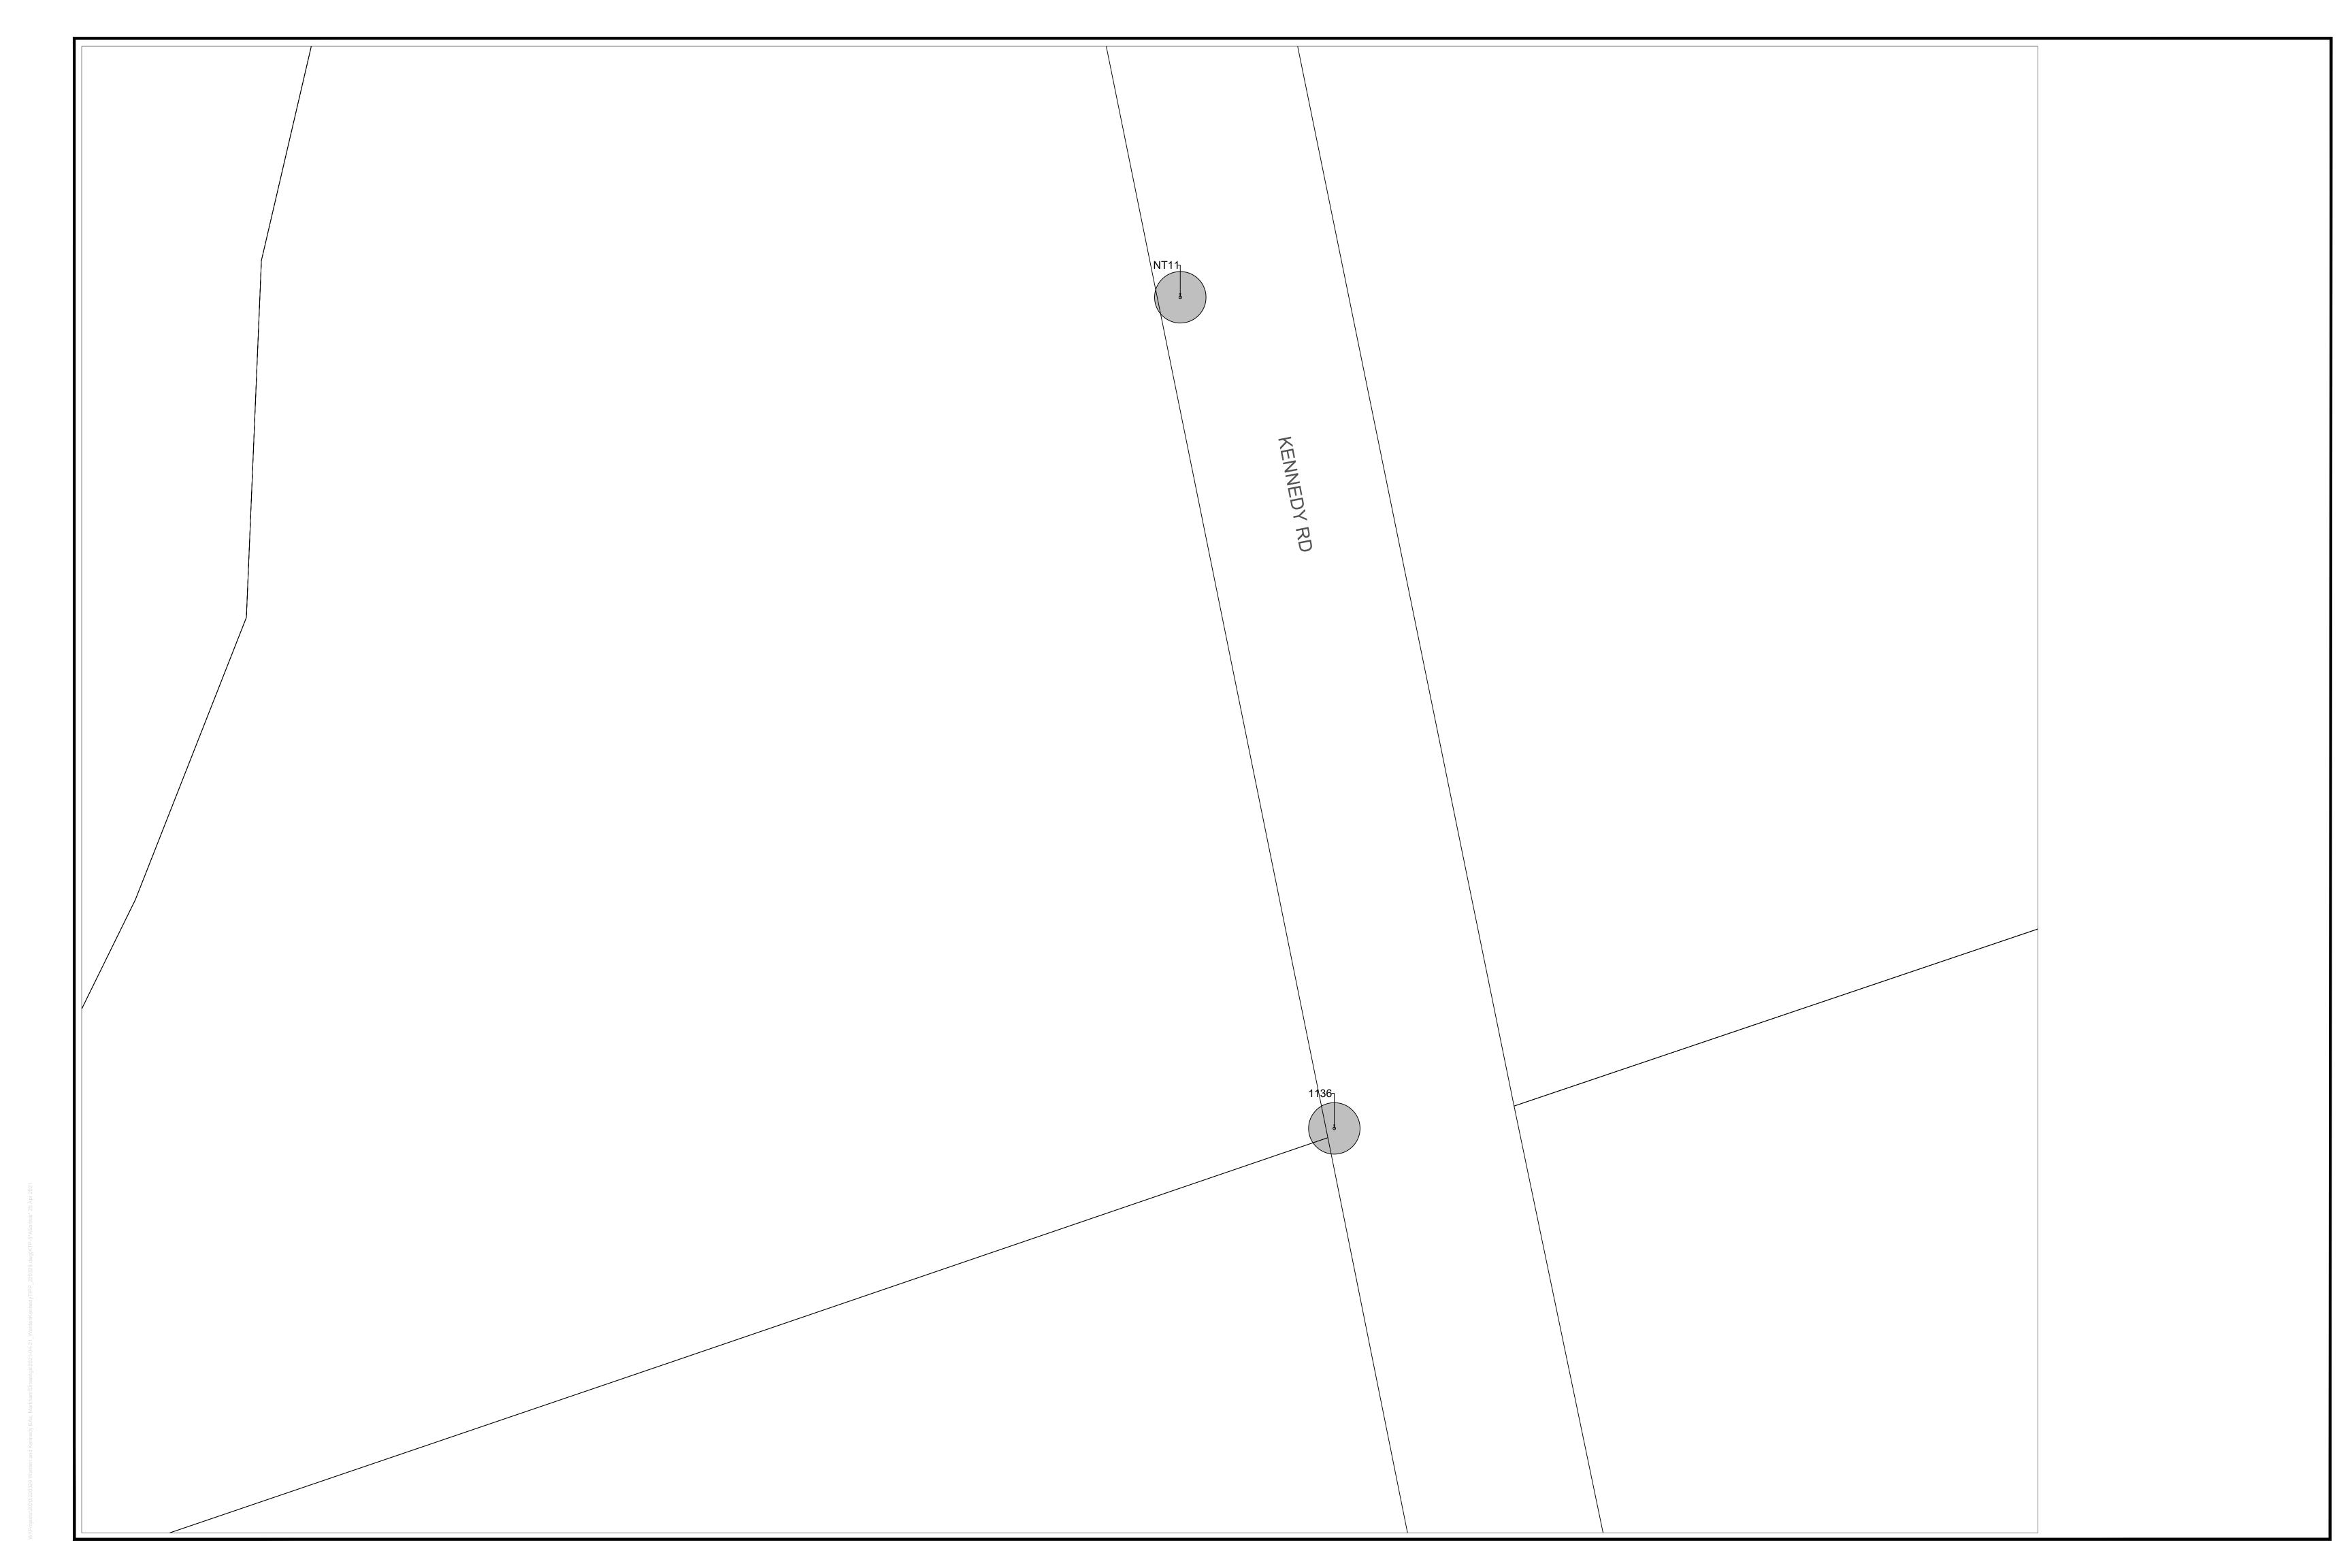
**Tree Inventory**

TREE	INVENTO	RY TABLE													
A	В	С	D E DBH Crown DBH Diameter	F	G	A 185 1170	B Picea abies	Norway Spruce	D 27	E 4	Fair-Good	G Minor dieback due to overcrowding.	A 5 1340	Acer platanoides	C. Norway Maple
1 <b>Tag/Tree No.</b>	Scientific Name Picea pungens	Colorado Blue Spruce	(cm) (m)	Good	Comments Good form and vigour; Crown raised.	186         1171           187         1172	Picea abies Quercus rubra	Norway Spruce Red Oak	46 22	8	Fair-Good Good	Minor dieback due to overcrowding. Good form and vigour; Tree located offsite on adjacent private property; DBH approximate as trunk not accessible	6 <u>1341</u> 7 <u>1342</u>	Pinus sylvestris Acer platanoides	Scots Pine Norway Maple
3         33           4         35           5         82	Aesculus glabra Tilia cordata Acer platanoides	Norway Maple	13         3           61         12         Fa           46         12         Fa	Good air-Good Good	Good form and vigour. Minor dieback and thinning. Good form and vigour.	188         1173           189         1174           190         1175	Fraxinus americana Fraxinus americana Fraxinus americana	White Ash White Ash White Ash	6	1 1 1	Good Good Good	Good vigour.	8 1343 9 1344 0 1345	Acer platanoides Acer platanoides Acer platanoides	Norway Maple Norway Maple Norway Maple

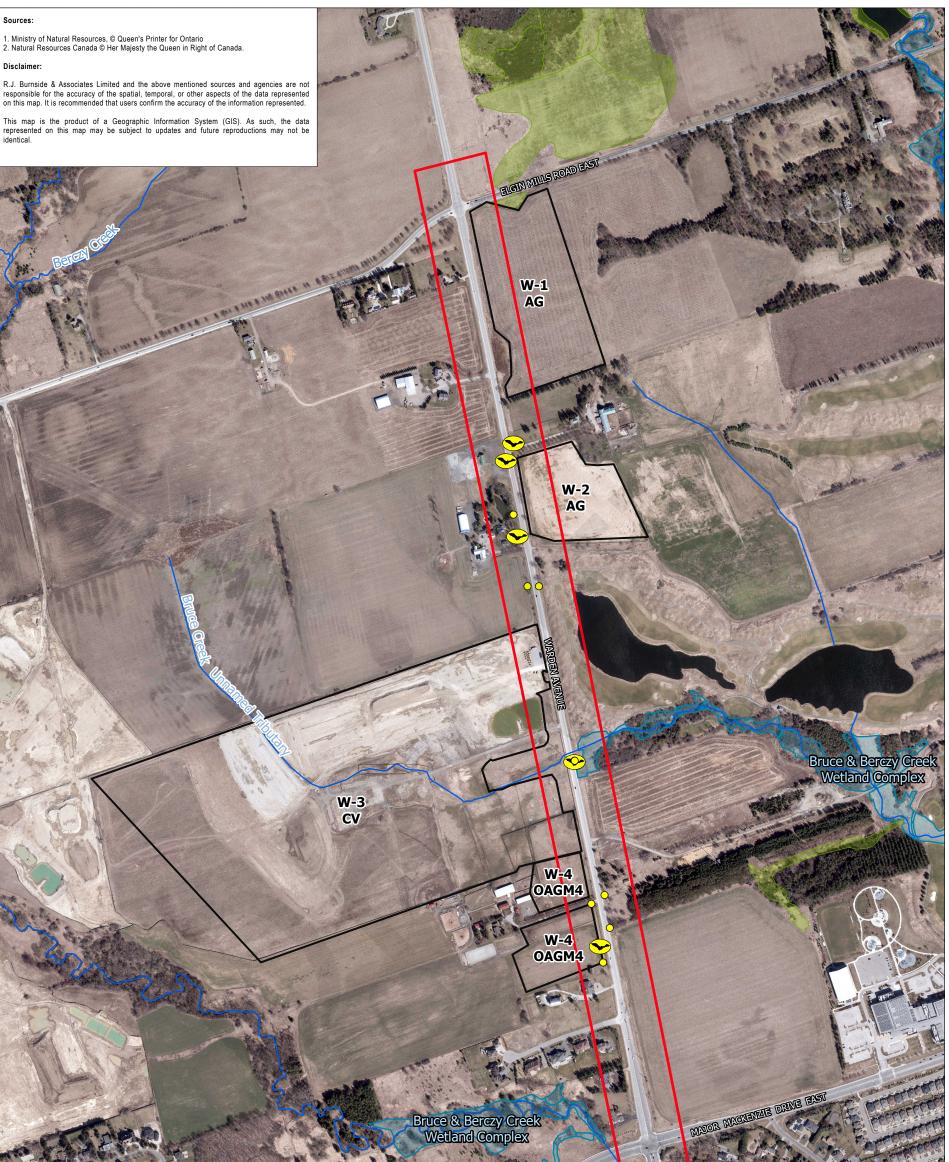
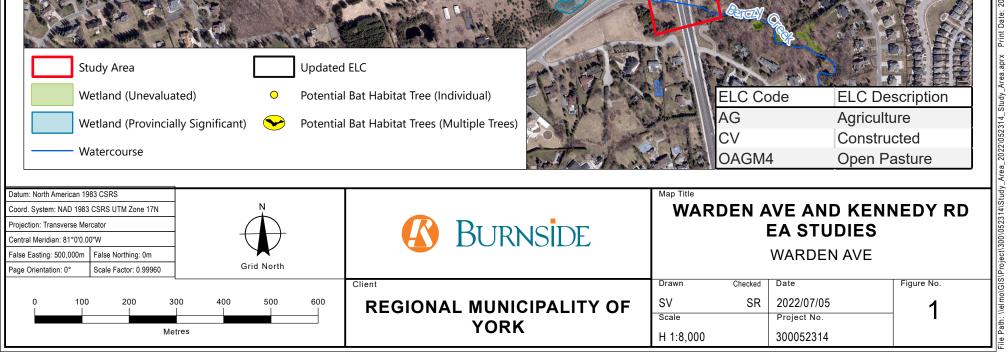
Enclosure(s) Figure 1 – Warden Avenue and K Figure 2 – Warden Avenue and K

In total, six communities consisting of undefined and defined ELC vegetation community descriptions from the 2021 Beacon Report, were updated following the 2022 Site Reconnaissance. Updates to ELC vegetation communities are outlined in Table 1. Updates to areas of potential SAR habitat are outlined in Table 1 and illustrated in Figures 1 and 2.

During the 2022 Site Reconnaissance, two Butternut trees were identified at the northern limits of the Kennedy Road Study Area, north of Elgin Mills Road, located immediately adjacent to the Study Area ROW, approximately 27 m and 29 m from the existing road centreline of Kennedy Road, on the south side of Bruce Creek. See Figure 1.

Fish habitat within the Study Area was identified during the 2022 Site Reconnaissance based on observations of aquatic features (see Figures 1 and 2):

During the 2022 Site Reconnaissance, potentially suitable bat roost habitat trees were identified within or adjacent to the Warden Avenue and Kennedy Road Study Areas. See Figures 1 and 2.

Potential habitat for Redside dace was observed within the Study Areas during the 2022 site visit. Redside dace habitat is present within Berczy Creek crossing on Warden Avenue, south of Major Mackenzie and within the Bruce Creek crossing on Kennedy Road, north of Elgin Mills. Additional Redside dace contributing habitat is present within the Warden Avenue crossing of the tributary of Bruce Creek, located approximately 840 m north of the intersection of Major Mackenzie Drive. See Figures 1 and 2.

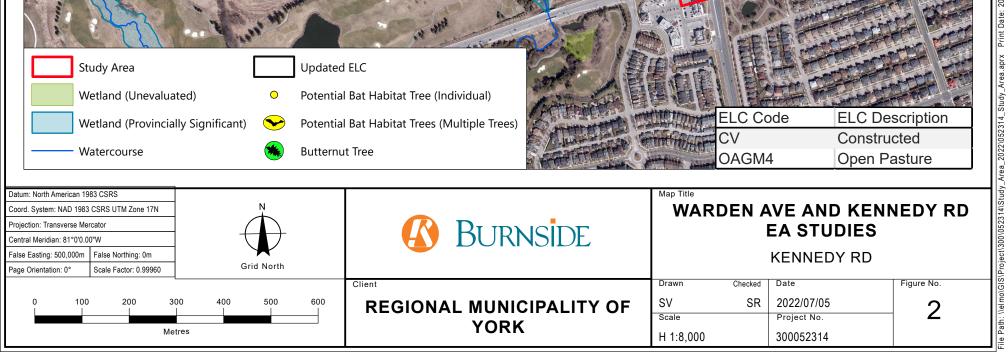
-	/ Observations	SAR Potential Habitat		
Location	2021 Beacon Reports	2022 Site Reconnaissance	Within Study Areas	Adjacent to Study Areas	
Figure 2	– Kennedy Road				
K-1	Agriculture with Breeding Bird Survey Area	Constructed (Earthworks in Progress)	No SAR potential	No SAR potential.	
K-2	Agriculture with Breeding Bird Survey Area	Open Pasture	No SAR potential	Size of available habitat not considered suitable habitat for area sensitive avian SAR.

Bruce & Berczy Creek Wetland Complex ELGIN MILLIS ROAD EAST

K-1 FCV
