**Contamination Overview Study Report**

Contamination Overview Study Warden Avenue and Kennedy Road between Major Mackenzie Drive East and Elgin Mills Road East

The Regional Municipality of York Markham, Ontario

January 2023 300052314.0000

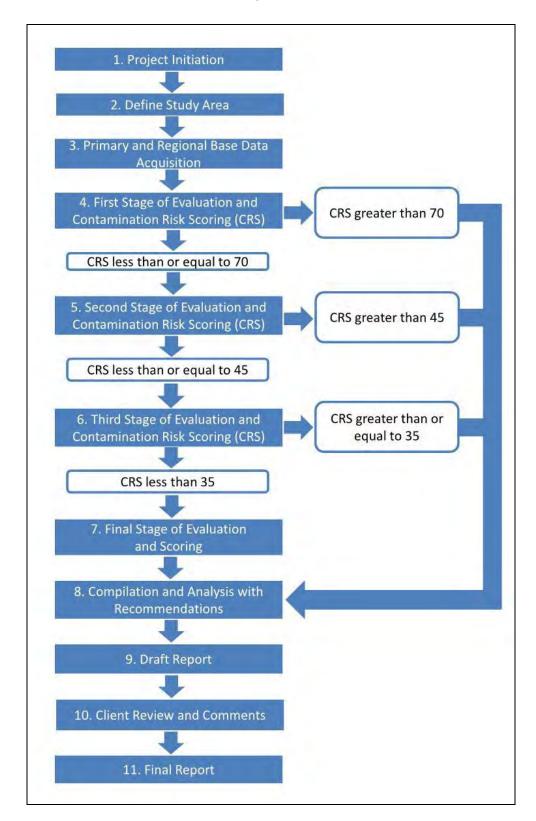
#### **Chart 1: Contamination Overview Study Flow Chart**

Chart 1 is a flow chart which displays the general steps of the COS process to evaluate and score an individual Site.

As shown in Chart 1, the evaluation is based on a step-by-step iterative process where each Site is screened and scored until each is defined within one of the environmental risk categories noted above. As shown, once a Site has been determined to be High Environmental Concern, it is no longer scrutinized in detail as the risk level determined by the CRS cannot be lowered, and as such, any additional scrutiny is of limited value to the final outcome and recommendations. This same approach is taken with each successive screening step. Further details are provided below to support Chart 1.
