# Memorandum

Project #: 170461

To: Dania Chehab, Abra Ens, John Bourrie  
From: Michael Brierley, Samantha Feist, Dan McParland  
cc: Susan Liver, Jason Cole, Robin McKillop  
Re: Phase 2600 – Geomorphic and Erosion Hazard Limit Assessment  
Class Environmental Assessment for Water and Wastewater Servicing in Nobleton

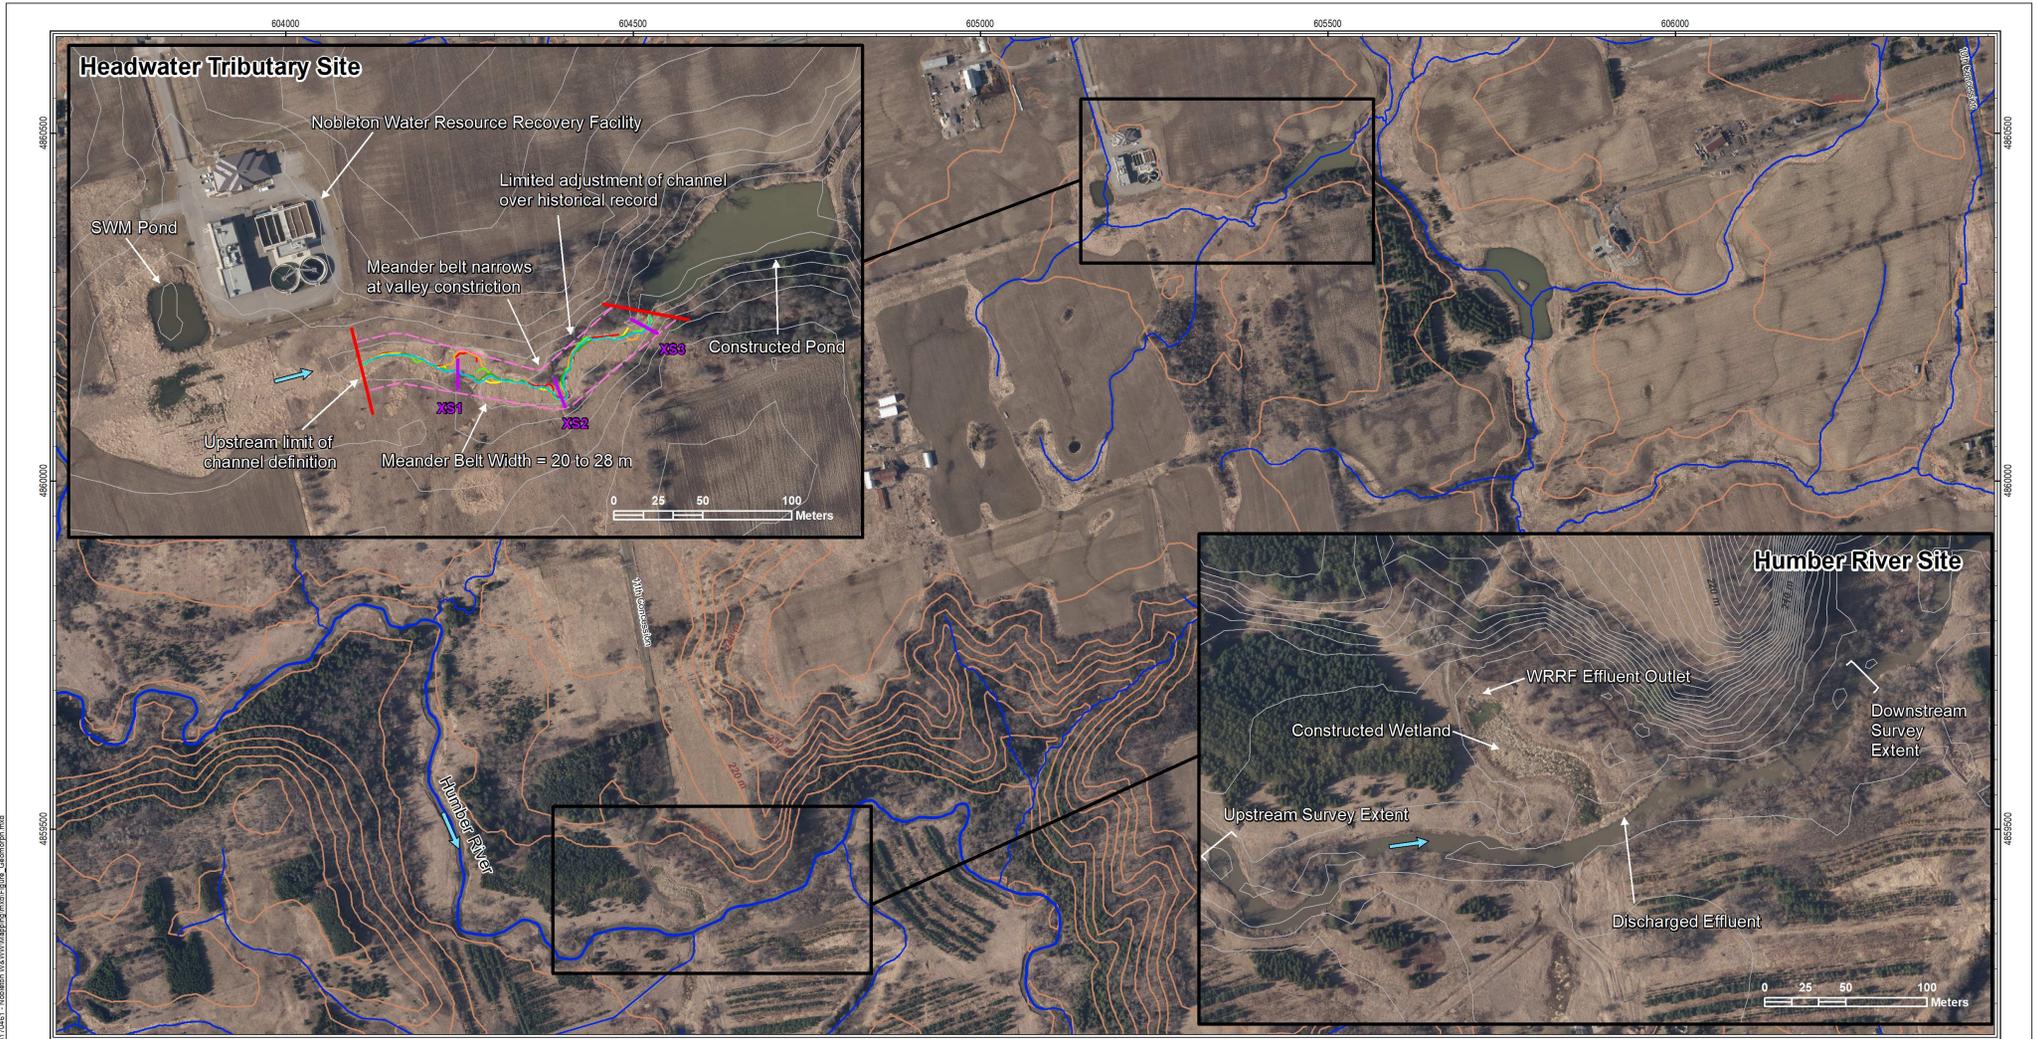
**FIGURE 1**

**Fluvial Geomorphological Assessment Sites**

The meander belt was delineated for the Headwater Tributary following TRCA's *Belt Width Delineation Procedures* (Parish Geomorphic Ltd., 2004) in order to inform predictions of future erosion along the Headwater Tributary. The meander belt width was established by delineating and then buffering the meander belt axis until the boundary lines encompassed the current and historical planform alignments. The final belt width was delineated through a further, parallel set-back of the boundary lines by a 20% factor of safety to account for potential changes to hydrological regime associated with upstream land use and climate change. In addition, channel dimensions were measured at three locations along the reach to characterize existing bankfull conditions (**Figure 1**).

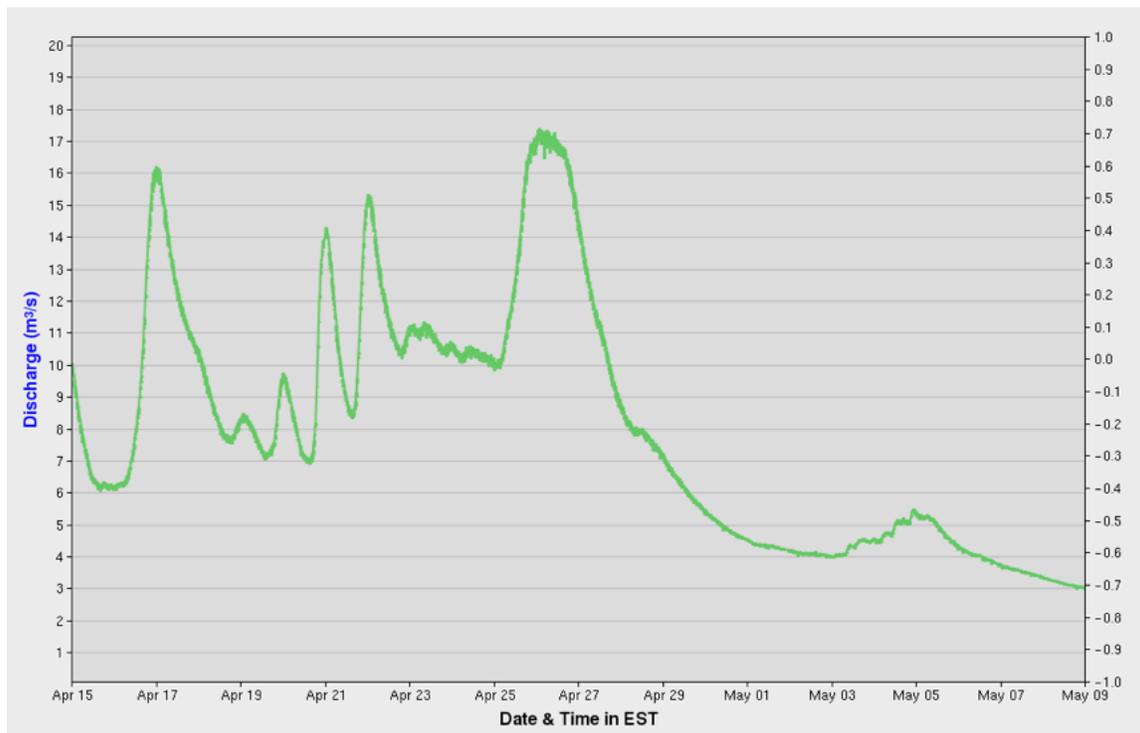
**Figure 2. Discharge recorded at the WSC Humber River at Elder Mills gauge (02HC025) located approximately 11 km downstream of the study reach from April 15, 2018 to May 9, 2018**

Field reconnaissance was completed on May 8, 2018. The daily discharge of the Humber River as measured at Elder Mills Water Survey of Canada (WSC) gauge 11 km downstream of the Humber River site was 3.4 m<sup>3</sup>/s, which is above the historical mean annual flow recorded at the WSC gauge (2.5 m<sup>3</sup>/s). From April 15, 2018 to April 25, 2018 there were three significant precipitation events of 15.2 mm, 18.6 mm and 18.8 mm, respectively, as measured at Toronto's International Airport. In addition, from May 3, 2018 to May 5, 2018, 17 mm of cumulative precipitation was recorded, which led to elevated flows prior to the field visit (**Figure 2**). The purpose of the field visit was to examine patterns and processes of local erosion near the WRRF effluent outlet, verify bankfull measurements, observe bed and bank materials, and ground truth aerial photograph-based interpretations in order to inform appropriate erosion threshold analysis. The grain size distribution of the alluvial bed material within the Humber River near the WRRF outlet was determined through modified Wolman (1954) pebbles counts.

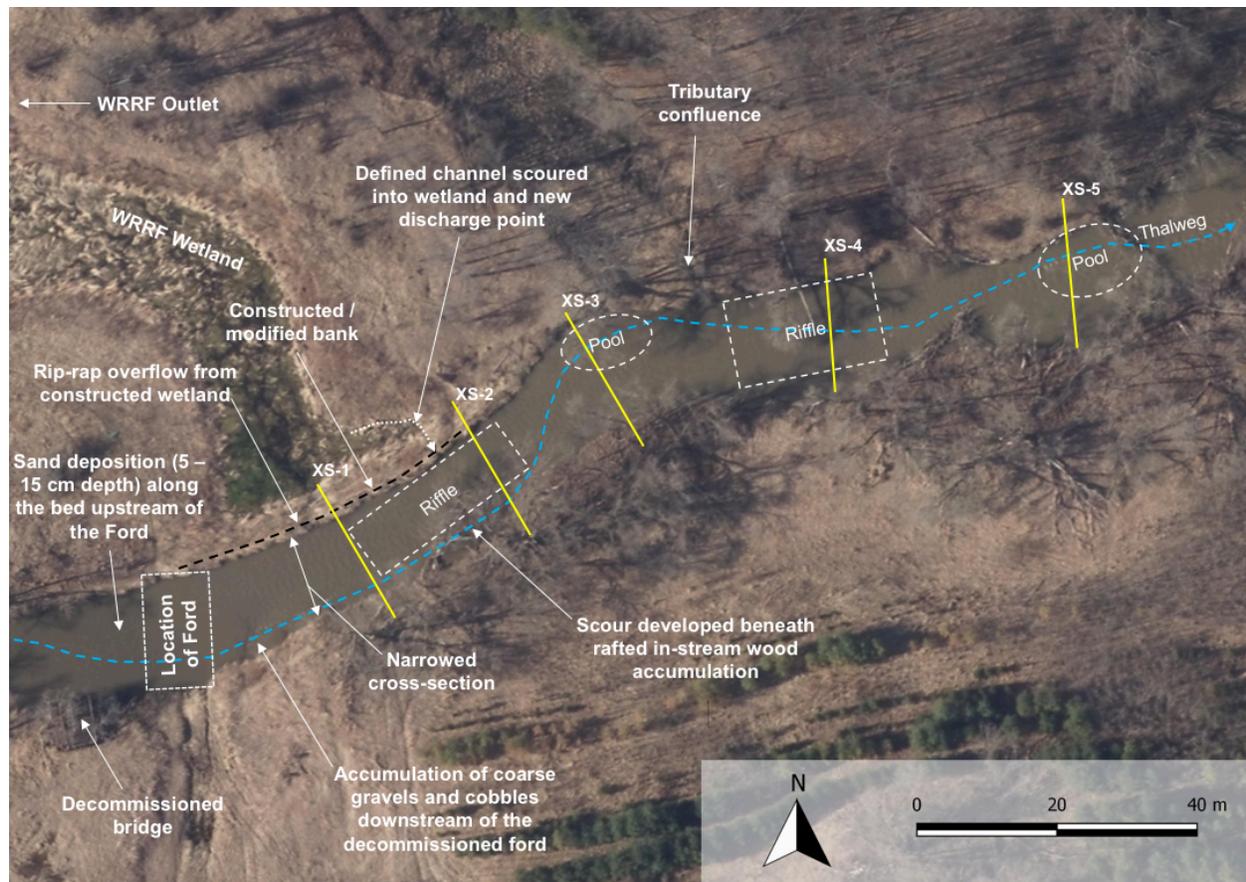
**Figure 3. Cross-section locations, anthropogenic disturbances, and site-scale geomorphic processes near the WRRF outlet on the Humber River**

Near the WRRF outlet, the Humber River flows within a defined valley and displays an irregularly meandering planform. The channel is generally well connected to its floodplain (overbank deposition of sand and large wood was observed) but is locally confined by fluvial terraces (**Photo 3**) and both valley walls, which limits planform development and floodplain access. A small tributary adjoins the Humber River along the left bank (defined looking downstream) near Cross-section 3 (**Figure 3**).

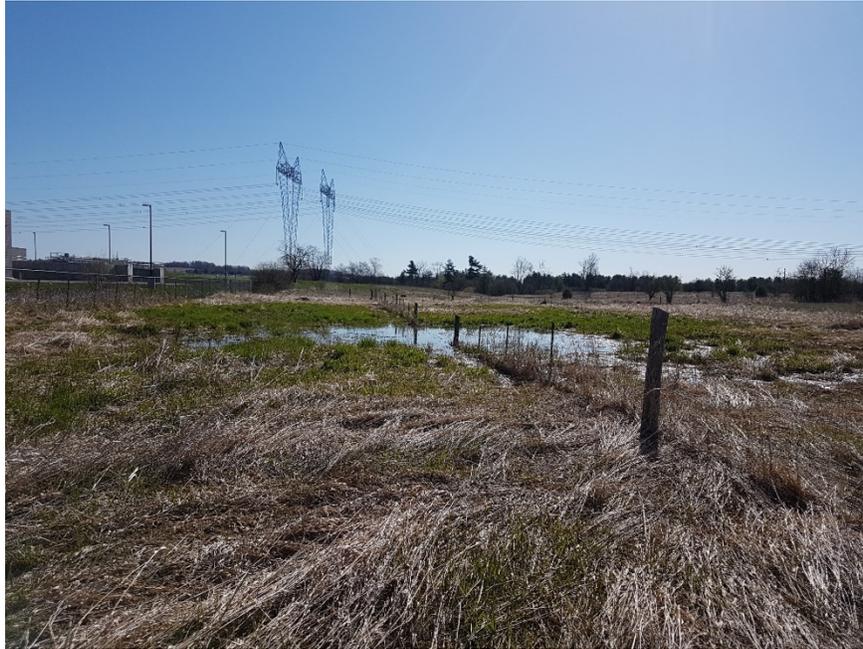
The Headwater Tributary originates downstream of a wetland feature (**Photo 1**) and WRRF stormwater management pond. A defined channel (**Photo 2**) was identified beneath the hydro corridor (upstream reach break), approximately 35 m from the southeast corner of the WRRF property limit (**Figure 1**). The Headwater Tributary has a meandering planform within a defined valley through the reach. Bed morphology (e.g. pool-riffle sequences) and bank erosion has been limited by dense bank and in-channel vegetation. The majority of the channel bed is covered by a layer of silts and organic matter. Sands and gravels are locally present on the channel bed where in-channel vegetation was absent. The channel is narrow and relatively deep, creating a low bankfull width: depth ratio (**Table 1**). The Headwater Tributary discharged into an anthropogenic pond at the downstream extent of the reach.

**Photo 1. Lack of channel definition upstream of Headwater Tributary reach.**

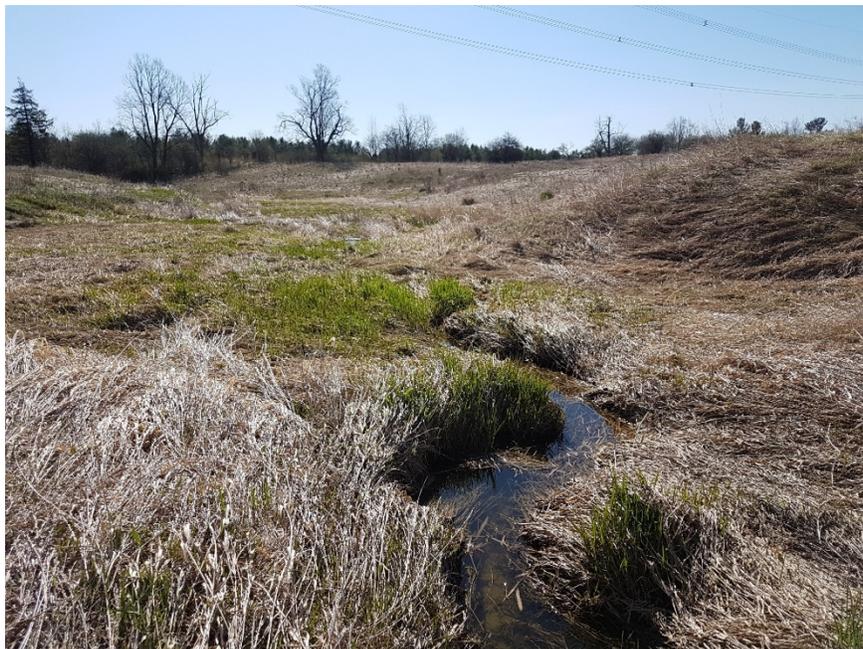
**Photo 2. Downstream view of Headwater Tributary meandering along the bottom of a defined valley.**

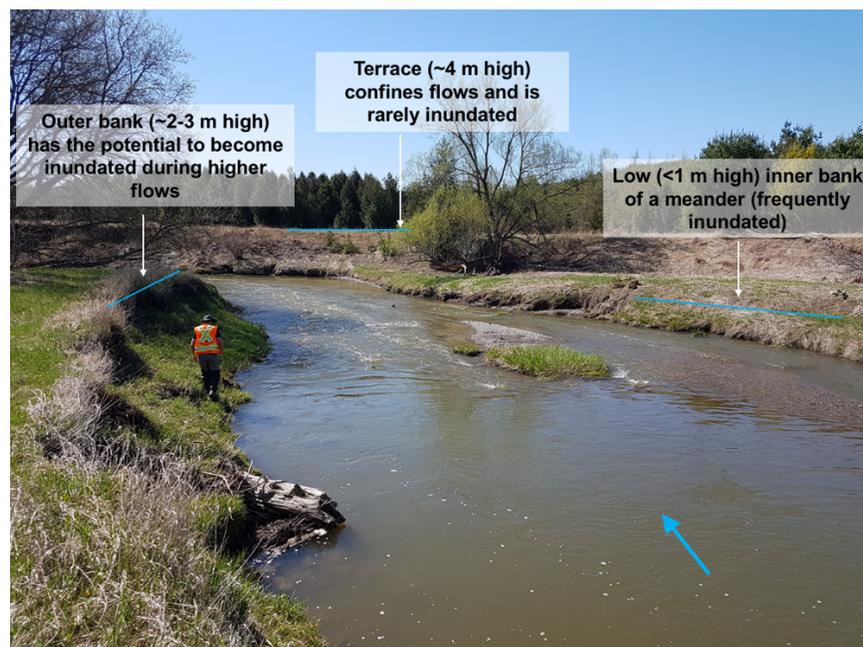
**Photo 3. Downstream view of variable bank and terrace elevations upstream of WRRF outlet.**

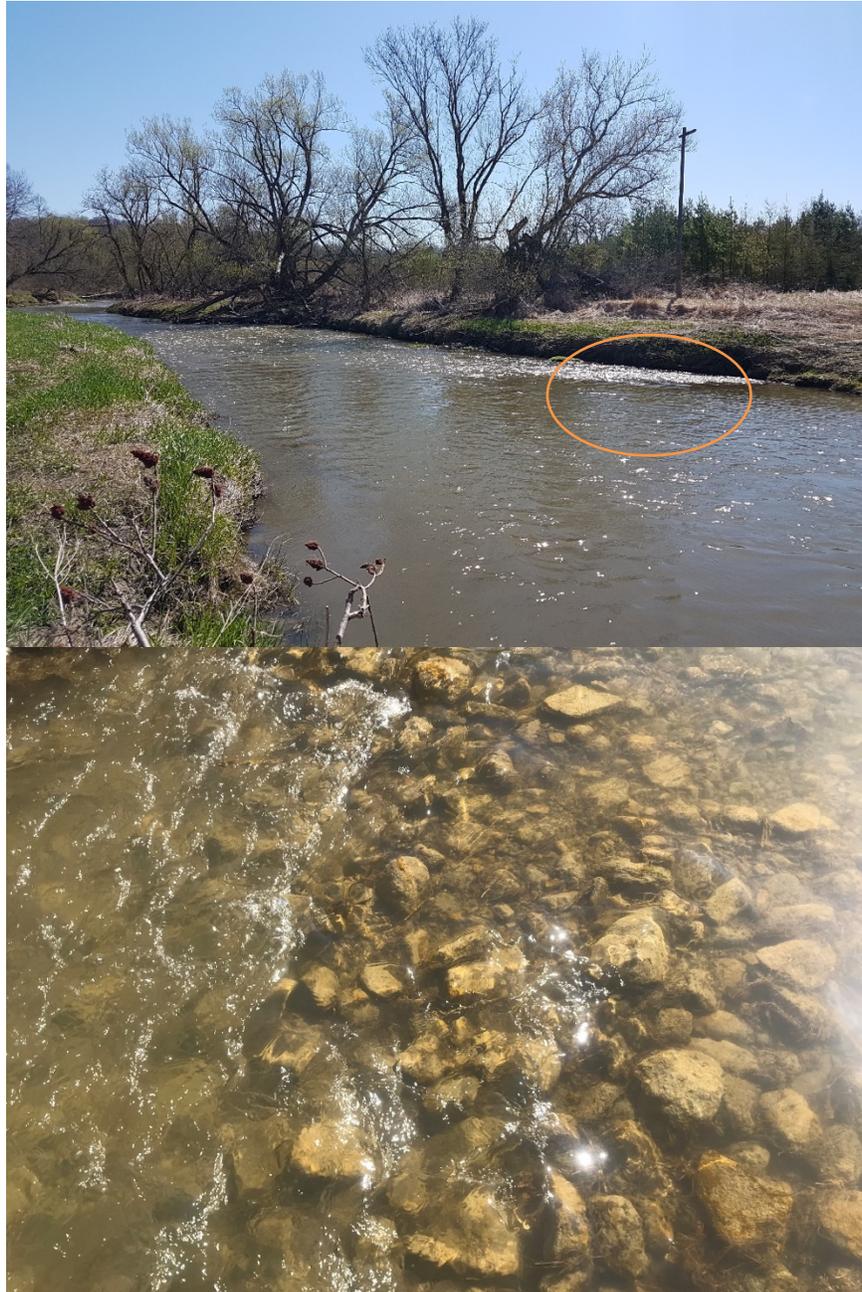
Bed materials within the Humber River ranged from silt to cobble and were dominated by gravels (**Figure 4**). Remnant gravel and cobble from the decommissioned ford was observed along the right bank and within the riffle adjacent the WRRF outlet (**Figure 3, Photo 4**). The remnant gravel and cobbles were both rounded and angular and algae was observed on the coarser materials indicating they are rarely entrained. Upstream of the decommissioned ford, the bed was dominated by loose sand deposits ranging from 5 to 15 cm in depth (**Photo 5**). Sand deposits were derived from easily erodible alluvium comprising the upper portion of

**Photo 4. Downstream view (Top) and overview (Bottom) of remnant gravel and cobble accumulation downstream of the decommissioned ford. Algae has established on the coarser material indicating they are rarely entrained.**

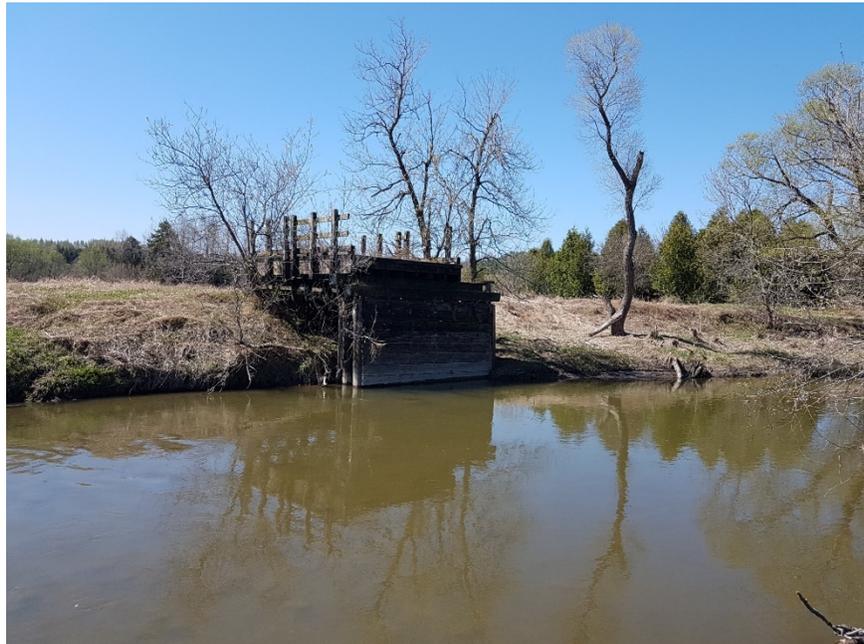
**Photo 5. Decommissioned bridge and pool upstream of the degraded ford (looking upstream). Loose sand deposits ranging from 5 to 15 cm in depth cover gravel and cobble bed material within the pool.**

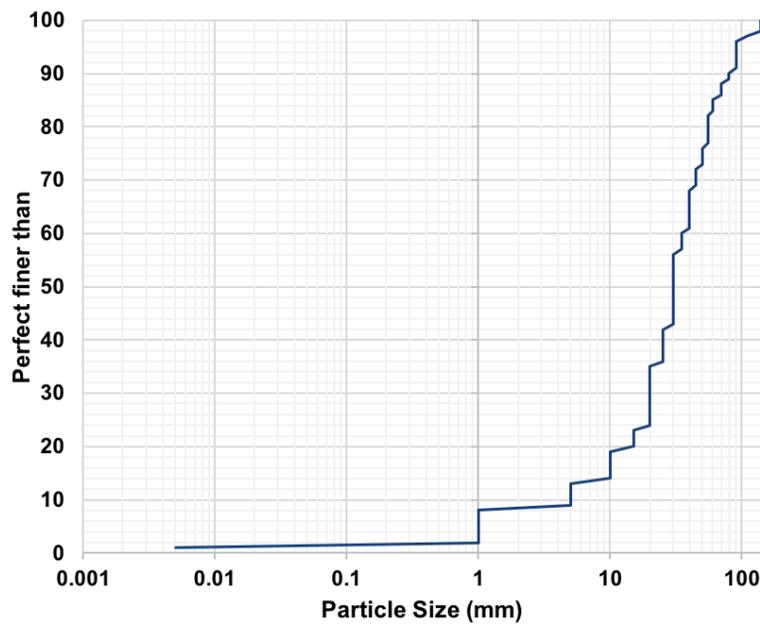
the banks. The representative median grain size ( $D_{50}$ ) of the Humber River within the study area was estimated to be 28 mm (**Figure 4, Table 2**).

**Figure 4. Representative Humber River bed material grain size distribution in the vicinity of the WRRF outlet**

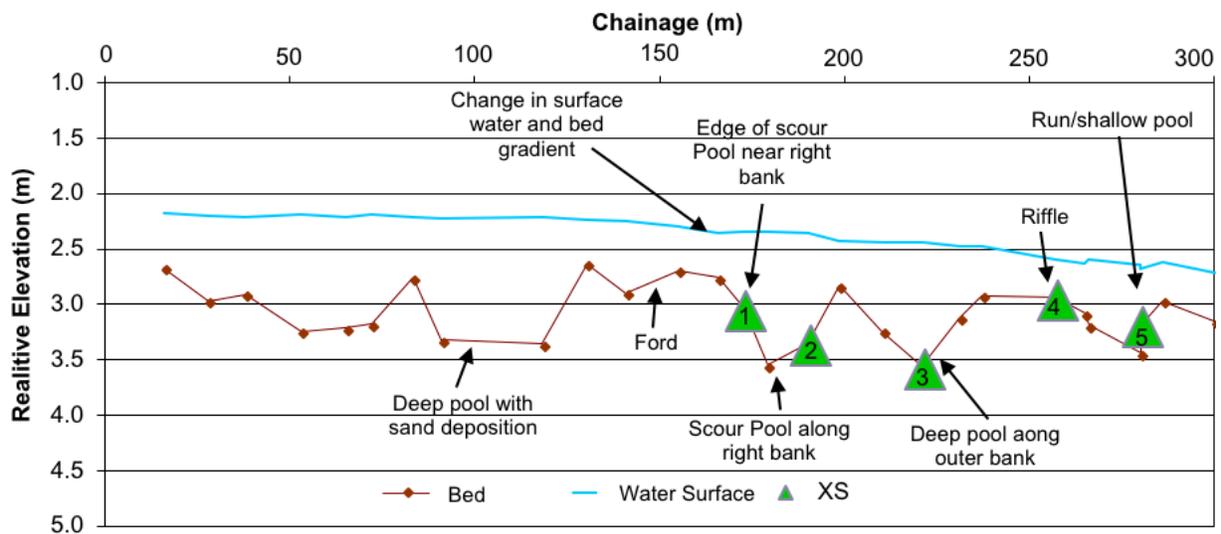
Pool-riffle morphology is generally well developed along the reach. Averaged bed gradient upstream and downstream of the WRRF outlet are 0.07% and 0.19%, respectively (**Figure 5**). The channel exhibits a natural, roughly trapezoidal to a rectangular cross-section along its riffles and an asymmetric cross-section deepest along its outer bank within pools along meanders. Riffles tend to have the coarsest material based on field measurements. Sand veneers were observed atop gravel beds in pools. Emerging and submerged sandbars were present along the inner banks of meander bends. The average bankfull width and depth of the surveyed cross-sections are approximately 15.6 and 1.1 m, respectively (**Table 3**). Maximum depth at bankfull stage averages 1.6 m. The bankfull discharge for the sub-reach was estimated as 28.8 m<sup>3</sup>/s.

**Figure 5. Longitudinal profile of Humber River along surveyed sub-reach**

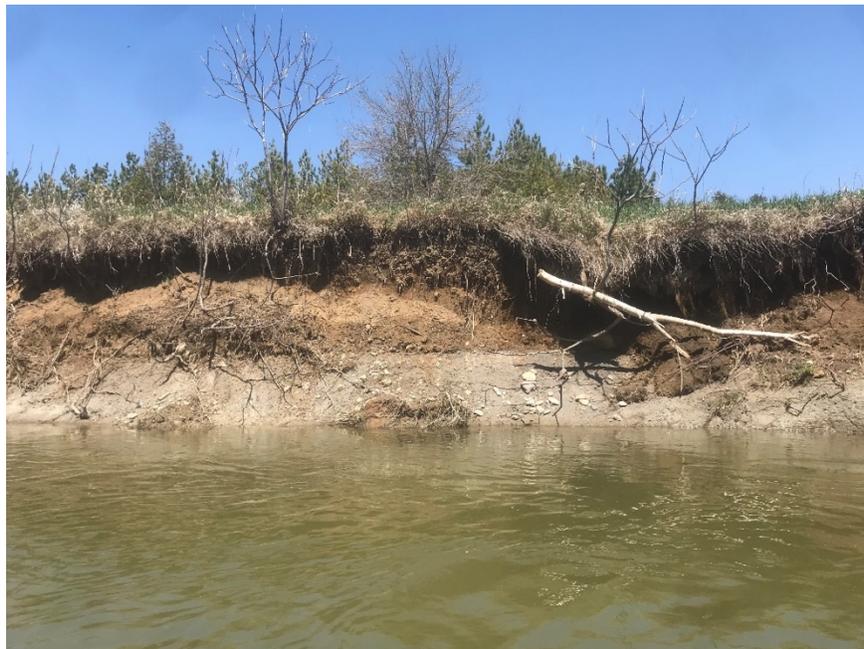
Banks are generally composed of alluvial sediments, with stratified deposits present (**Photo 6**) grading from silts and fine sands (flood deposits) at the surface to coarse sands and gravels near the bank toe. Clay and silty till was locally exposed near the bottom of banks and on the channel bed. Localized toe-slope erosion and slumping are active along high terraces (**Photo 3**). The riparian vegetation is a mix of grasses, shrubs, and trees. Few mature trees are present along the channel banks, which is likely attributed to historic agricultural activity. Large wood was observed locally along channel banks but no channel spanning jams were present.

**Photo 6. View of stratified bank deposits (left bank), graded from silts and sands at the surface to gravels and till at depth.**

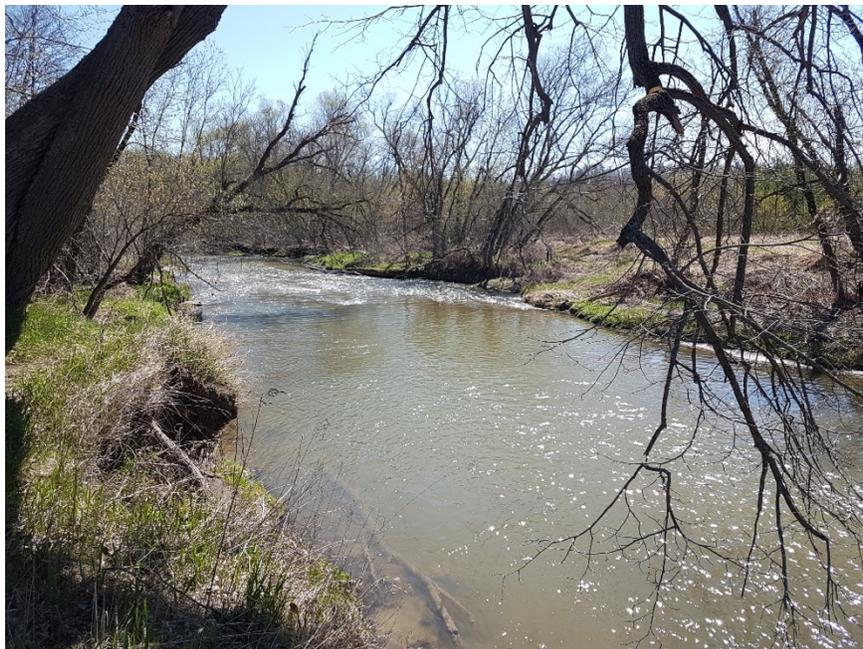
**Photo 7. Defined pool (foreground) and riffle (background) sequence downstream of Cross-section 2 (looking downstream).**

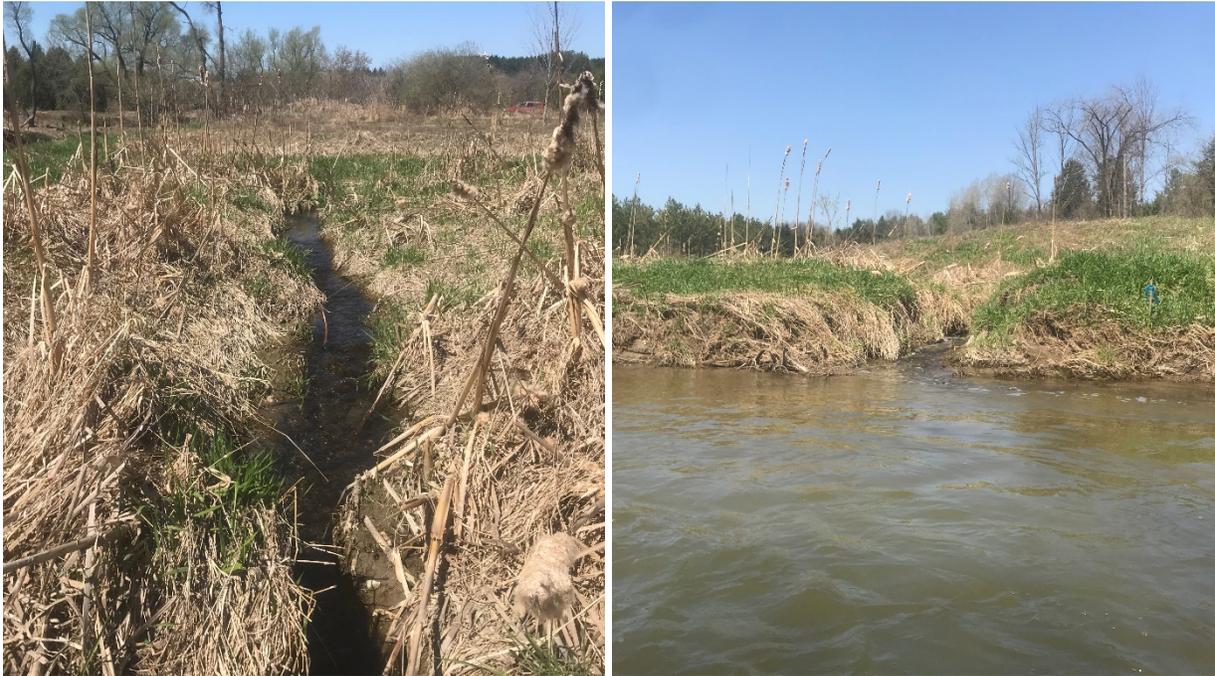
The effluent from the WRRF discharges into a constructed wetland, which originally came to a confluence with the Humber River at a designed rip-rap overflow along the left bank (**Figure 3**). However, a failure/breach of the rip-rap overflow in 2013 and 2016 (York Region, personal communication) and the associated lack of ponding has resulted in formation of a defined flow path within the wetland (**Photo 8**), which has shifted the confluence 20 m downstream from its designed confluence (**Figure 6**). The new outlet channel within the wetland is narrow (<2 m) and relatively deep with gravel and till exposed along its bed. A knickpoint (0.5 m in height) 3 m upstream of the confluence has developed and may propagate upstream into the wetland; however, the new outlet channel and knickpoint do not present an erosional risk to the headwall. Within the Humber River at the new confluence, bed material is characterized by gravel and cobbles with sands embedded. Coarsest bed material is concentrated along the left bank where WRRF flow discharges (**Photo 8**), consisting of poorly organized cobbles. No bed scour within the Humber River was observed at the designed rip-rap overflow or the new discharge location.

**Photo 8.** Upstream view of deep and narrow channel scoured within the constructed wetland (left). Looking toward the left bank where the newly developed outlet confluences with the Humber River (right).

Erosion within the WRRF effluent wetland has led to the development of a defined channel and new confluence with the Humber River. It is recommended that confluence of the wetland and the Humber River be restored to the constructed riprap overflow structure in order to reduce fine sediment input to the Humber River and reduce the risk of bank erosion/instability along the Humber River at the existing confluence. The integrity of the riprap overflow should be assessed by a Water Resources Engineer. Periodic monitoring of bedform morphology and stability of the Humber River adjacent and downstream of the WRRF outlet is recommended.

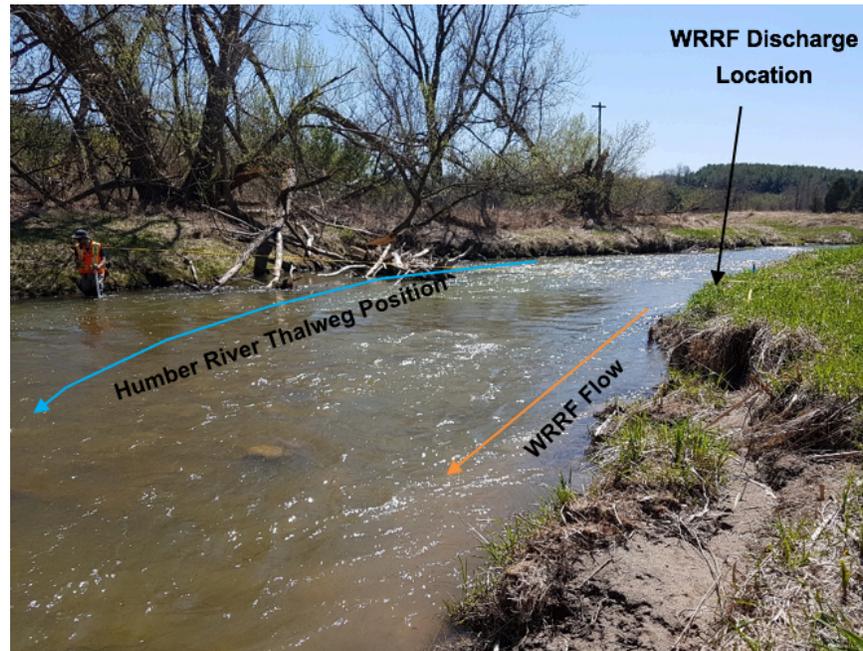
**Figure 6. Upstream view at Cross-section 2 highlighting WRRF flow path along the left bank in relation to thalweg position.**
