### Stage 1 Archaeological Assessment Report

# Stage 1 Archaeological Assessment Warden Avenue and Kennedy Road from Major Mackenzie Drive to Elgin Mills Road (Lots 21-26, Concession 4-6, Former Township of Markham, County of York) City of Markham, Regional Municipality of York

## Original Report

Archaeological Services Inc. File: 21EA-073

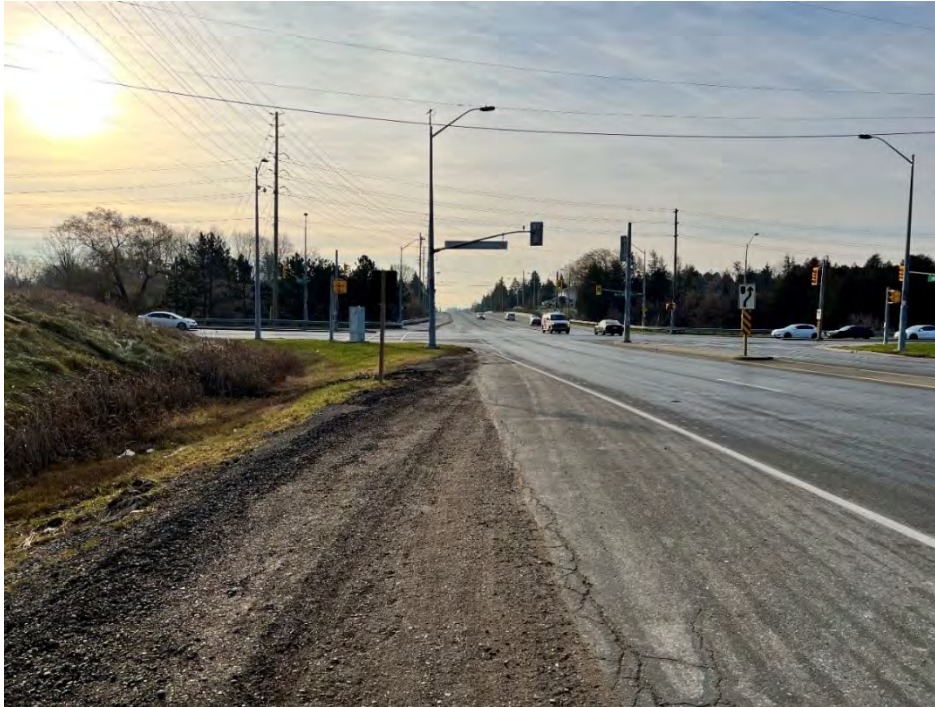
**Image 1: Warden Avenue, road right-of-way and property beyond are disturbed, no potential**

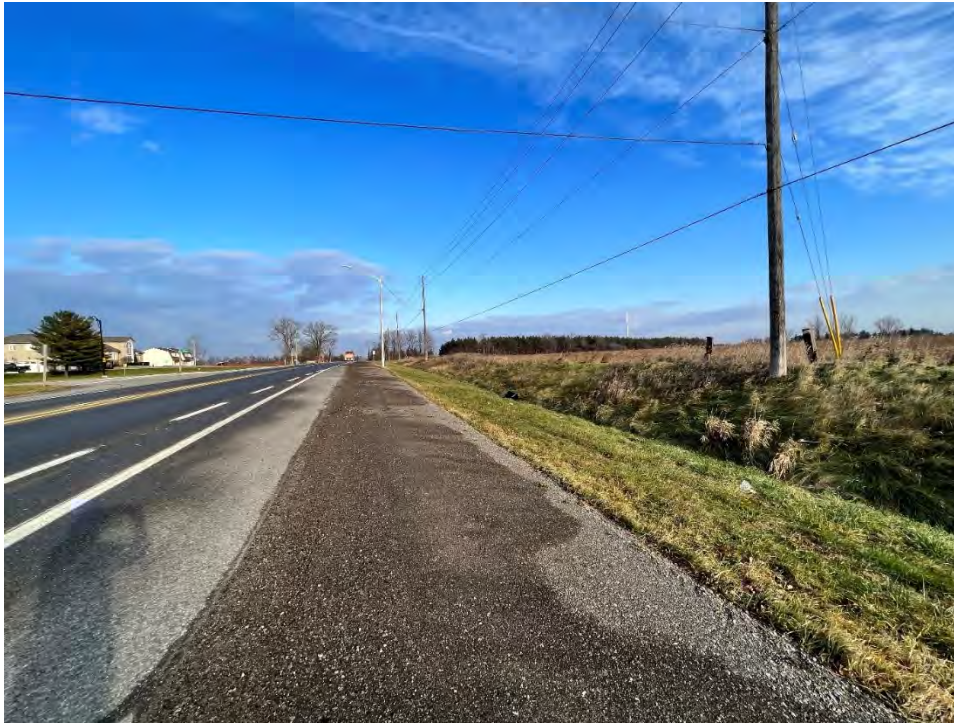
**Image 2: Warden Avenue, roadbed and ditch is disturbed. Lands above ditch have potential, require Stage 2 survey.**

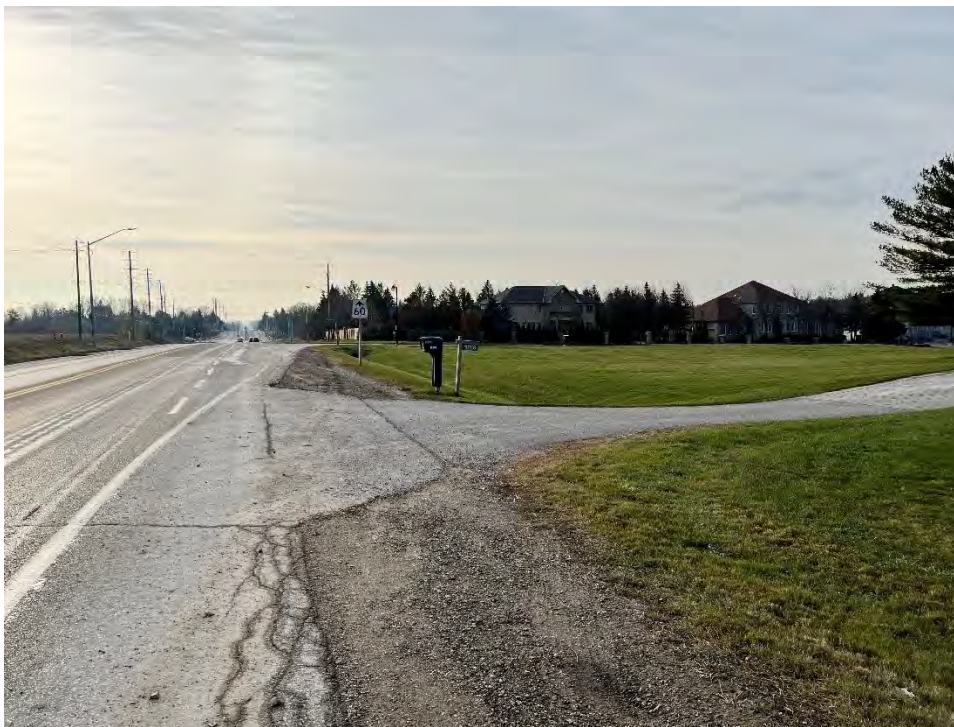
**Image 3: Warden Avenue, roadbed and ditch is disturbed. Lands above drainage ditch have potential, require Stage 2 survey.**

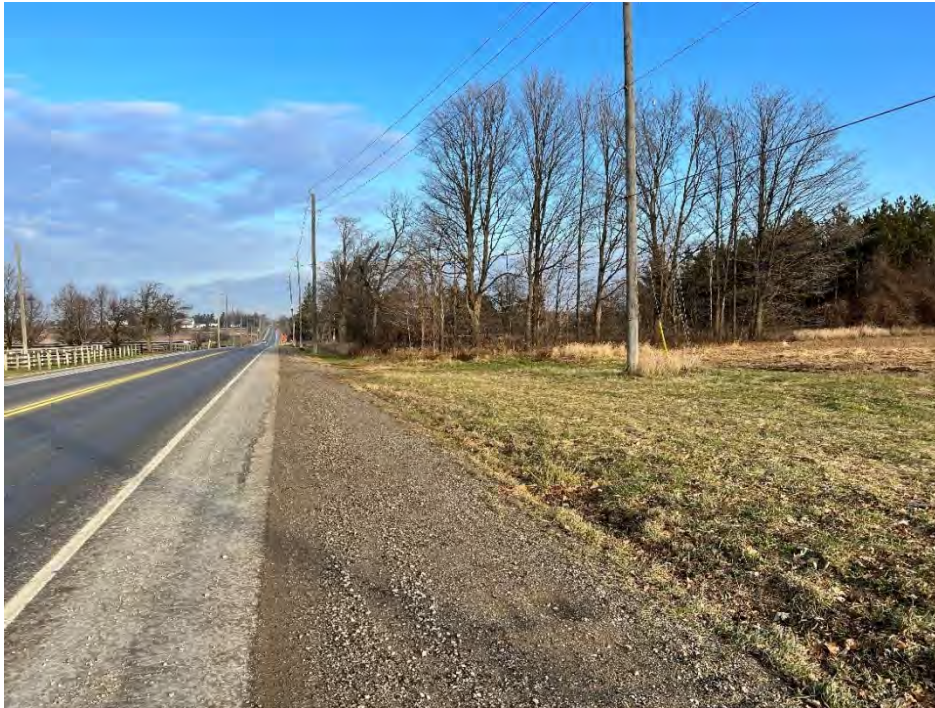
**Image 4: Warden Avenue, roadbed and ditch is disturbed. Lands above ditch have potential, require Stage 2 survey.**

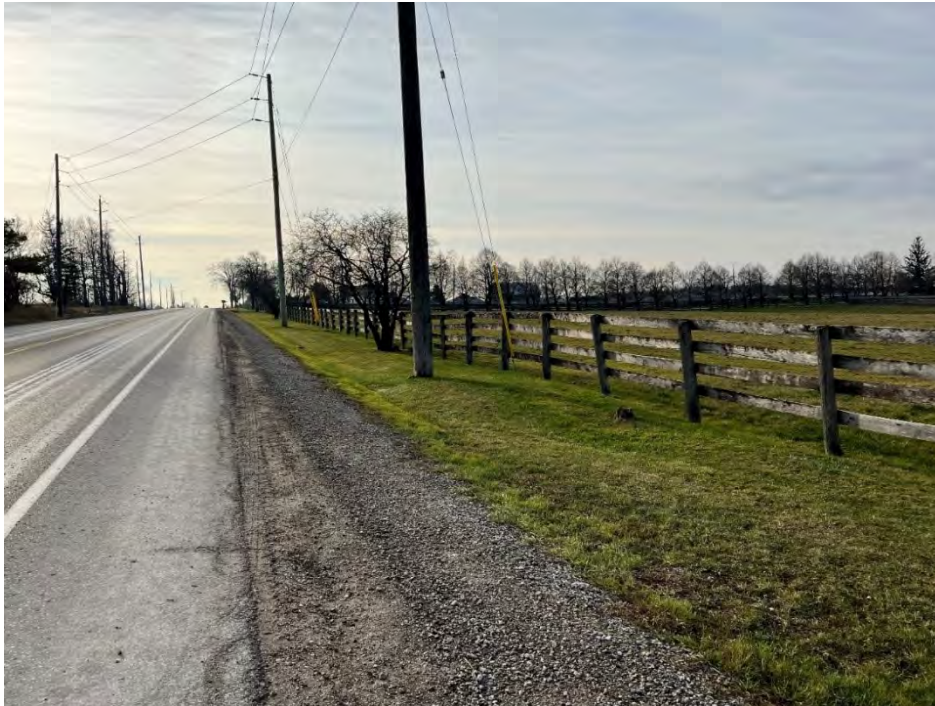
**Image 5: Warden Avenue, roadbed and ditch is disturbed. Lands above ditch have potential, require Stage 2 survey.**

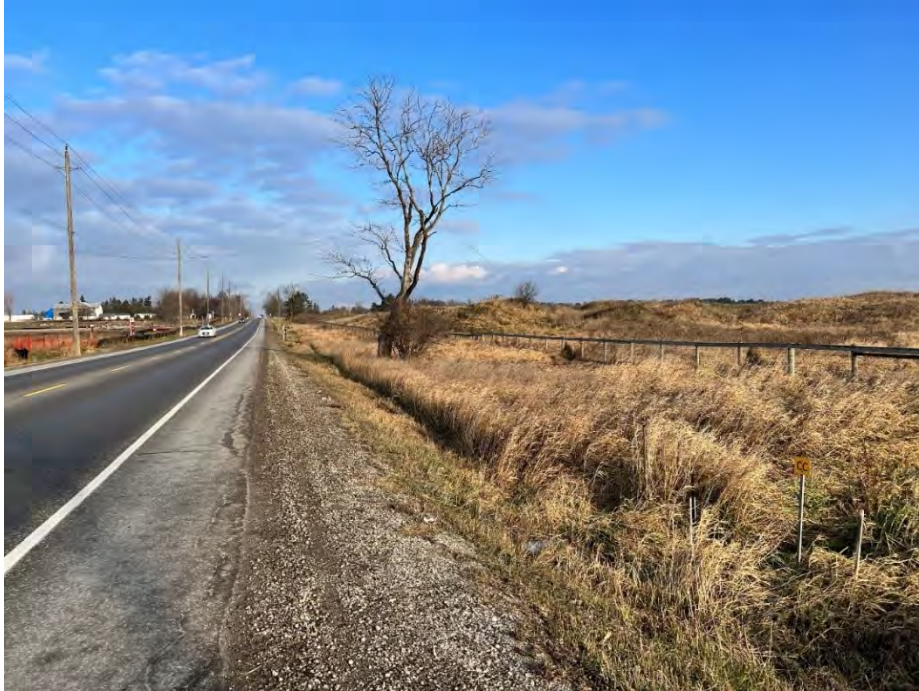
**Image 6: Warden Avenue, roadbed and ditch is disturbed. Lands above ditch have potential, require Stage 2 survey. Culvert in foreground leads to low and wet area, no potential.**

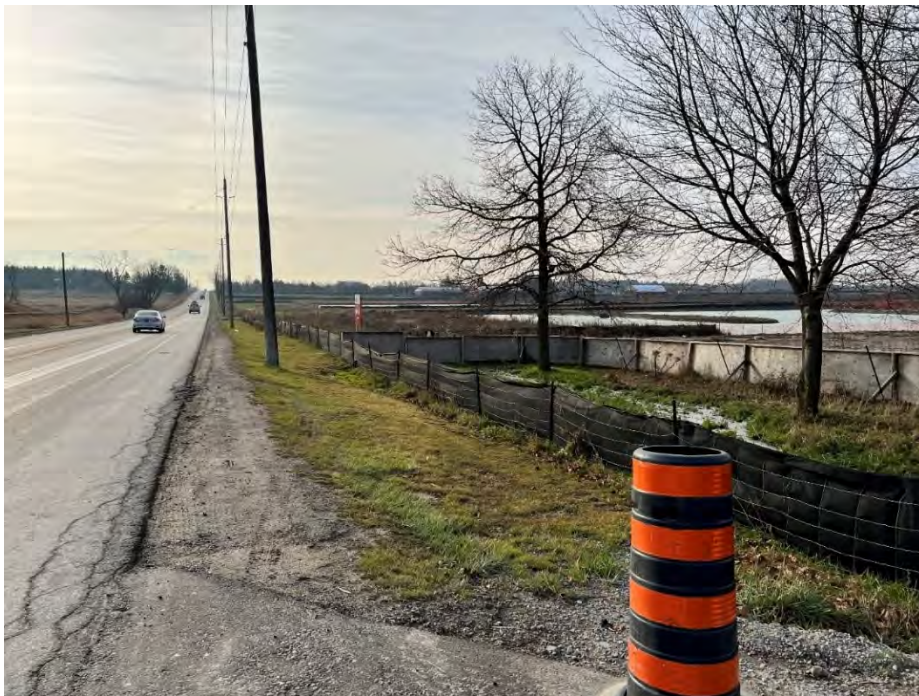
**Image 7: Warden Avenue, roadbed and ditch is disturbed. Lands beyond silt fencing have potential, require Stage 2 survey.**

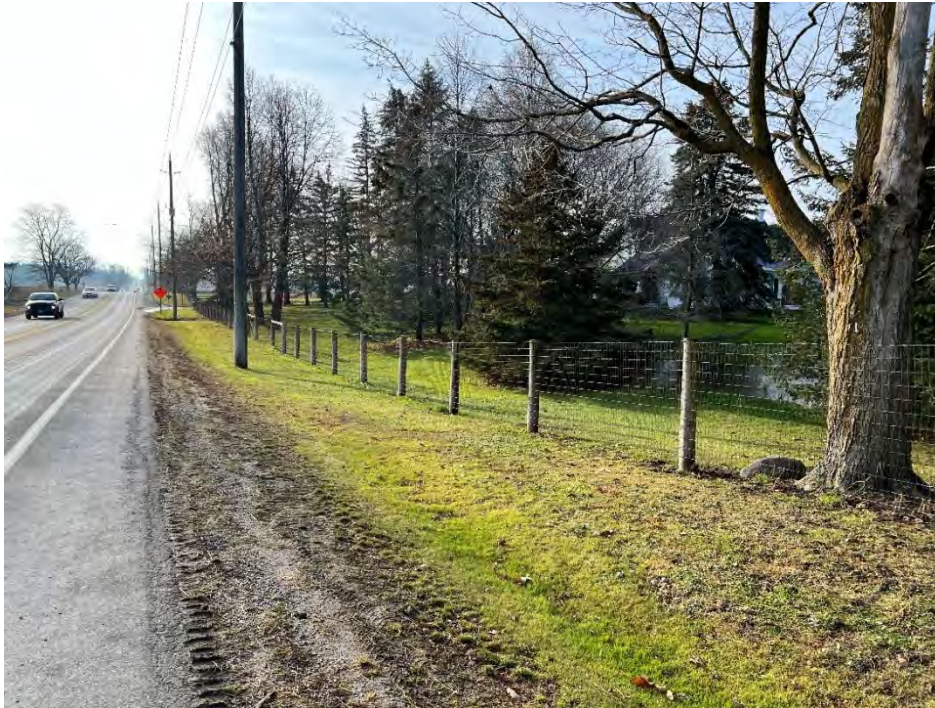
**Image 8: Warden Avenue, roadbed and ditch is disturbed. Lands above ditch have potential, require Stage 2 survey. Banks of pond are low and wet, no potential.**

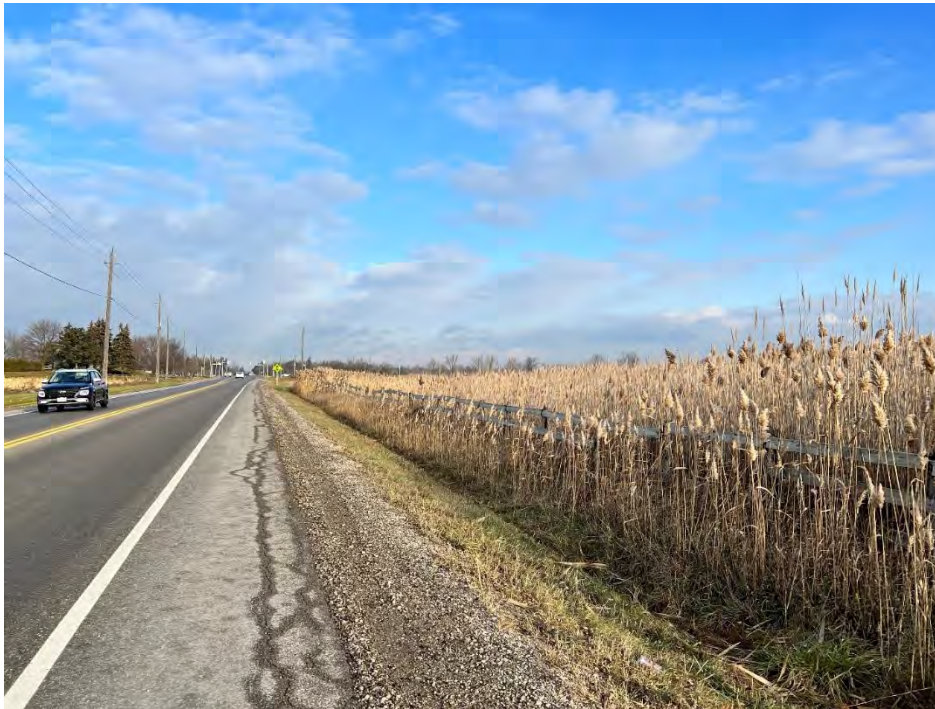
**Image 9: Warden Avenue, road right-of-way is disturbed and property beyond is low and wet, no potential.**

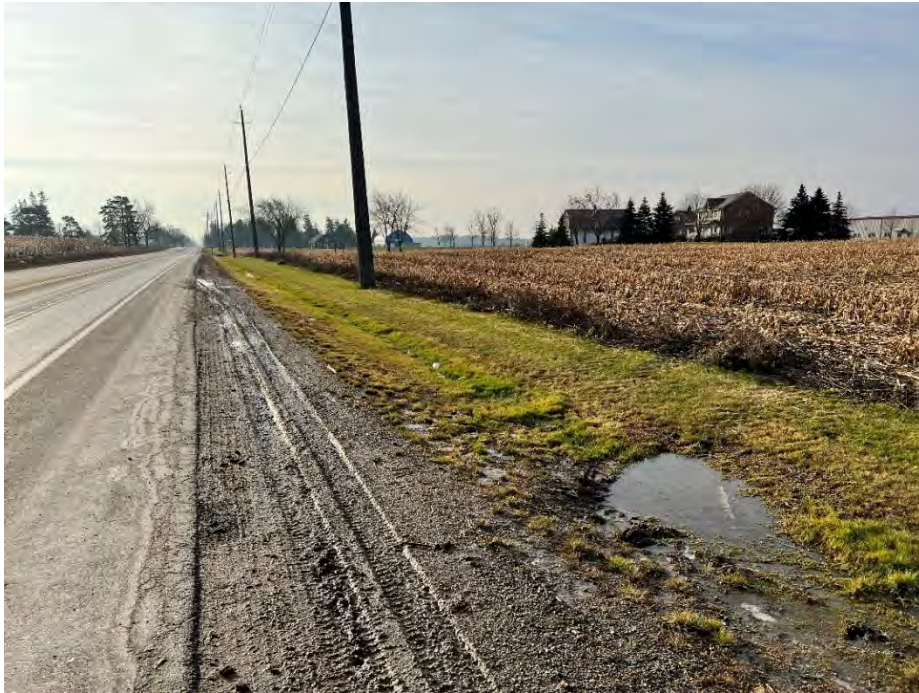
**Image 10: Warden Avenue, roadbed and ditch is disturbed. Lands above ditch have potential, require Stage 2 survey.**

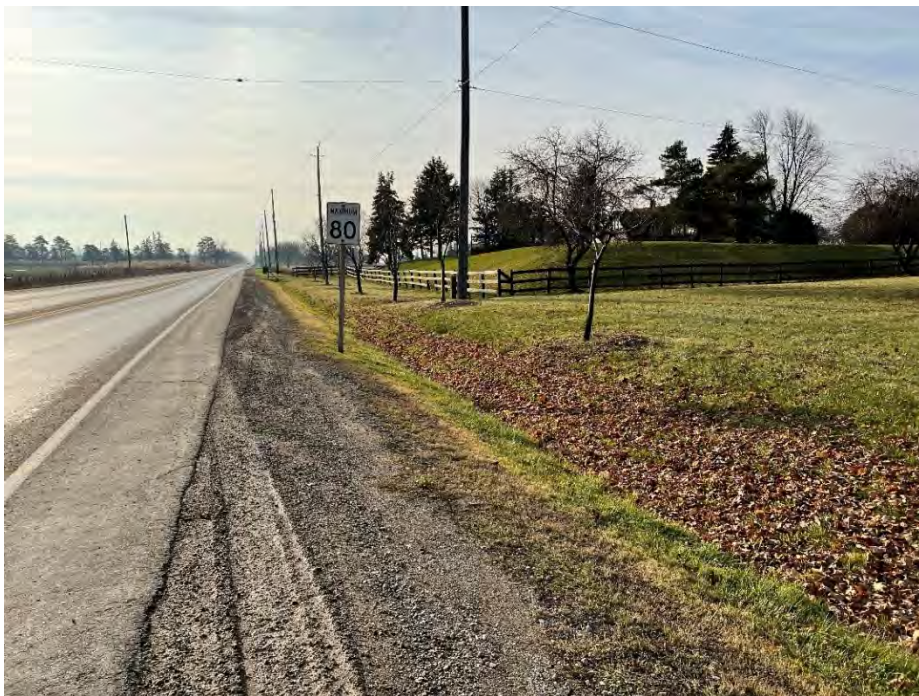
**Image 11: Warden Avenue, roadbed and ditch is disturbed. Lands above ditch have potential, require Stage 2 survey. Raised berm in the background is disturbed, no potential.**

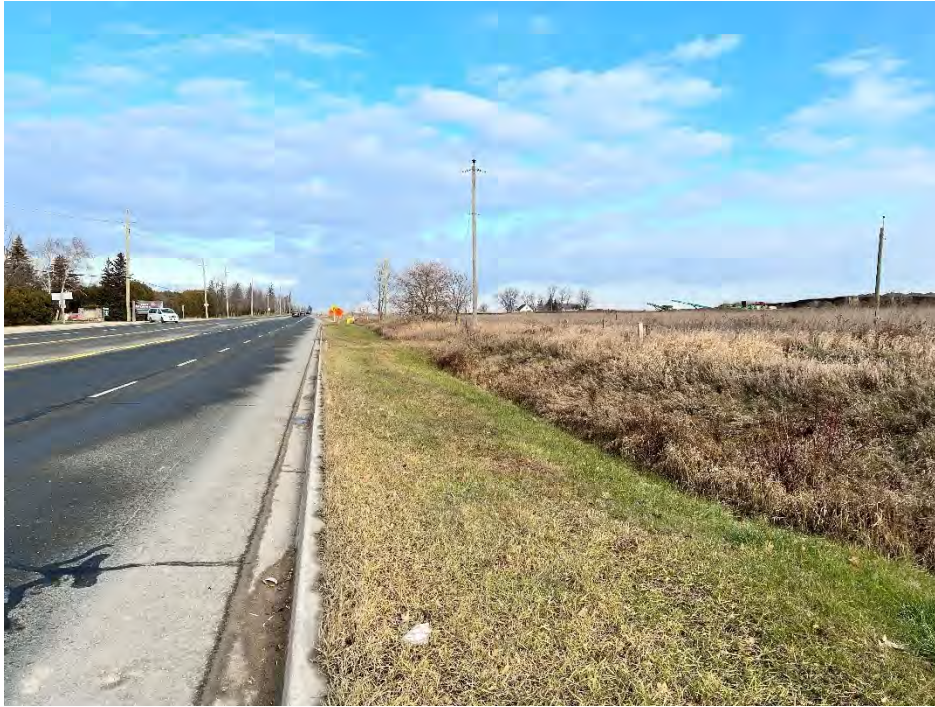
**Image 12: Kennedy Road, roadbed and ditch is disturbed. Lands above ditch have potential, require Stage 2 survey.**

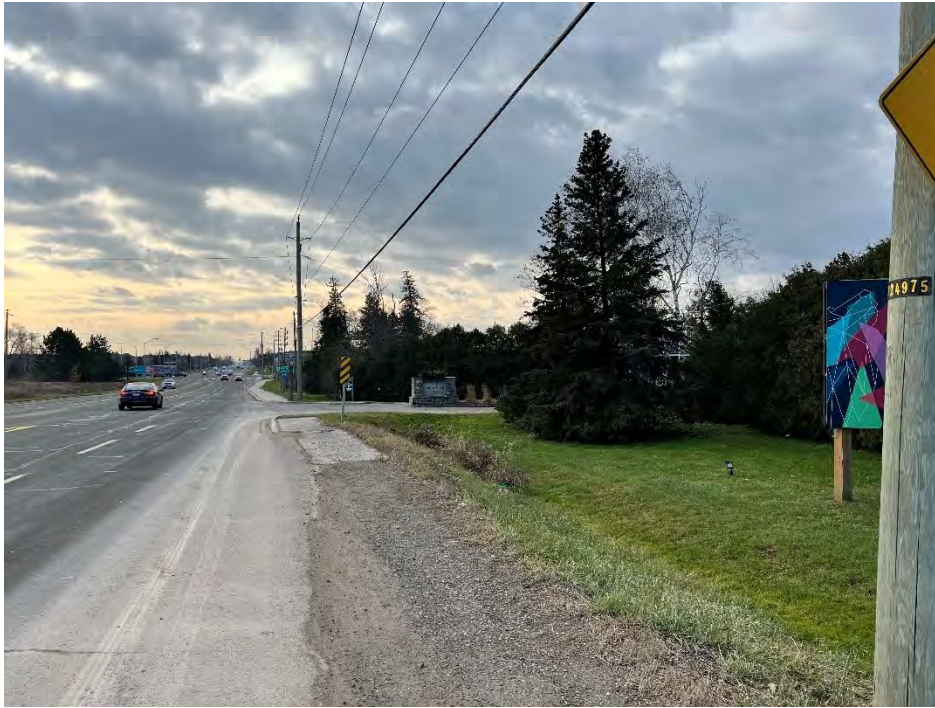
**Image 13: Kennedy Road, roadbed and ditch is disturbed. Lands above ditch have potential, require Stage 2 survey.**

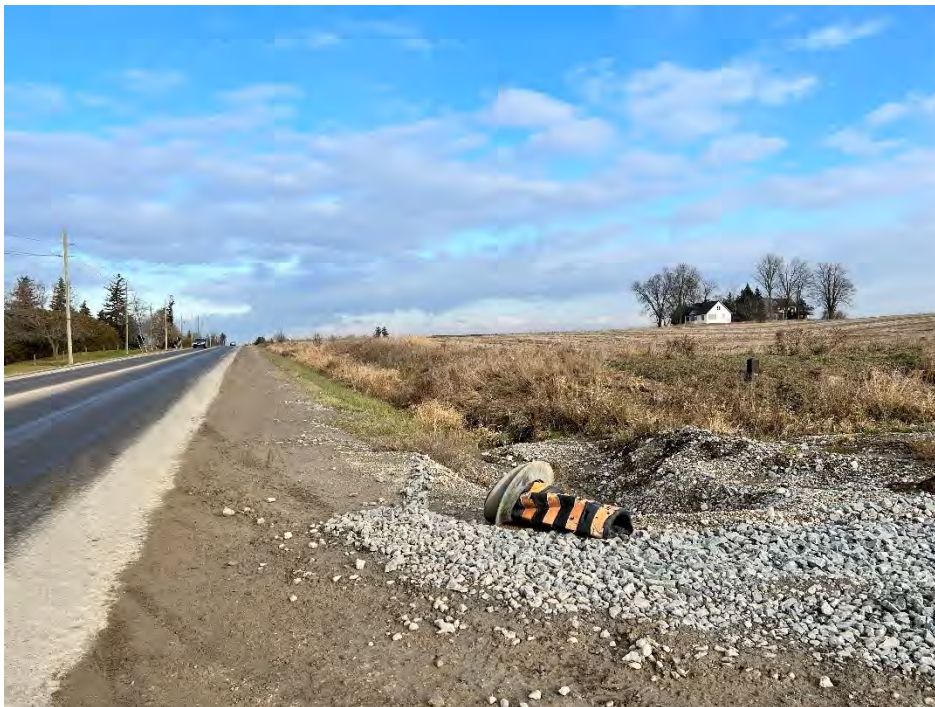
**Image 14: Kennedy Road, road right-of-way is disturbed, no potential. Property beyond has potential, requires Stage 2 survey.**

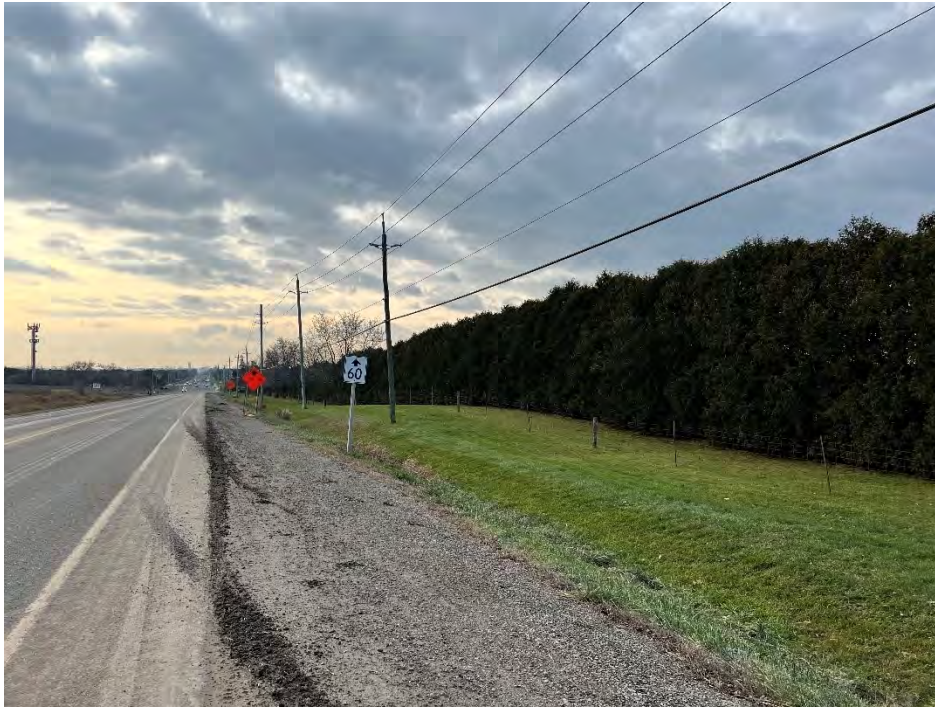
**Image 15: Kennedy Road, roadbed and ditch is disturbed. Lands above ditch have potential, require Stage 2 survey.**

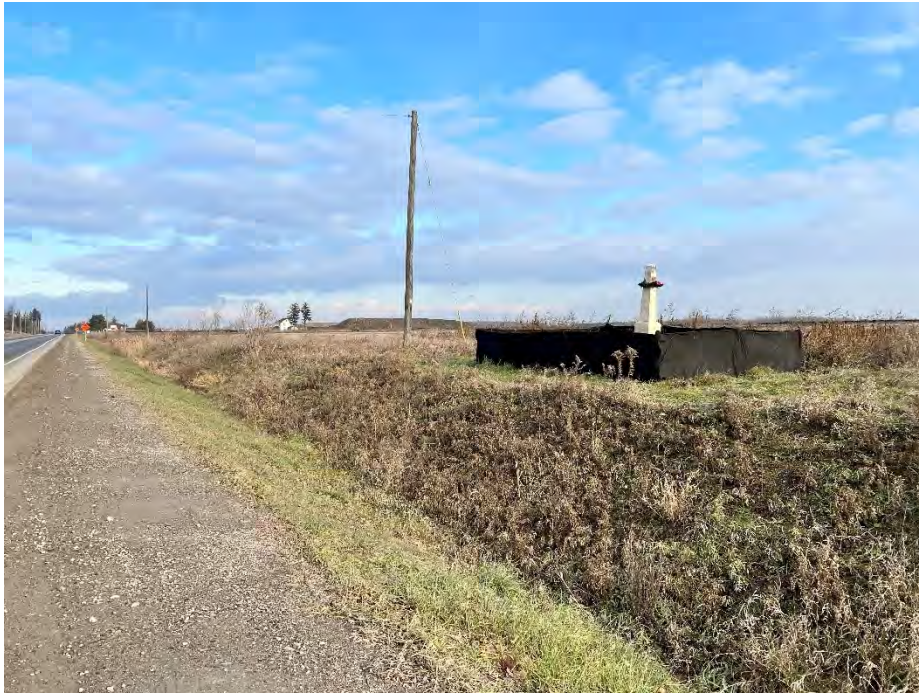
**Image 16: Location of previously assessed Pingle cemetery (legal limits of the cemetery are marked with fencing). Property beyond disturbed Kennedy ROW and assessed area has potential, requires Stage 2 survey.**

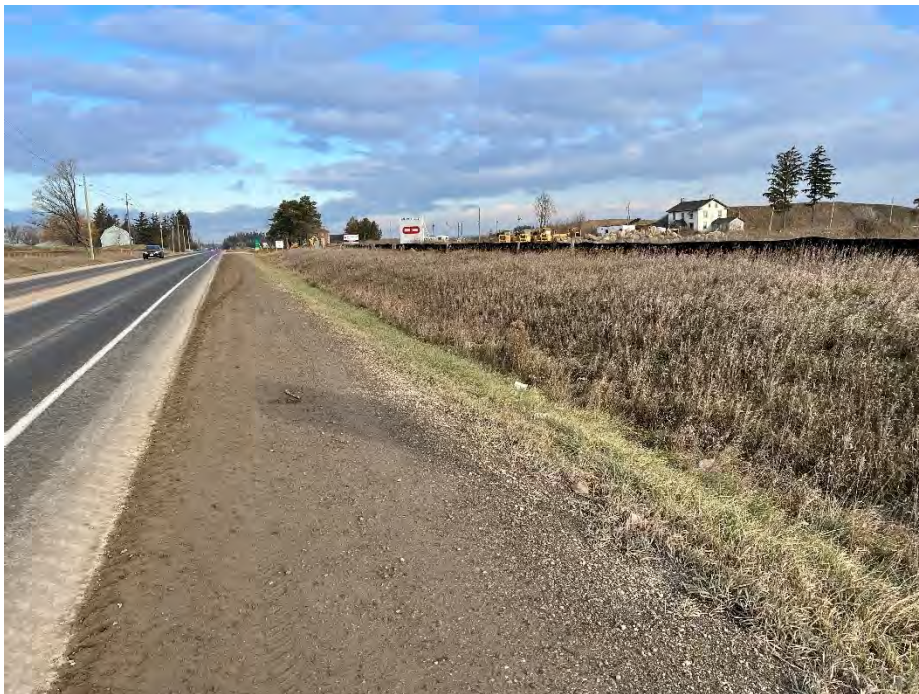
**Image 17: Kennedy Road, road right-of-way is disturbed, no potential. Property beyond has been previously assessed.**

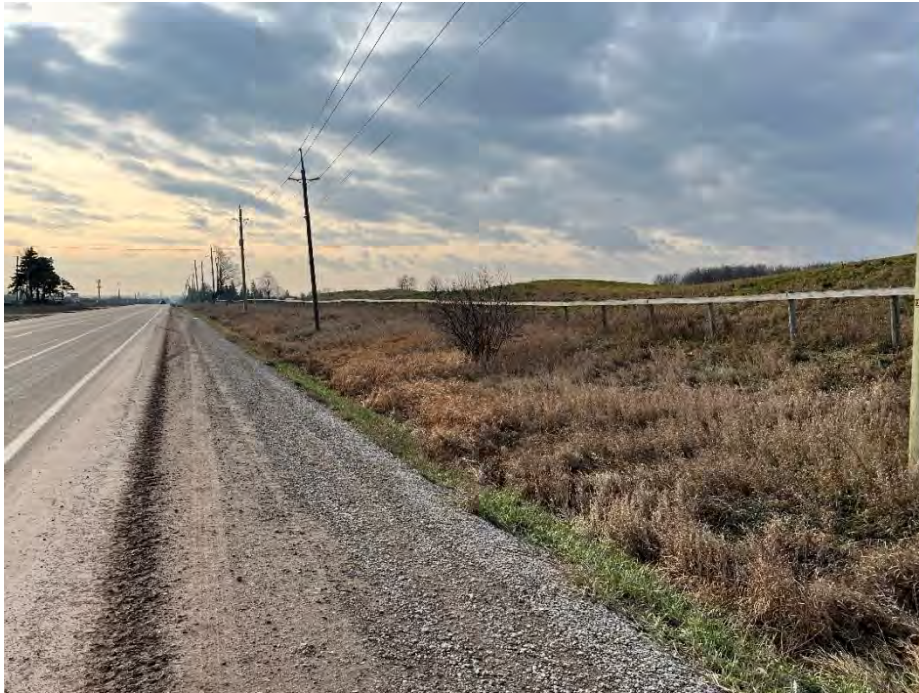
**Image 18: Kennedy Road, road right-of-way is disturbed, no potential. Property beyond has potential, requires Stage 2 survey.**

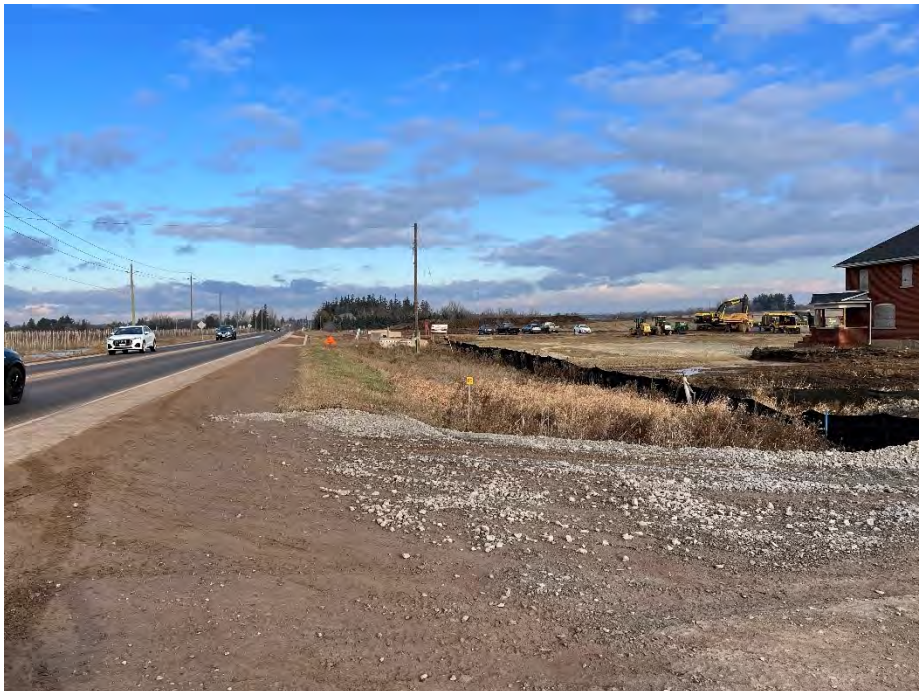
**Image 19: Kennedy Road, road right-of-way is disturbed, no potential. Property beyond has been previously assessed. Adjacent property at 10537 Kennedy Road was under construction at the time of the site visit.**

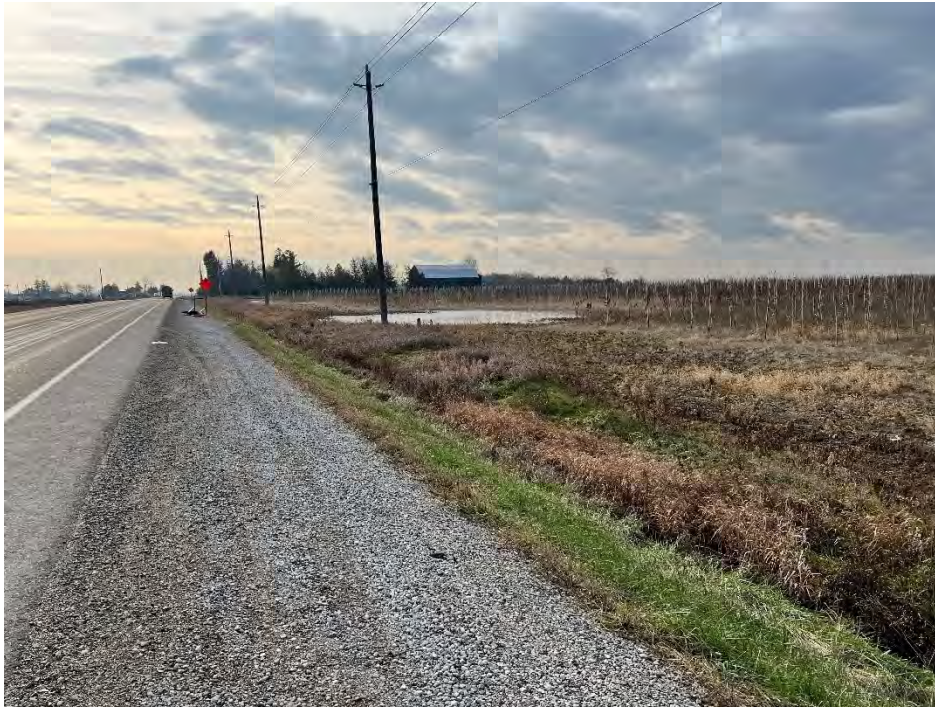
**Image 20: Kennedy Road, road right-of-way is disturbed, no potential. Property beyond has potential, requires Stage 2 survey.**

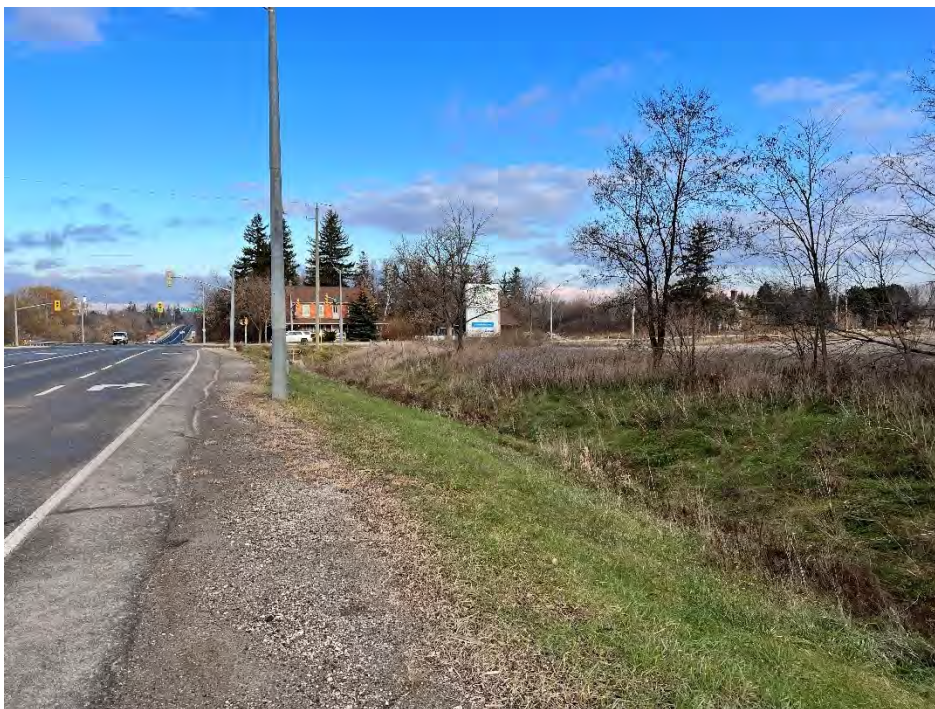
**Image 21: Kennedy Road, road right-of-way has been previously assessed. Property beyond has potential, requires Stage 2 survey.**

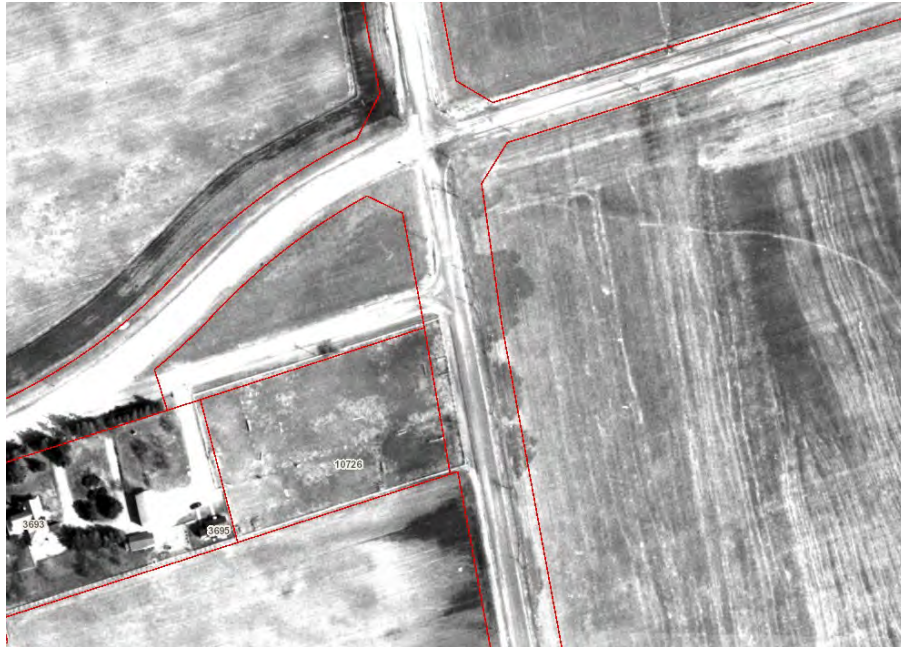
**Image 22: Aerial imagery from 1970, showing realignment of Elgin Mills Road at Warden Avenue. The old intersection is still visible to the north of 10726 Warden Avenue.**

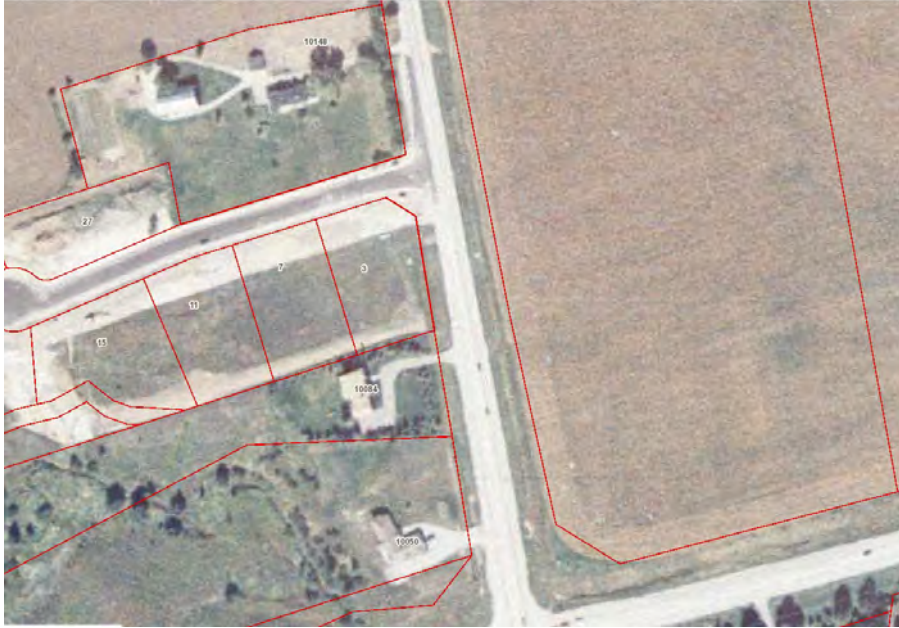
**Image 23: Aerial imagery from 1995, showing the development of properties at 10050 and 10084 Warden Avenue as well as 3 Heritage Hill Drive.**

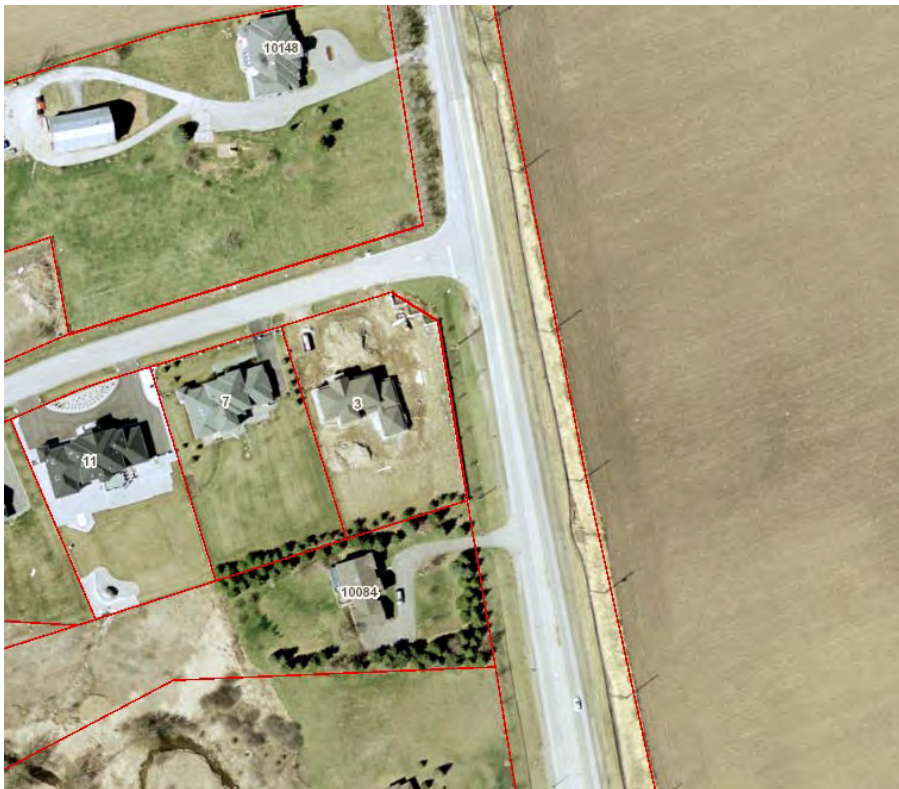
**Image 24: Aerial imagery from 2005 showing the development of 3 Heritage Hill Drive.**

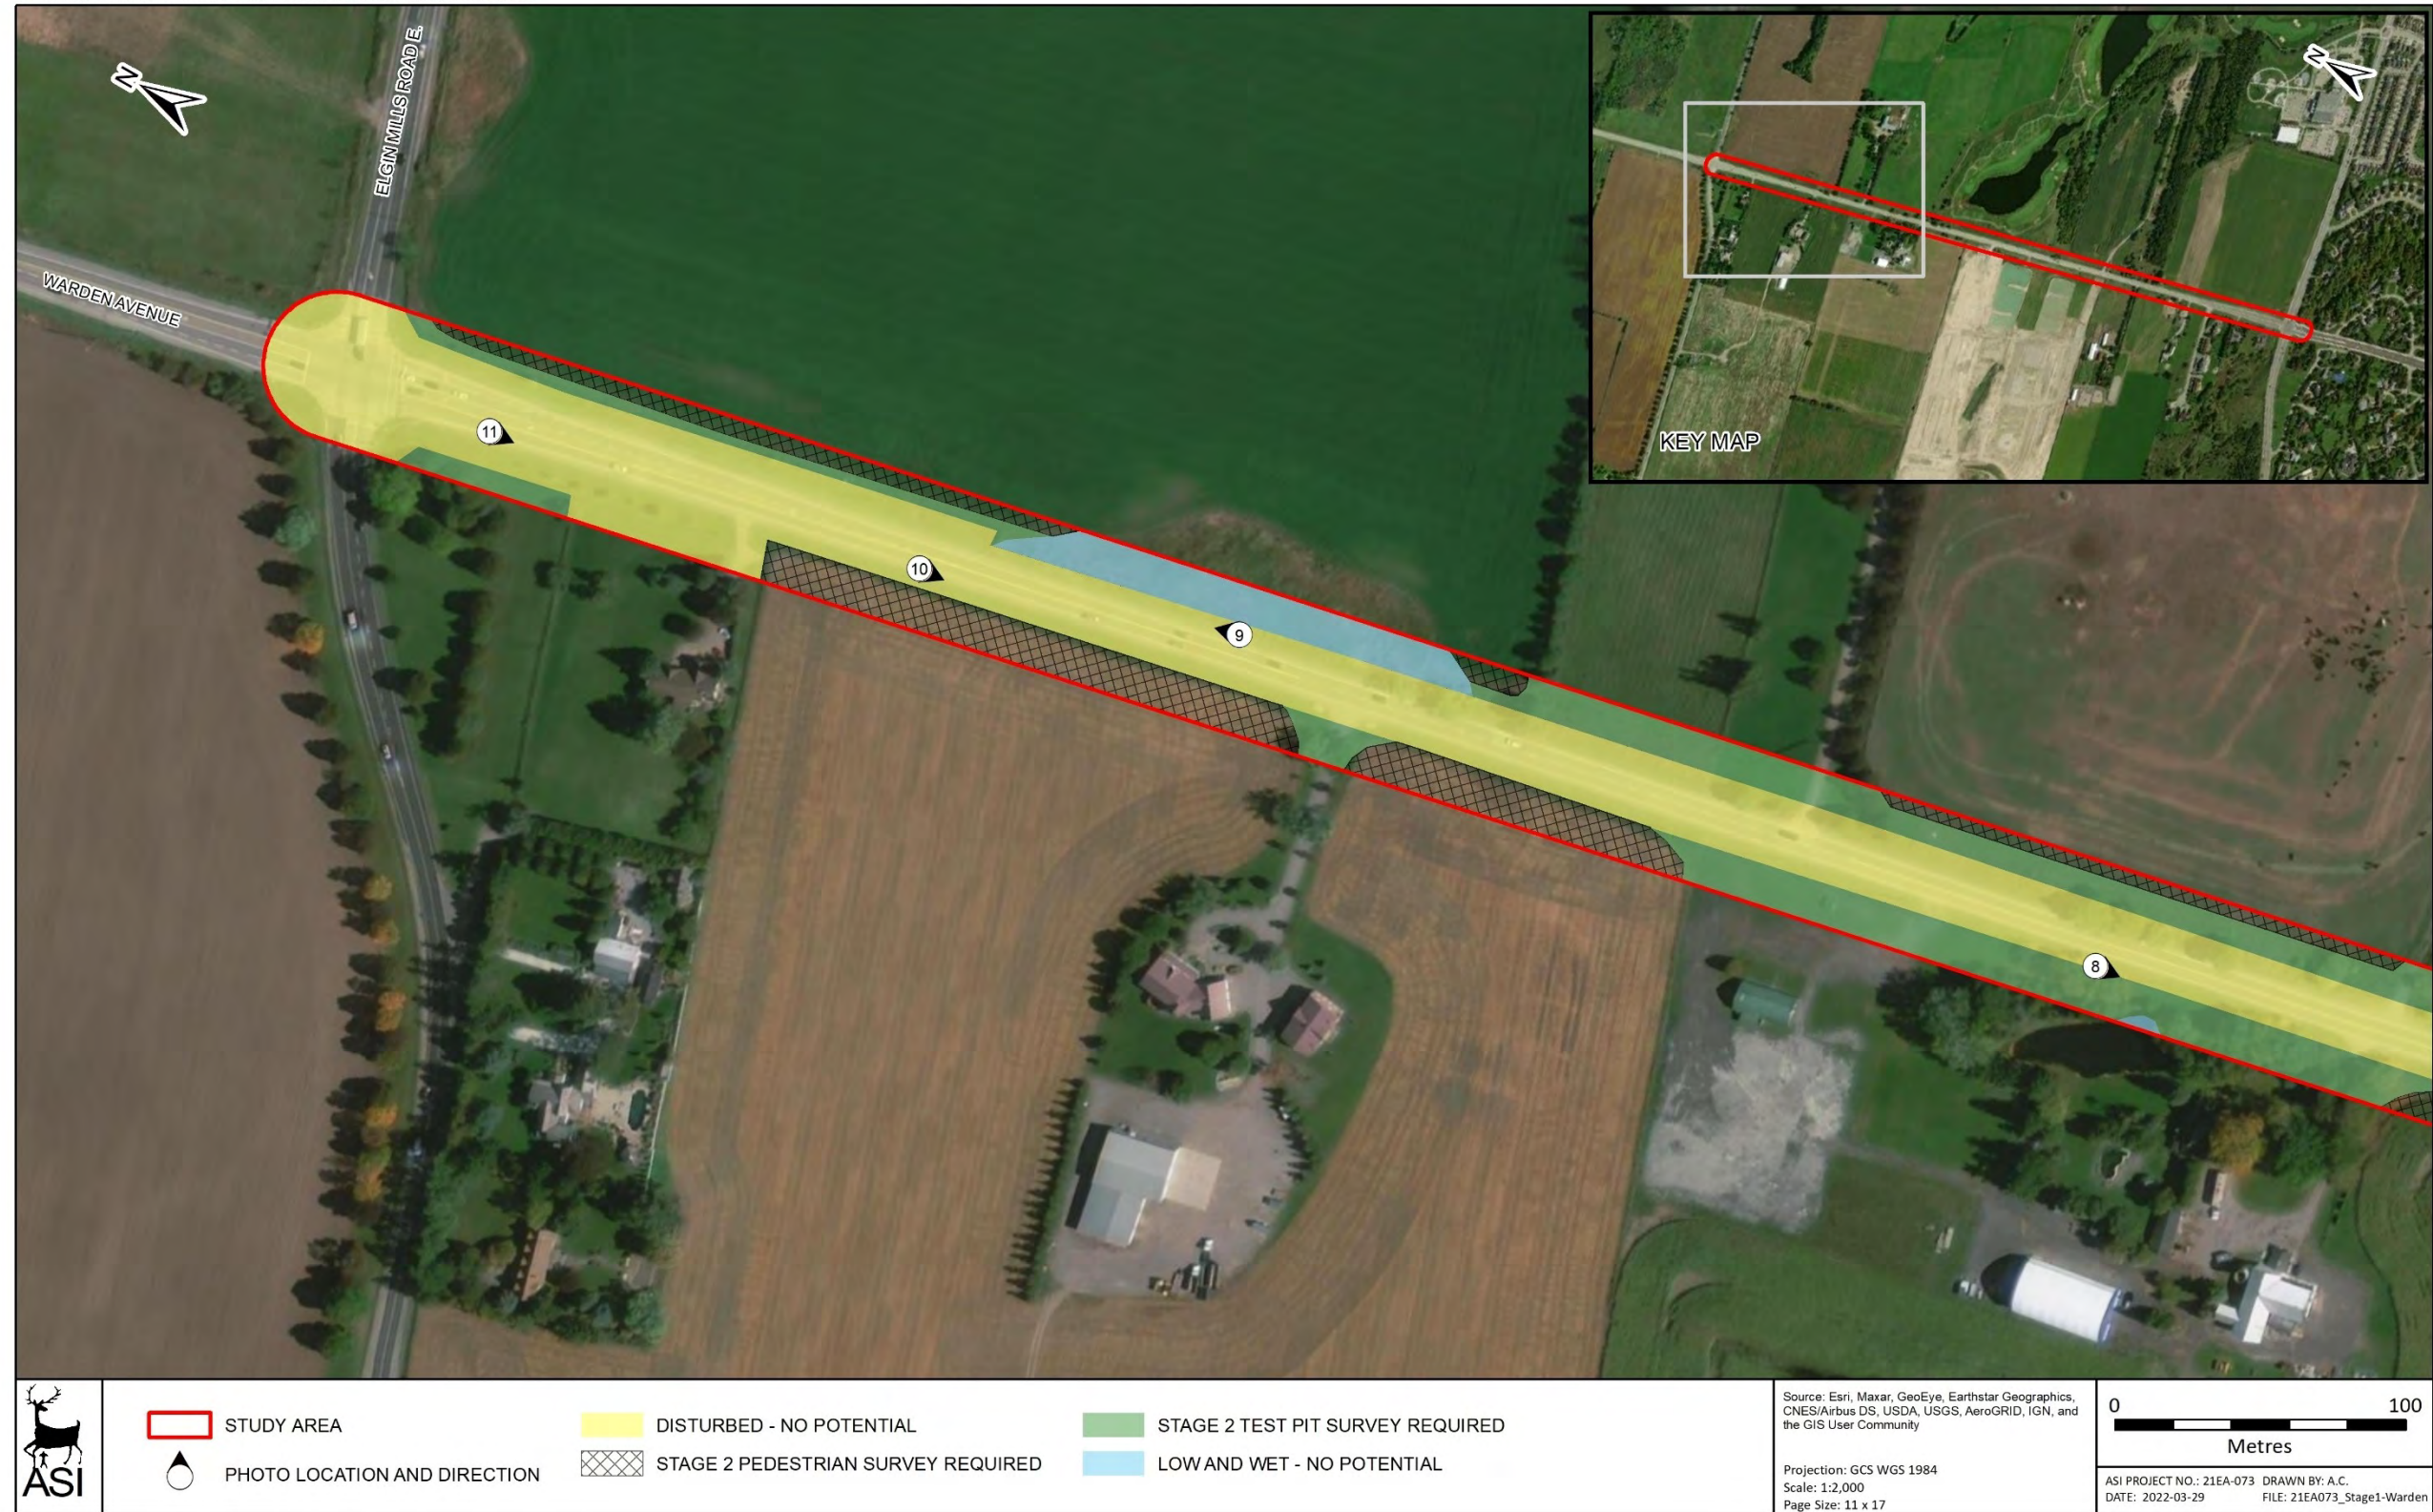
Figure 11: Warden Avenue – Results of Stage 1 (Sheet 1)

2.1.1, pedestrian survey is required in actively or recently cultivated fields (Images 7, 9 and 10; Figure 11 to Figure 13: areas highlighted by hatching). According to the S & G Section 2.1.2, test pit survey is required on terrain where ploughing is not viable, such as wooded areas, properties where existing landscaping or infrastructure would be damaged, overgrown farmland with heavy brush or rocky pasture, and narrow linear corridors up to 10 metres wide (Images 2-8, and 11; Figure 11 to Figure 13: areas highlighted in green).

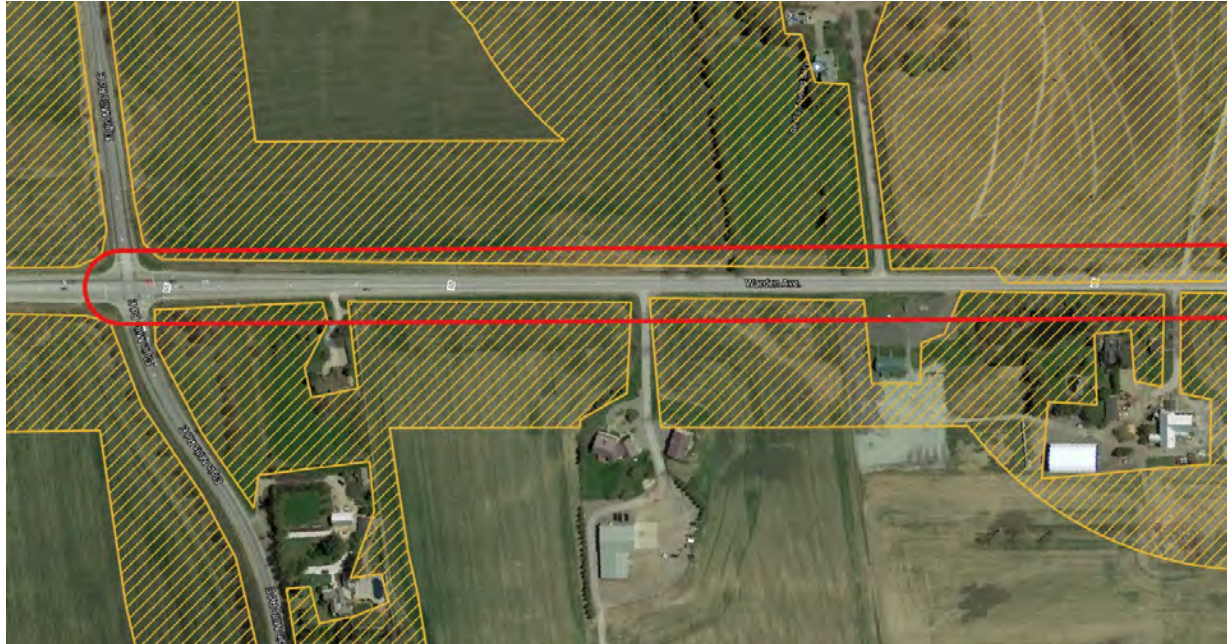
**Image 25: Areas modeled as having archaeological potential (in yellow hatching) in the York Region Archaeological Management Plan**

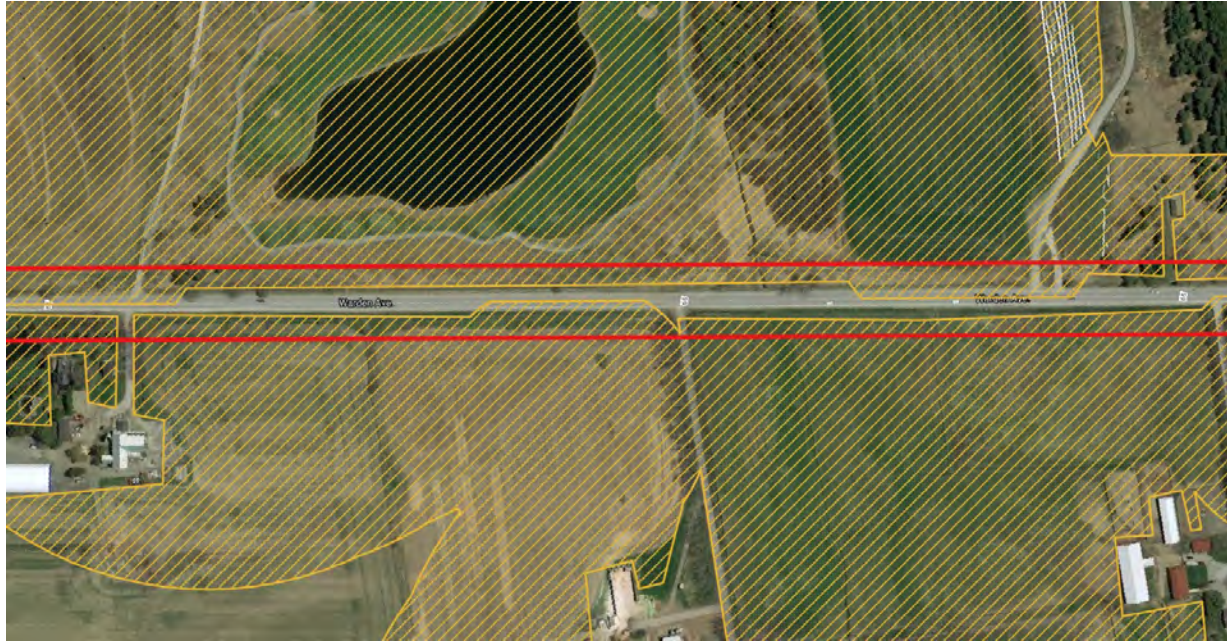
**Image 26: Areas modeled as having archaeological potential (in yellow hatching) in the York Region Archaeological Management Plan**

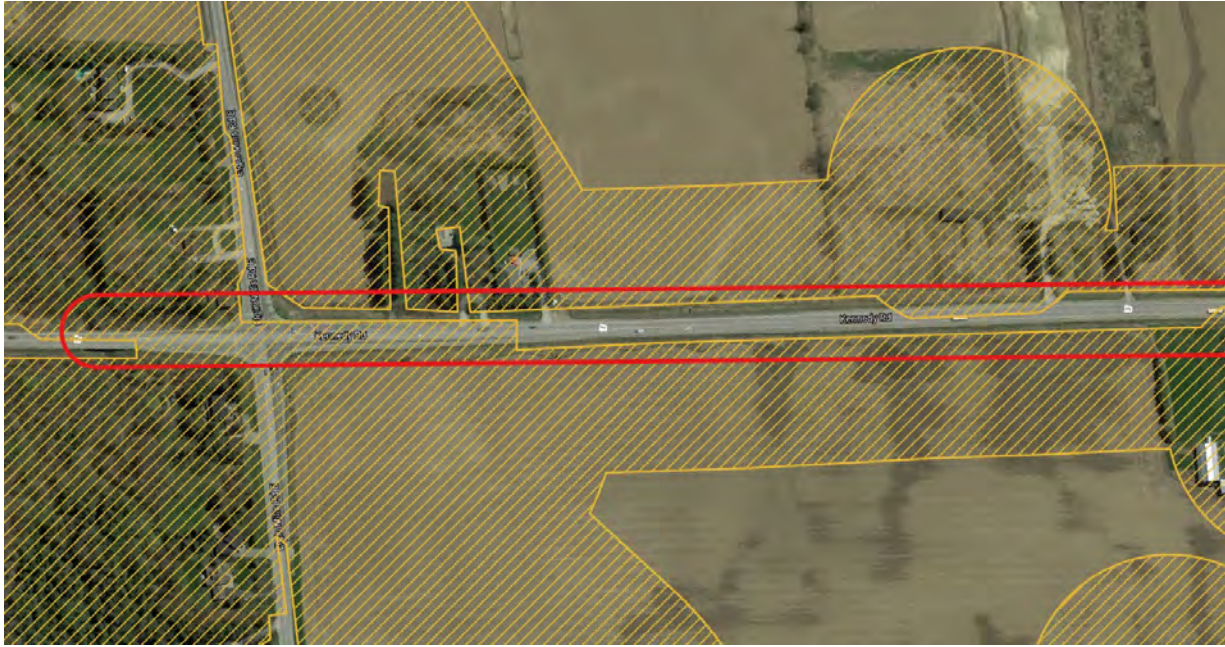
**Image 28: Areas modeled as having archaeological potential (in yellow hatching) in the York Region Archaeological Management Plan**
