### Stage 1 Archaeological Assessment Report

# Stage 1 Archaeological Assessment Warden Avenue and Kennedy Road from Major Mackenzie Drive to Elgin Mills Road (Lots 21-26, Concession 4-6, Former Township of Markham, County of York) City of Markham, Regional Municipality of York

## Original Report

Archaeological Services Inc. File: 21EA-073

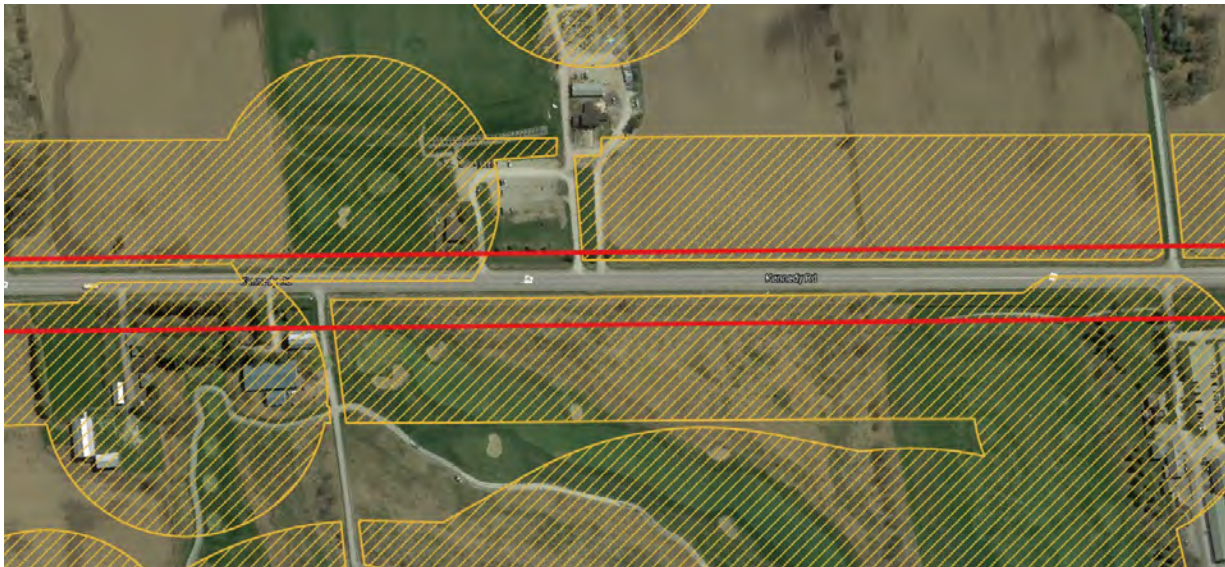
**Image 29: Areas modeled as having archaeological potential (in yellow hatching) in the York Region Archaeological Management Plan**

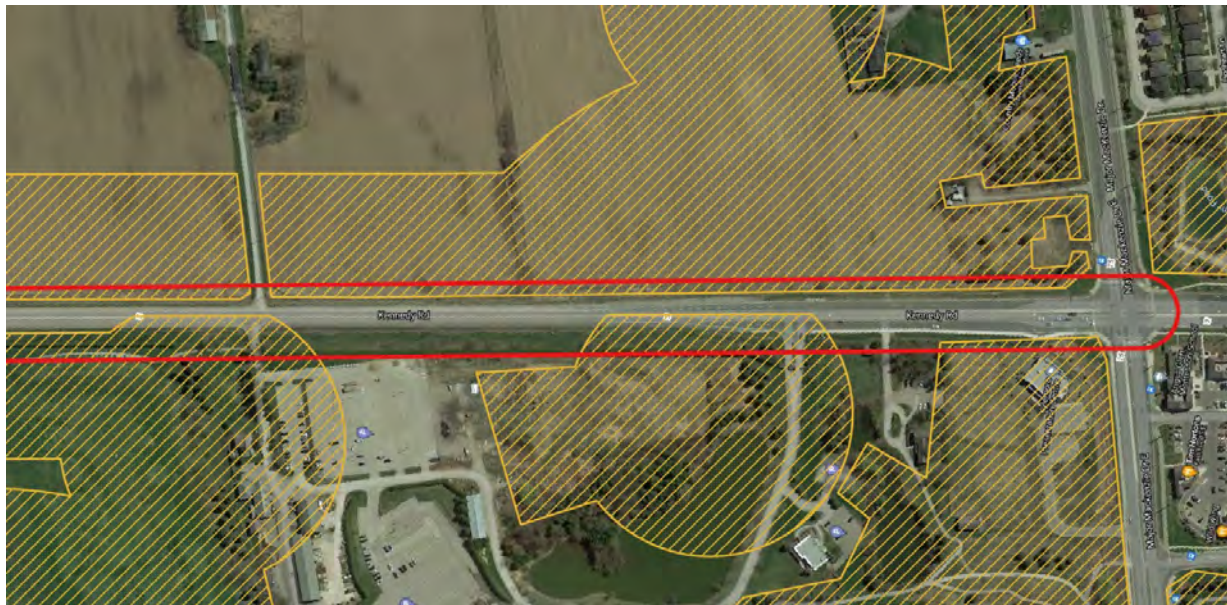
**Image 30: Areas modeled as having archaeological potential (in yellow hatching) in the York Region Archaeological Management Plan**

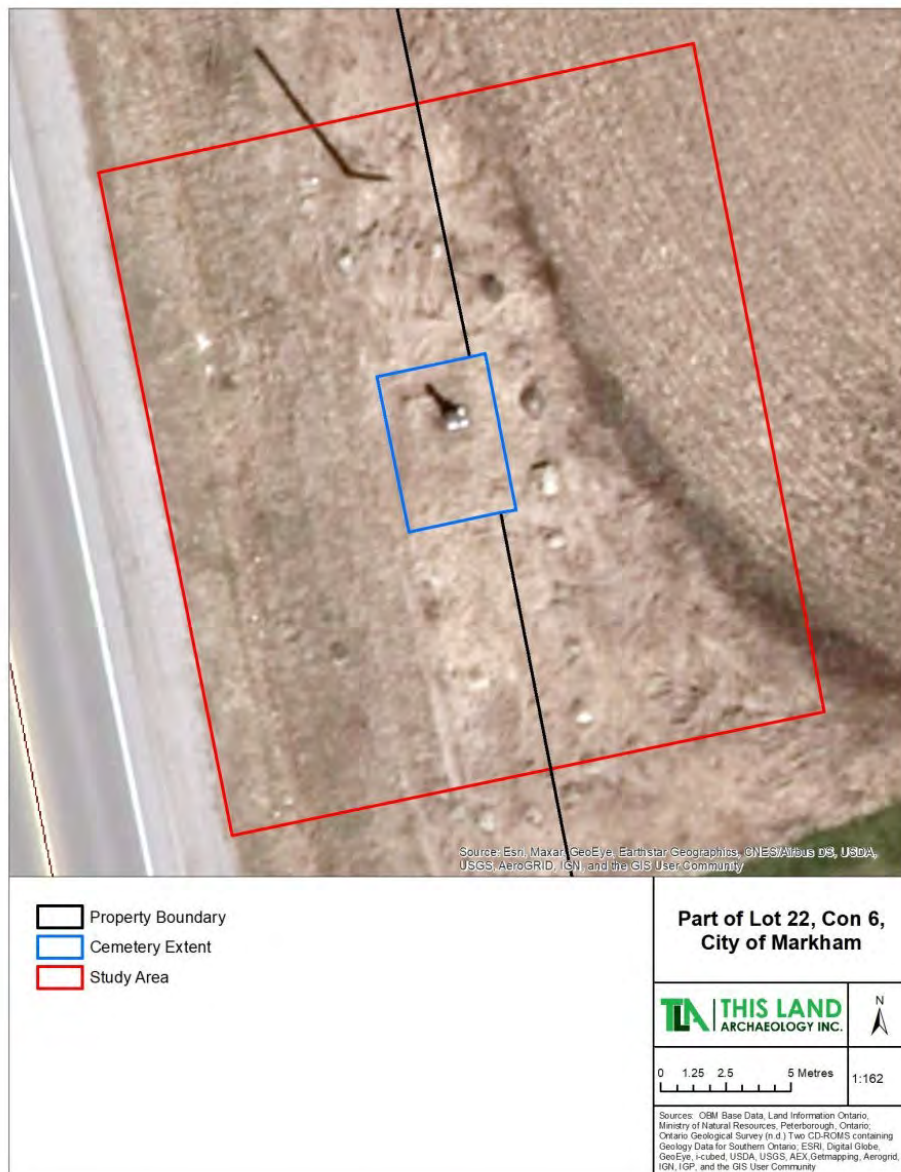
Figure 4: Current land use showing the cemetery extent in relation to the proponent's property line.
