# Hydrogeological Existing Conditions Review Report

**Hydrogeological Existing Conditions  
Review for Warden Avenue and  
Kennedy Road Environmental  
Assessment Studies between Major  
Mackenzie Drive East and Elgin Mills  
Road East**

**Regional Municipality of York  
Markham, Ontario**

**March 2022  
300052314.0000**

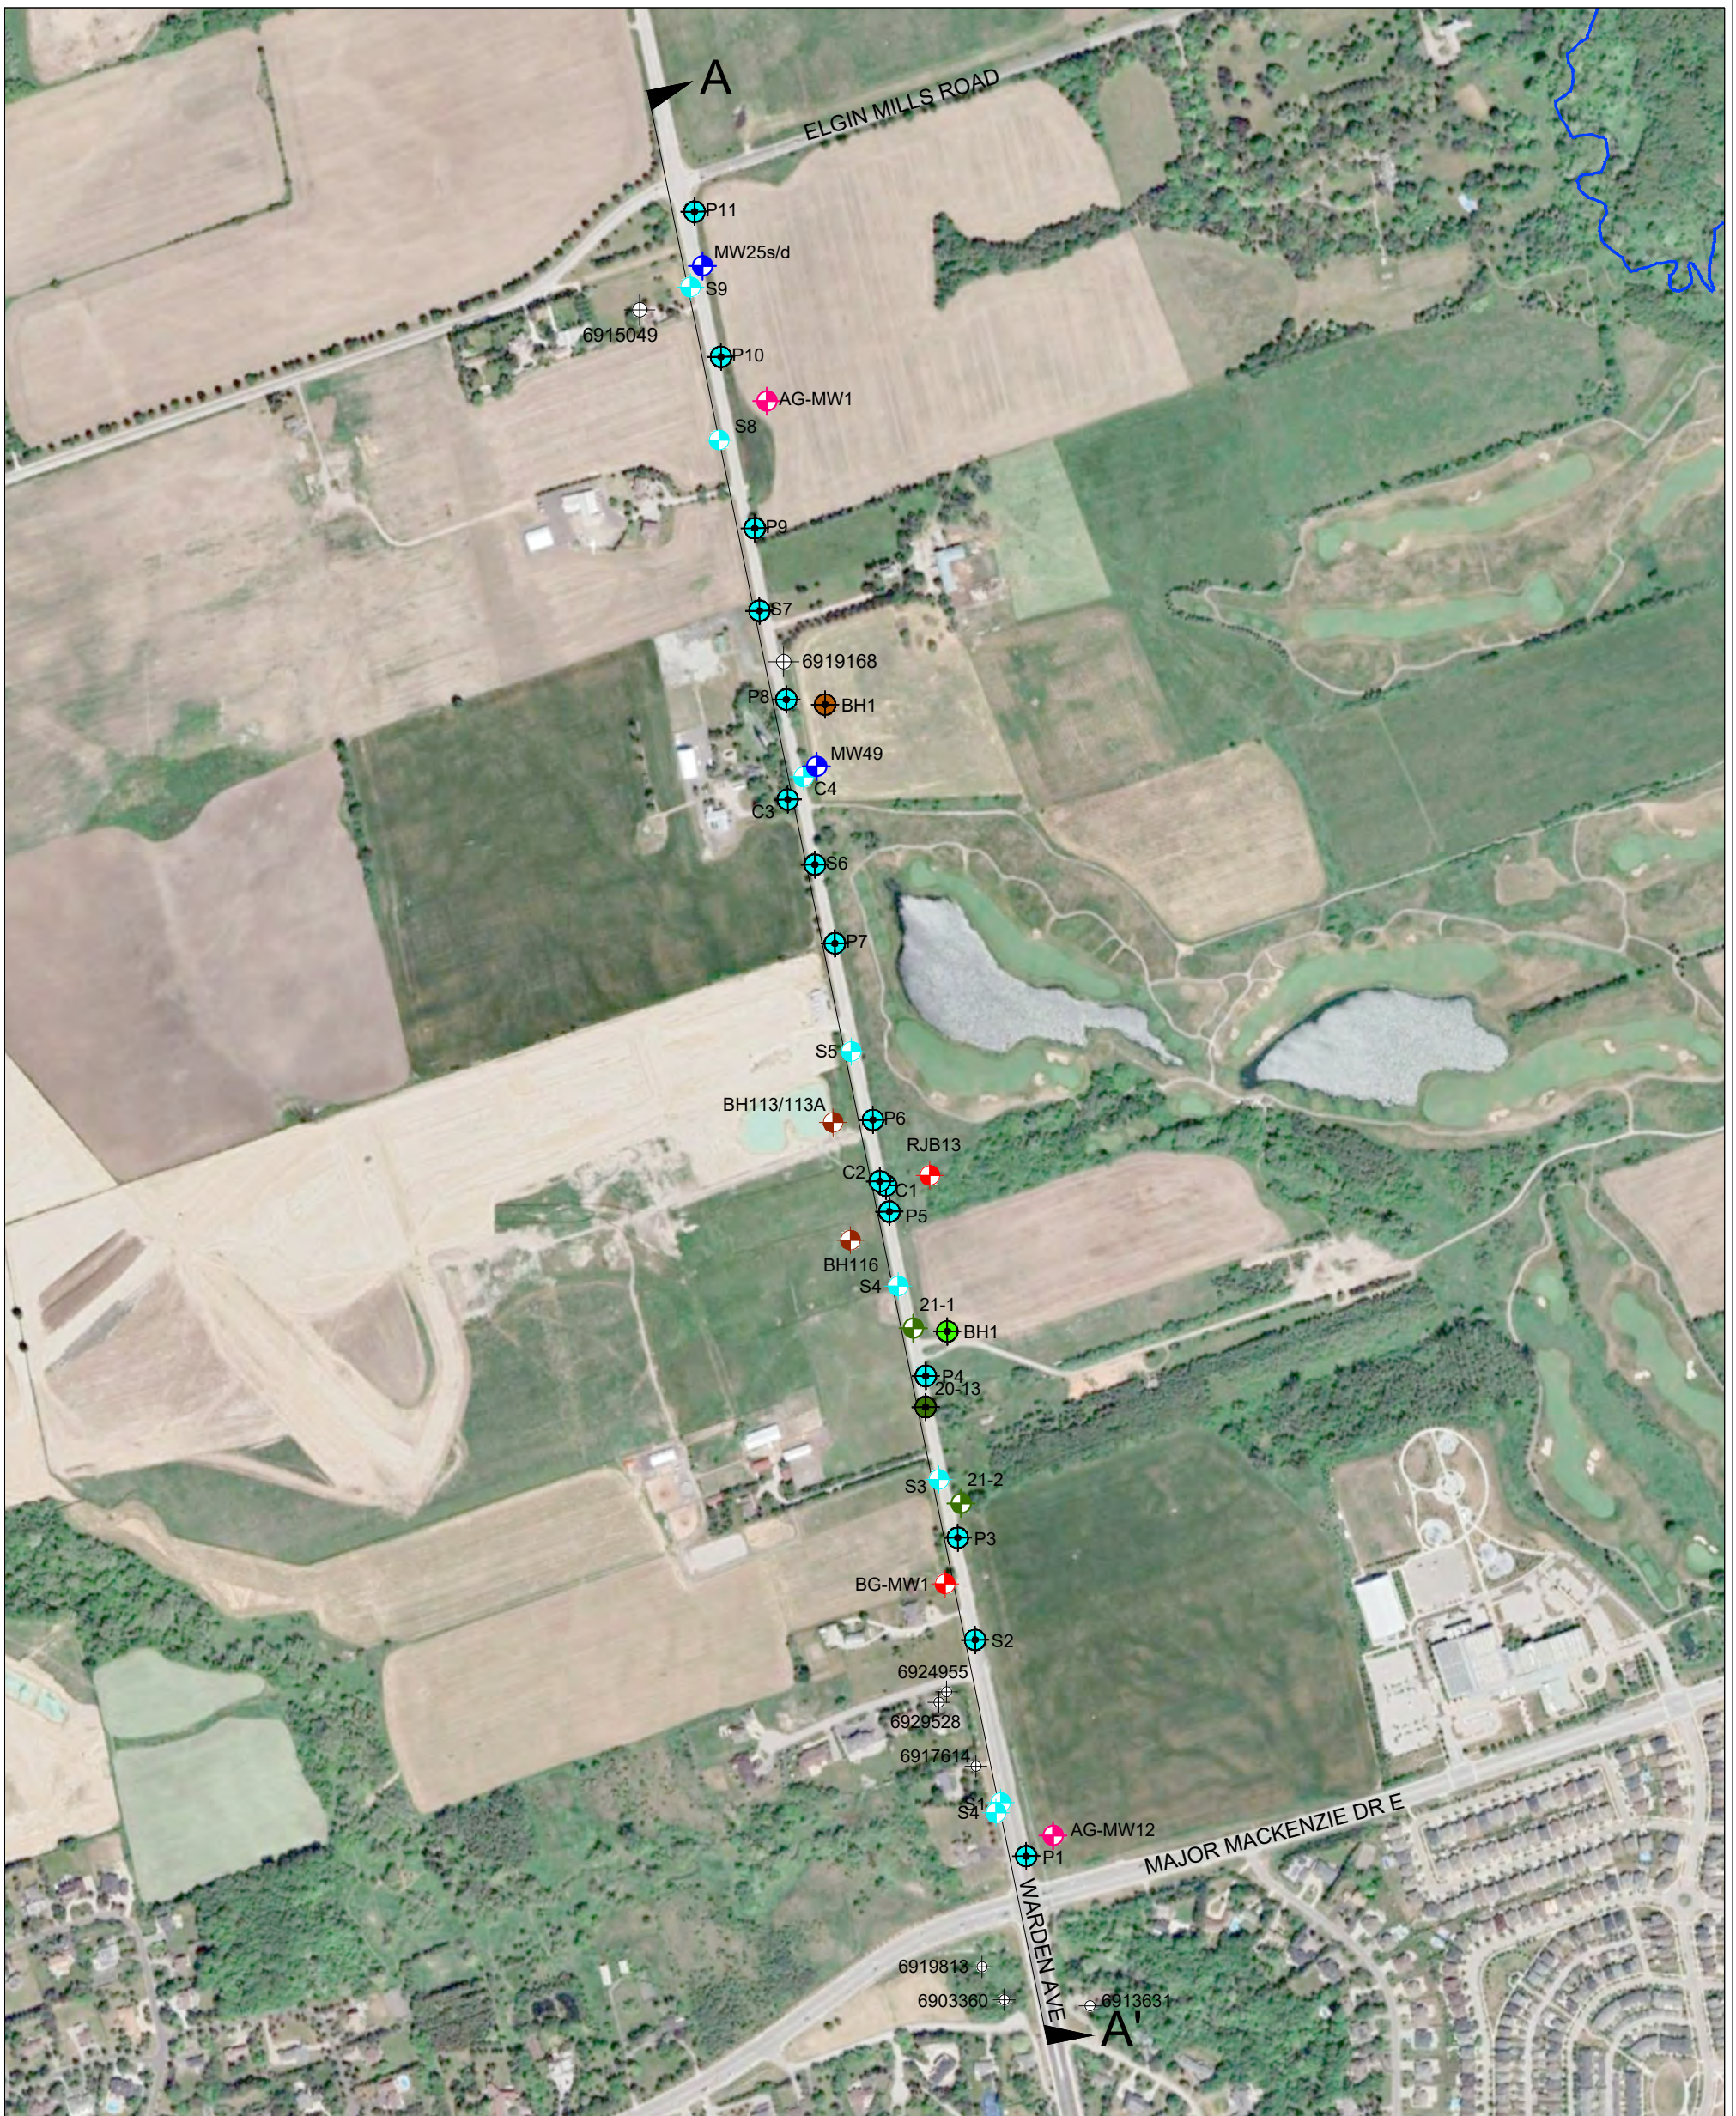
**3**

The shallow groundwater in the Study Areas has been observed in hydrogeological and geotechnical studies (see Section 2.0). The locations of monitoring wells in or near the Study Areas are shown on Figures 3 and 4 and hydrographs showing groundwater level data are provided in Appendix C.

Site-specific geological information obtained from the geotechnical boreholes and groundwater monitoring wells drilled within the Study Area (Appendix A) and local MECP well records (Appendix B) have been used to prepare schematic cross-sections along Warden and Kennedy Road within the Study Areas to illustrate the shallow stratigraphy. The cross-sections location are shown on Figure 3 and 4 and the cross-sections are provided as Figures 5 and 6.

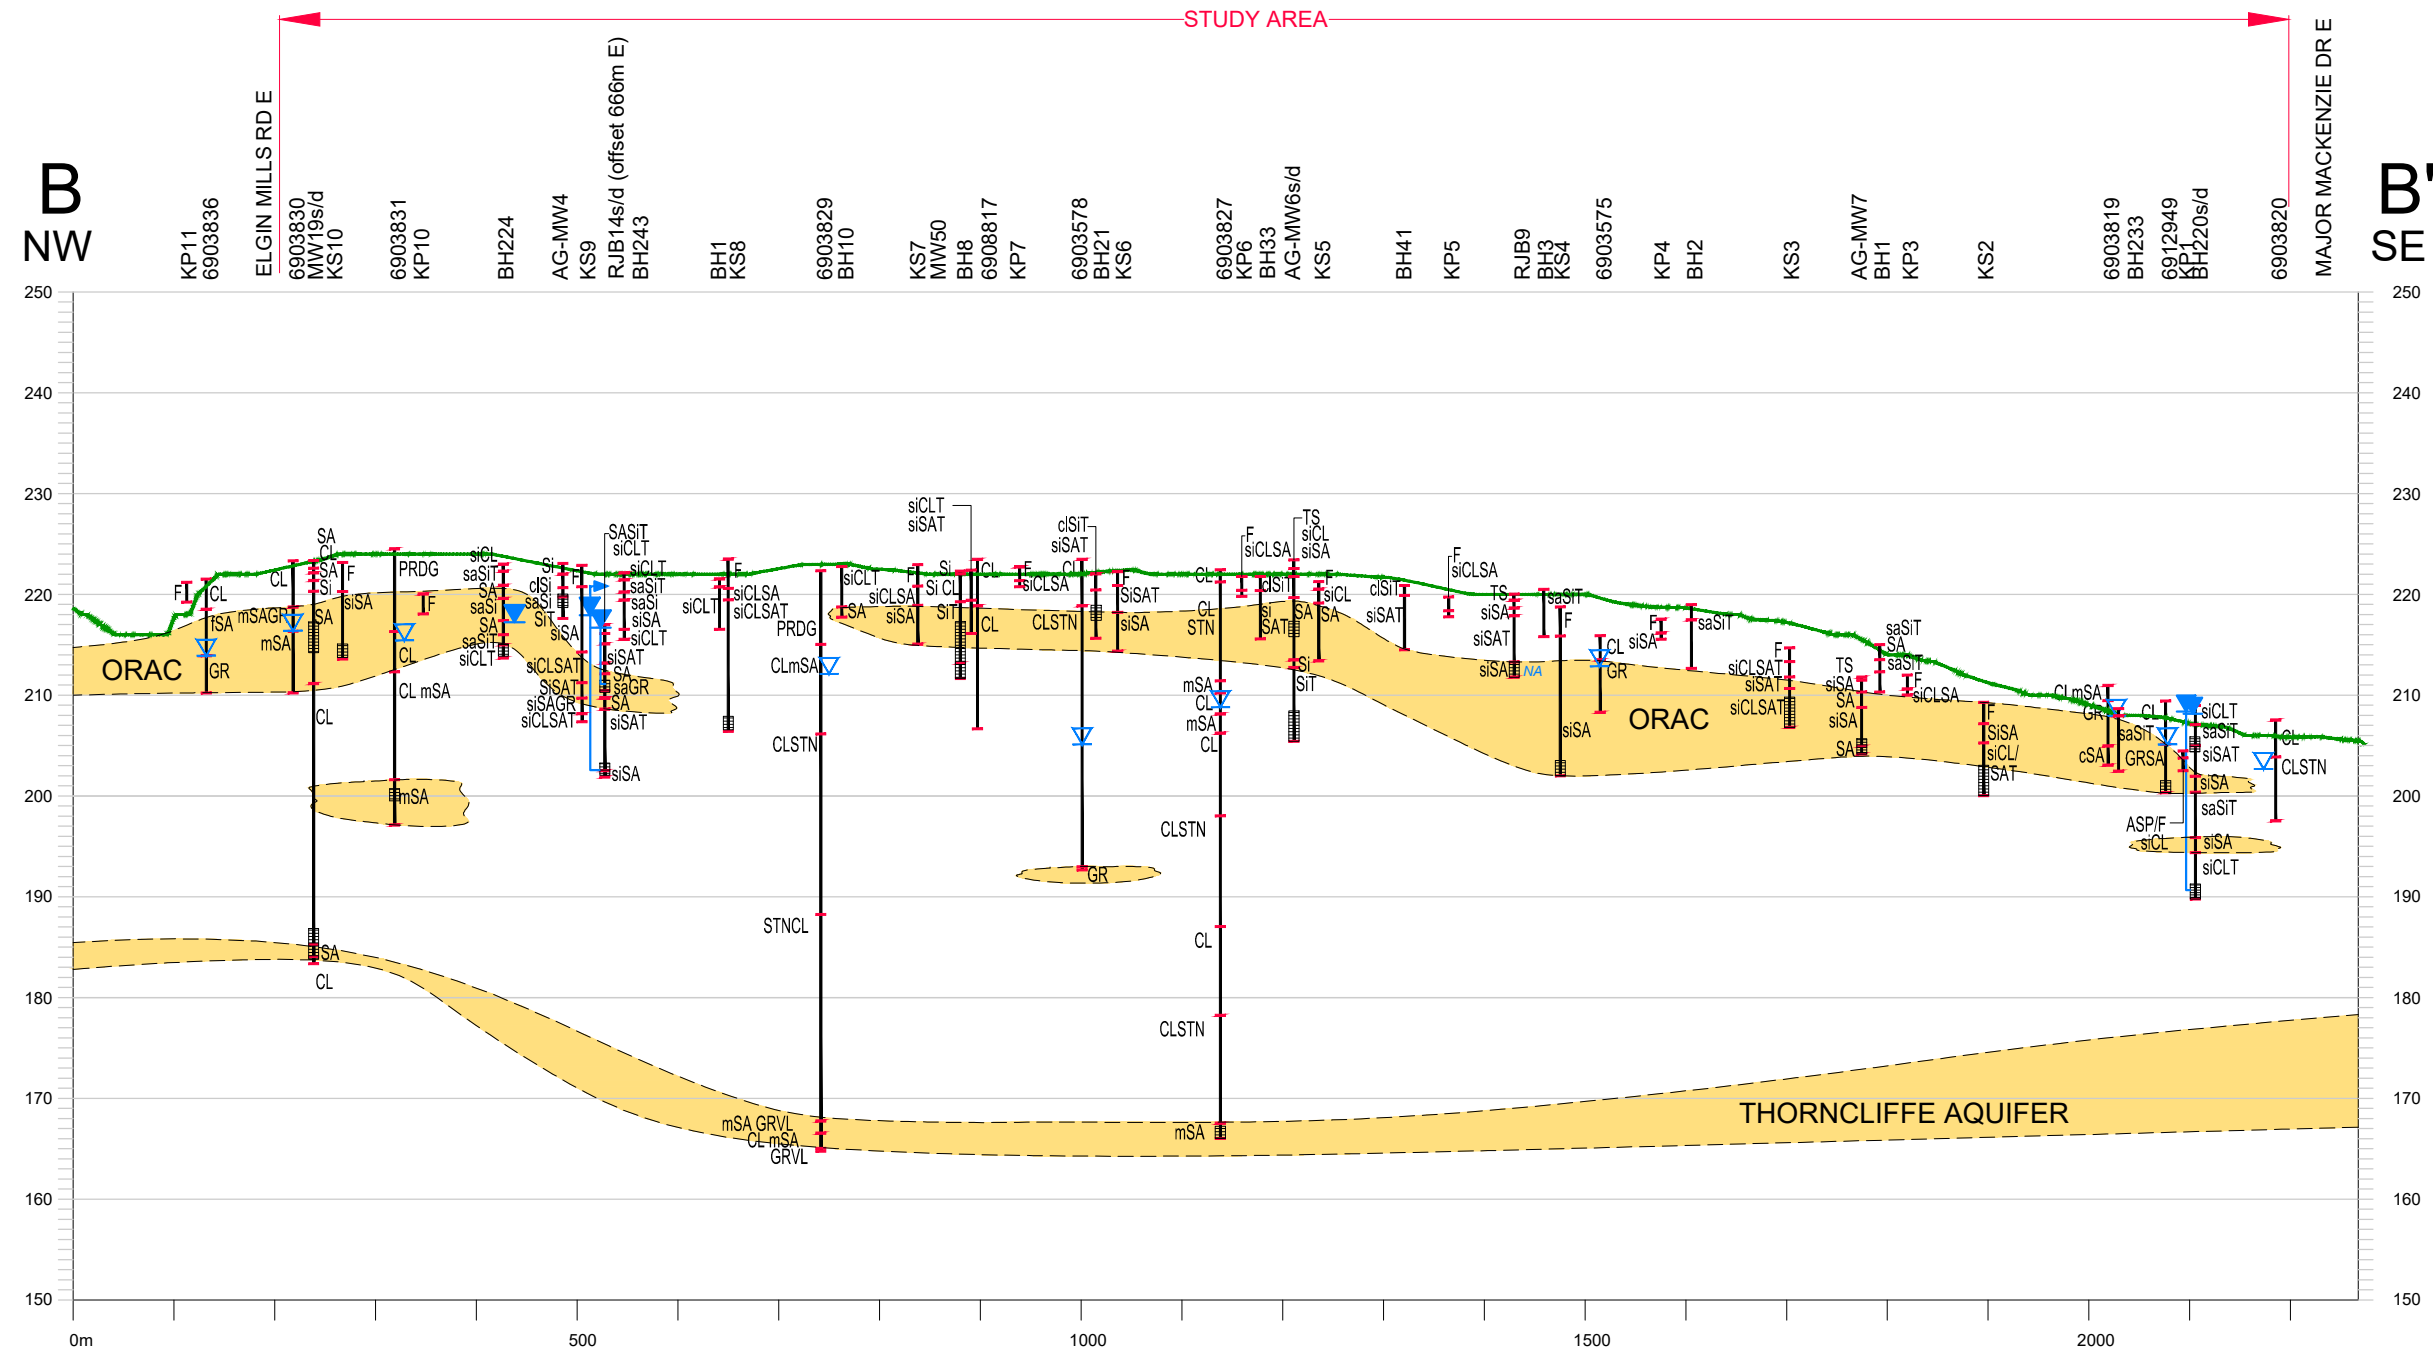
Figure Title **INTERPRETED GEOLOGICAL  
 CROSS-SECTION B-B'  
 (KENNEDY ROAD)**

The cross-section along Kennedy Road (Figure 6) also shows a layer of fine grained soils overlying a layer of sand/gravel and silty sand at depths of 1 m to 10 mbgs and a thickness of 5 to 10 m. The coarse grained layer is interpreted to be the ORAC and appears to be continuous in the northern part of the Study Area before becoming discontinuous in the south.

The Thorncliffe aquifer is interpreted to be generally found between elevations 160 masl and 180 masl (i.e., more than 35 mbgs) in the vicinity of the Study Area (Figures 5 and 6). (Stonybrook et al., 2020). The Scarborough aquifer was interpreted to be found between 120 masl and 130 masl (Stonybrook et al., 2020).

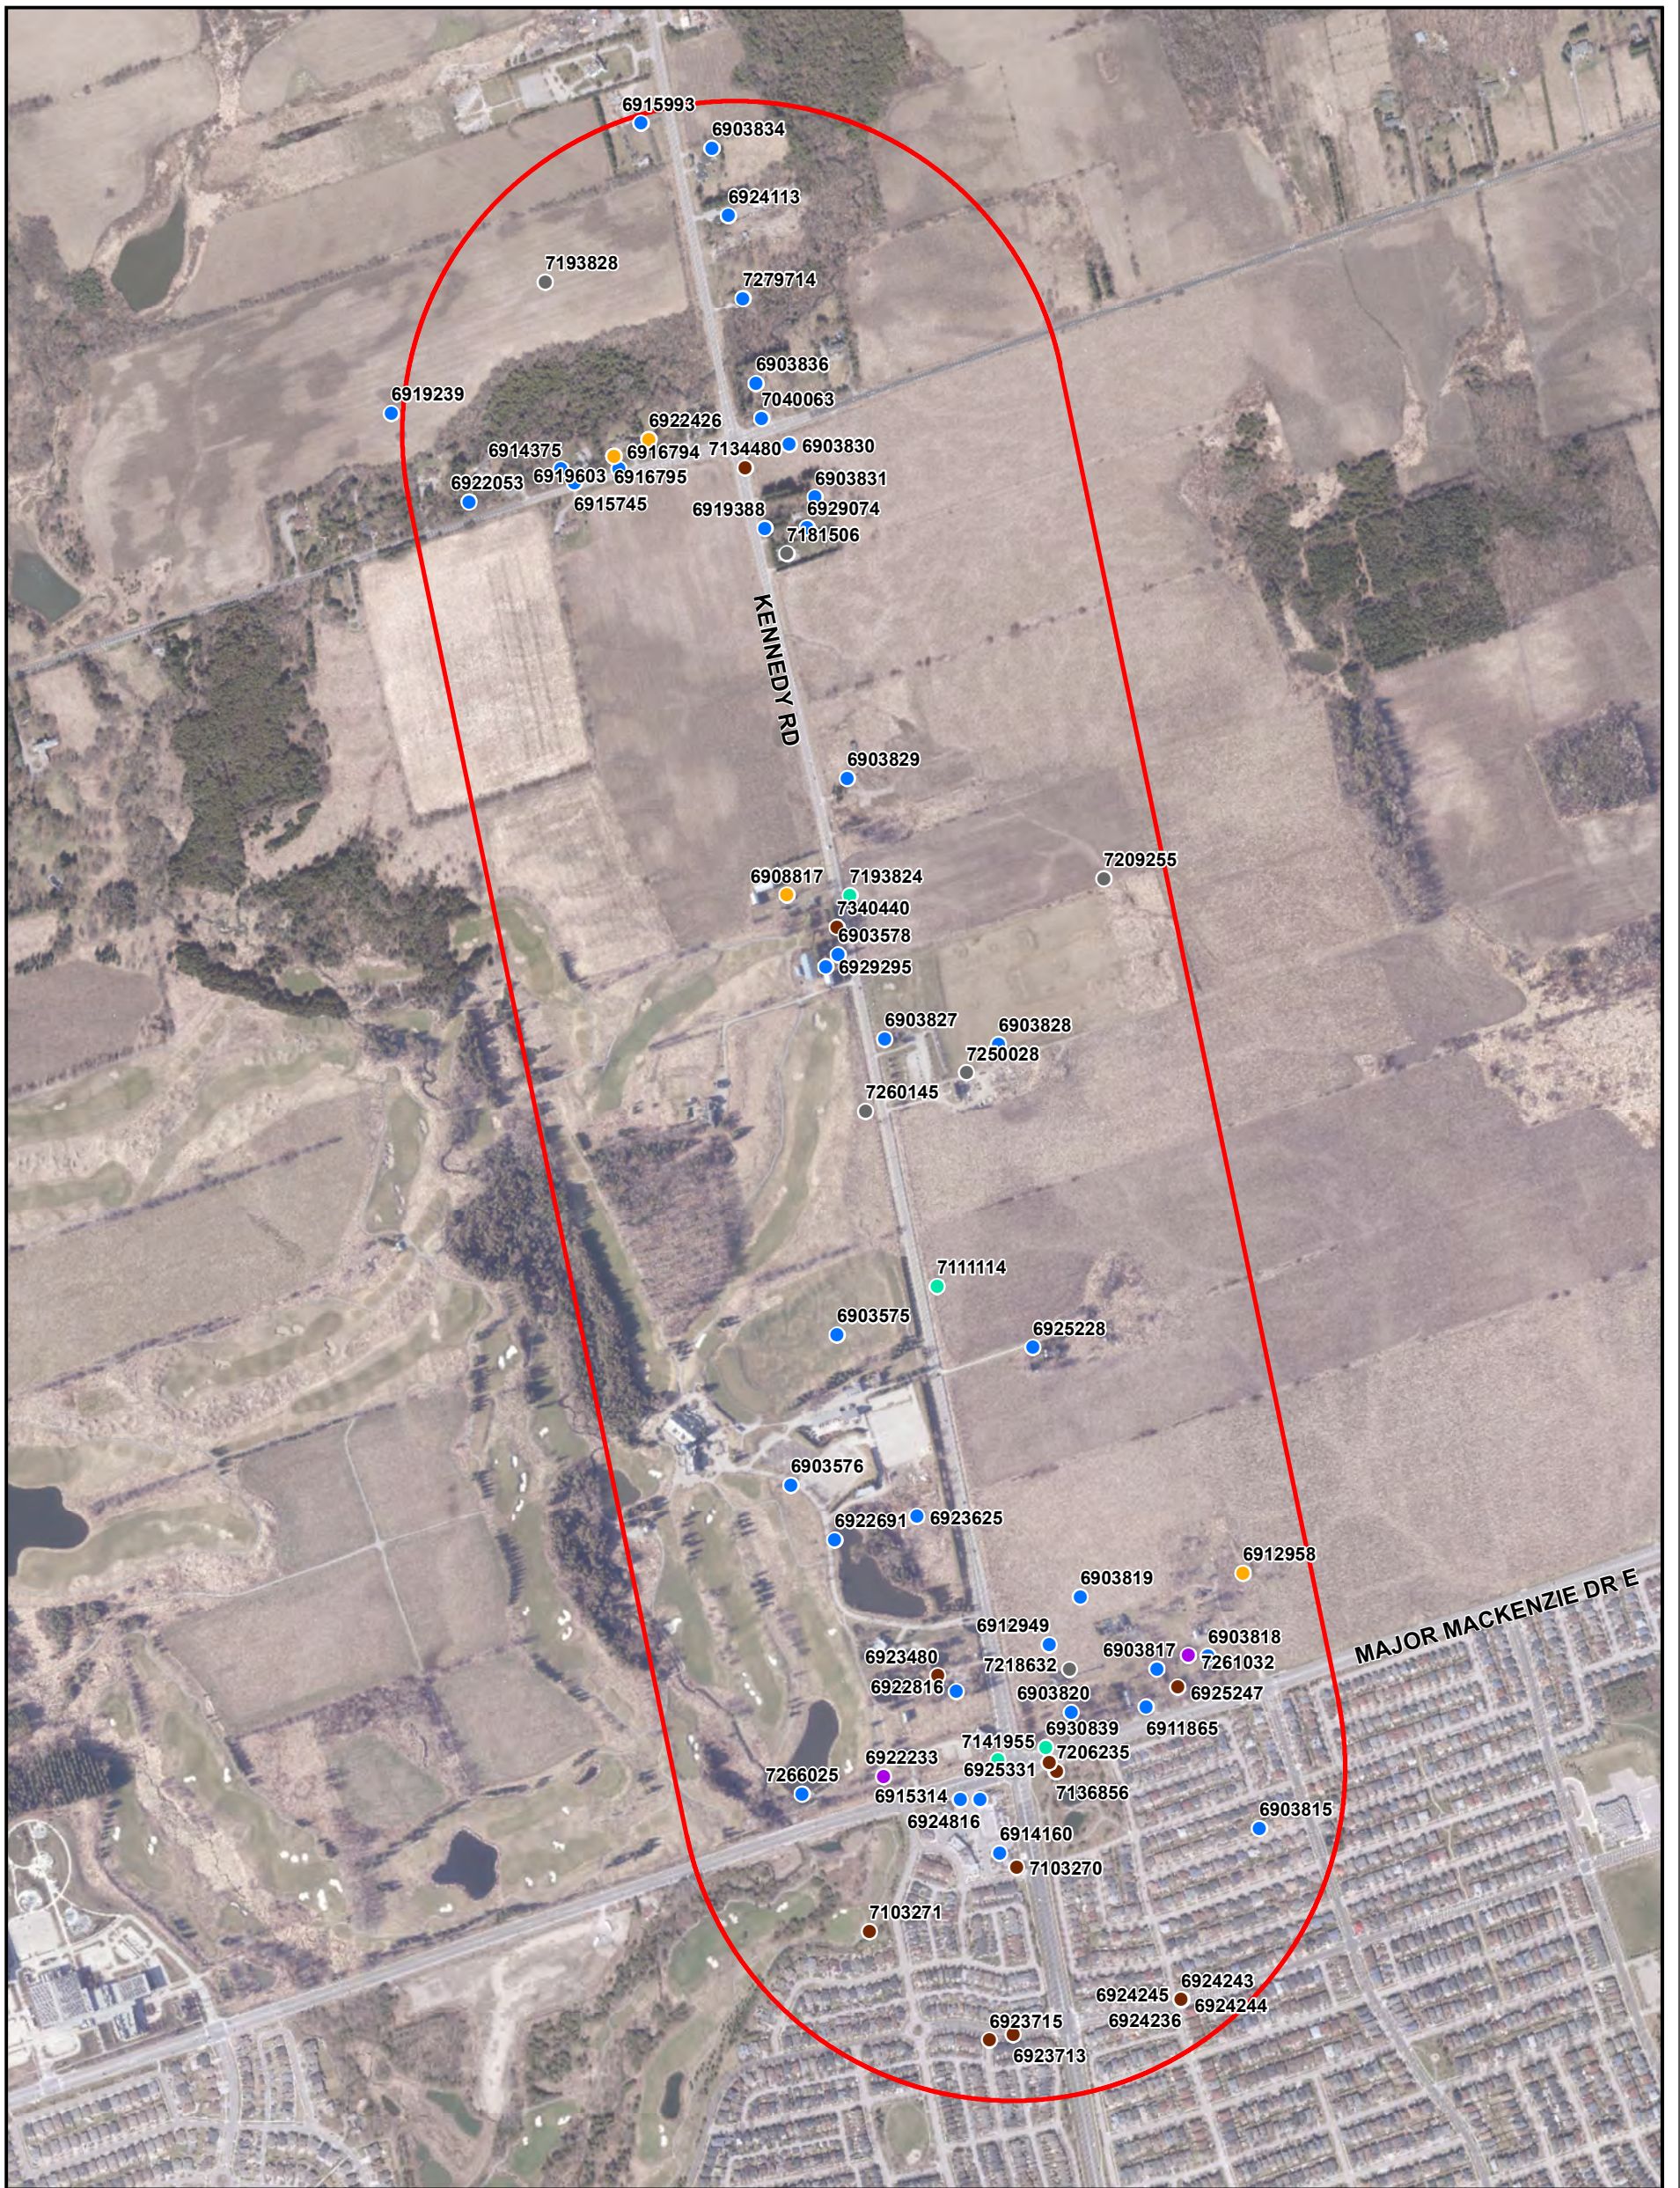
Within 500 m of the Kennedy Road Study Area, 38 of the well records are listed as water supply wells (Figure 8). The majority of the water supply wells were drilled wells screened in the overburden at depths ranging from 9 mbgs to 177 mbgs. Eleven of the wells were bored wells with depths of 5 to 12 mbgs. Two of the wells were in the bedrock at depths of approximately 53 m to 71 mbgs.

Areas are plotted on Figures 7 and 8. It is noted that the well locations listed in the MECP records are approximations only and may not be representative of the precise well locations in the field.
