**Stage 2 Archaeological Assessment  
Teston Road - Highway 400 to Bathurst Street  
Individual Environmental Assessment  
Part of Lots 25 and 26, Concessions 2 and 3,  
and Part of Lot 26, Concession 4  
(Geographical Township of Vaughan, County of  
York)  
City of Vaughan, Regional Municipality of York**

**Original Report**

Archaeological Services Inc. File: 19EA-200

11 March 2024

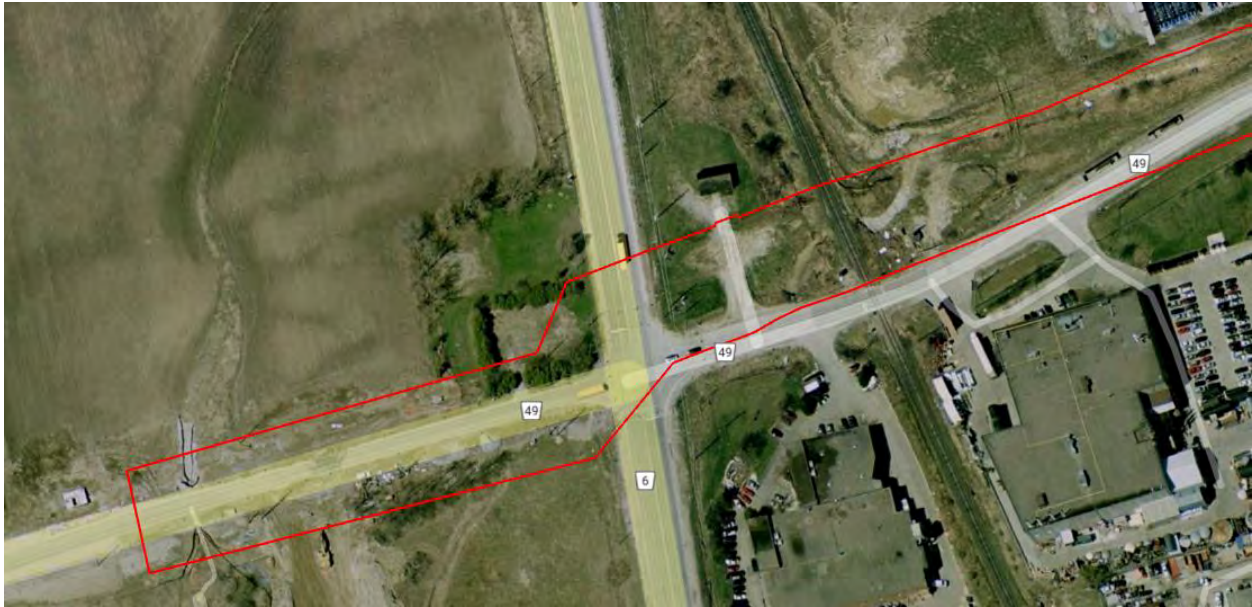
**Image 1: Google Earth satellite imagery showing grading and earthmoving activities along Teston Road, east and west of Keele Street, *circa* December 2005**

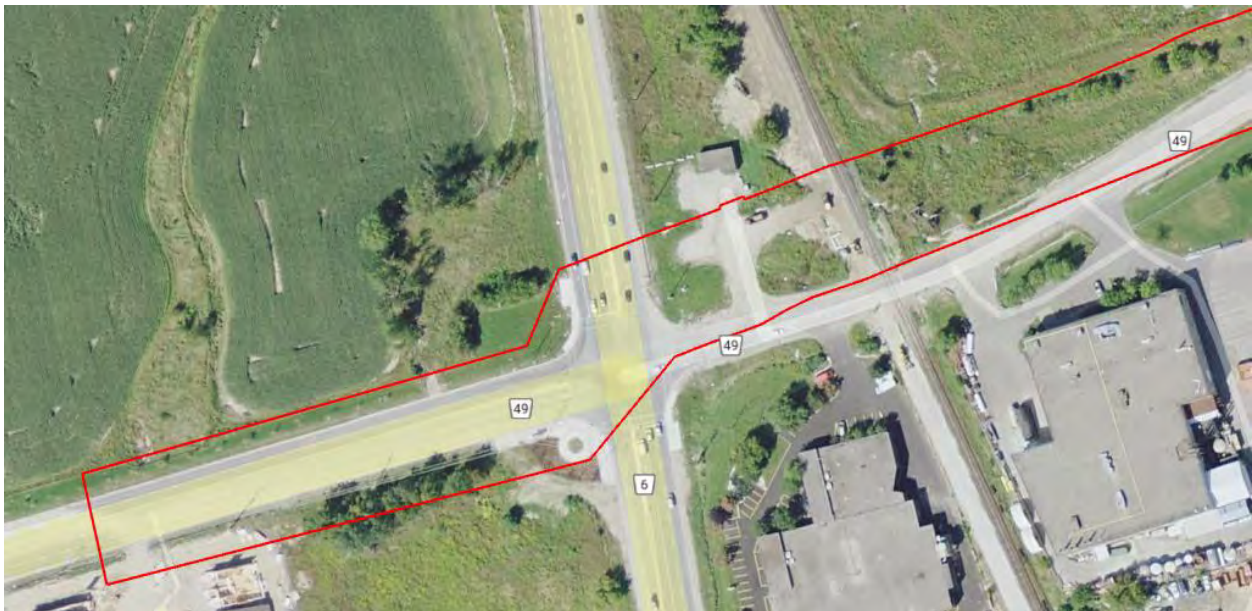
**Image 2: Google Earth satellite imagery showing construction at the southwest corner of Teston Road and Keele Street, *circa* September 2009**

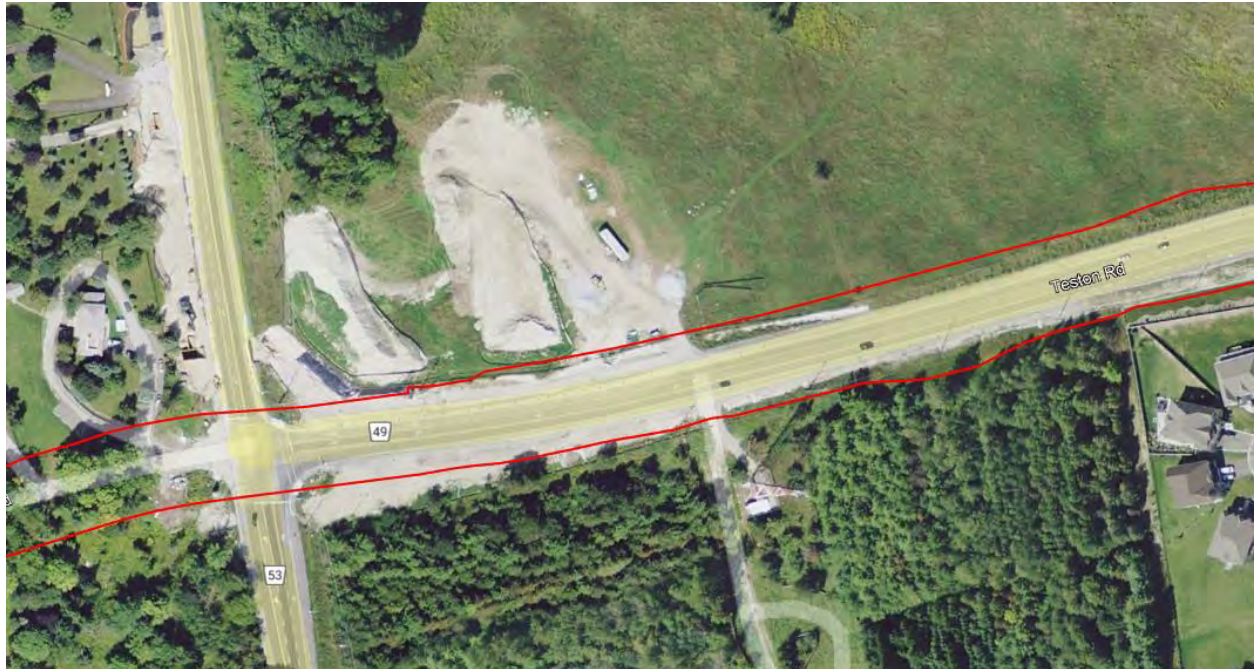
**Image 3: Google Earth satellite imagery showing grading and earthmoving activities at the northeast corner of Teston Road and Dufferin Street, *circa* September 2009**

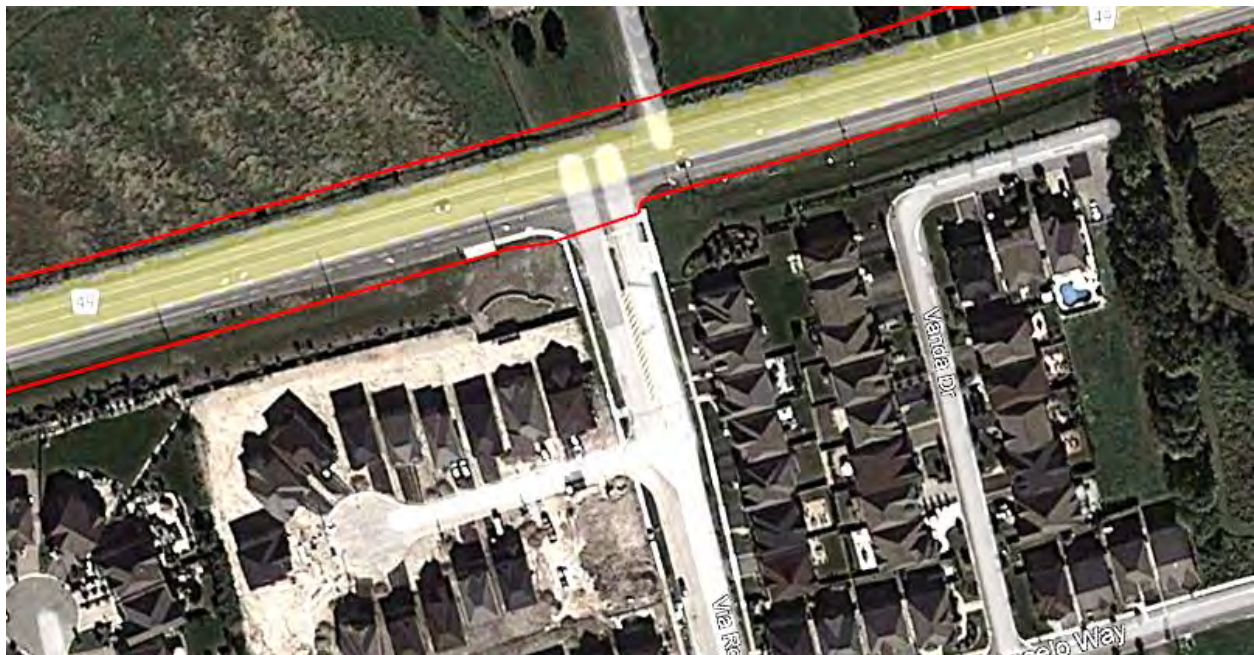
**Image 4: Google Earth satellite imagery showing grading and earthmoving activities at the southwest corner of Teston Road and Via Romano Boulevard, *circa* September 2013**

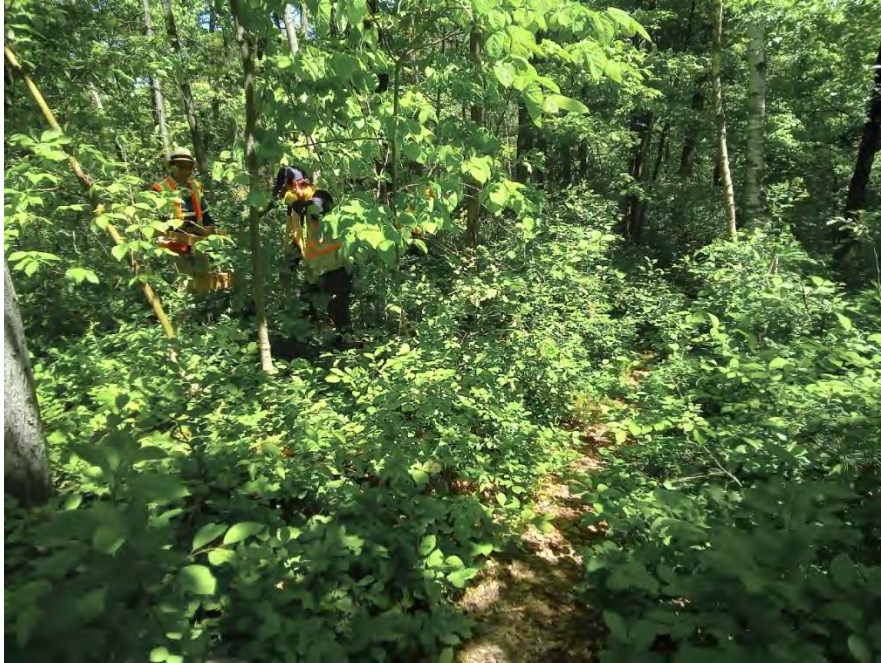
**Image 13: Judgmental test pit survey at 10 metre intervals.**

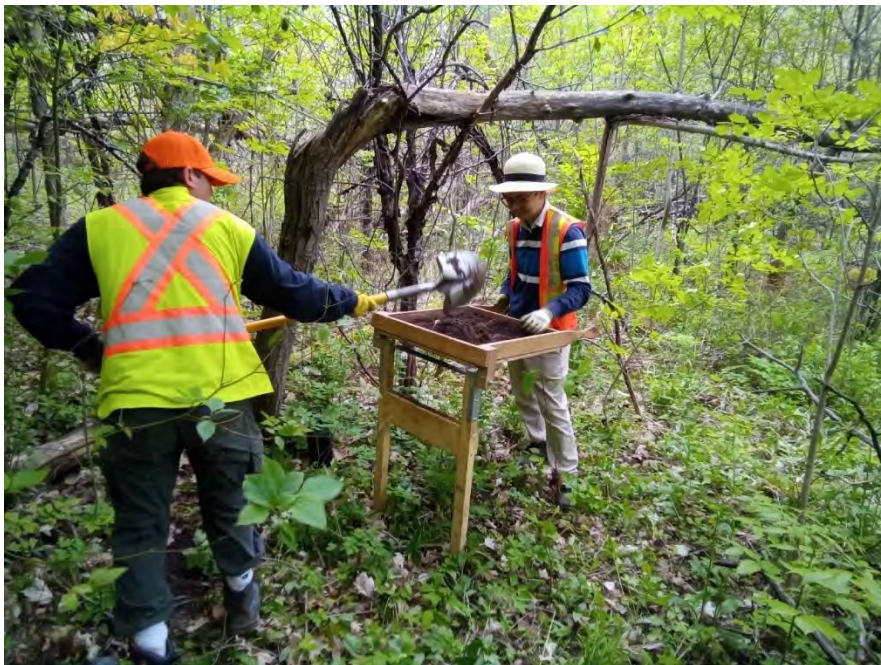
**Image 14: Test pit survey at five metre intervals.**

Approximately 11.8 percent of the Study Area (2.09 hectares) was found to contain natural topsoil (A-horizon) and was subject to test pit survey at five metre intervals following S & G Section 2.1.2, Standards 1-9. The areas subject to test pit survey at five metre intervals include a large woodlot spanning a tributary of the Don River west of Dufferin Street (Figure 5, Figure 6; Image 14 and Image 23),

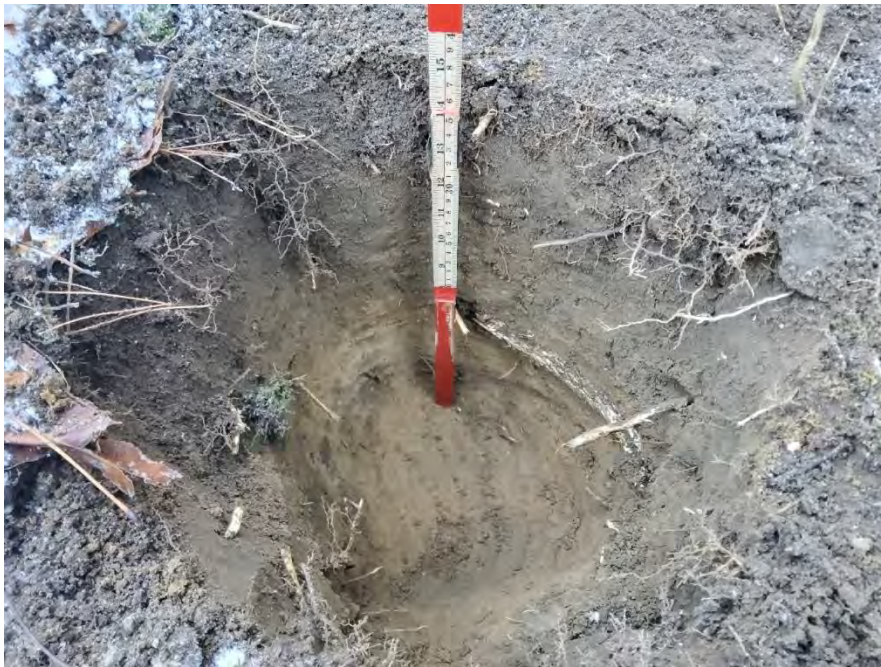
**Image 16: Test pit demonstrating intact topsoil (A-horizon).**

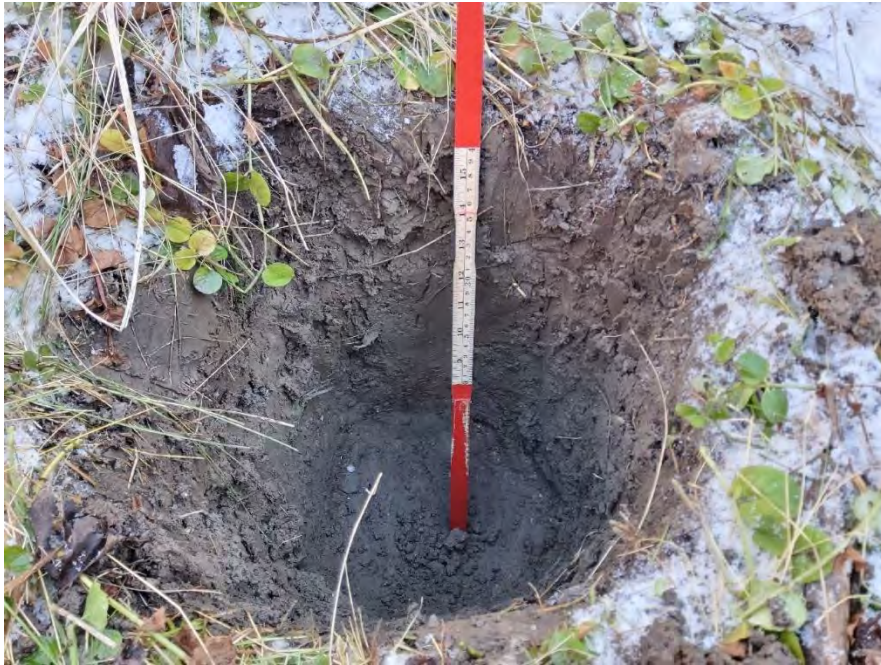
**Image 17: Test pit demonstrating gleysolic soil conditions.**

Gleysolic soils result from prolonged water saturation of the soil profile. Landscapes with clay-dominated soil textures have very slow rates of water movement through the soil which causes water saturation. Water saturation leads to depletion of oxygen in the soil and soil features associated with

oxygen-depleted conditions. These conditions cause the transformation of metals, such as iron, and lead to changes in the dominant colour of soil horizons. When oxygen becomes depleted (due to water saturation) the iron is reduced and takes on a blue-gray hue and this dominates the colour of the horizon. Reduced iron is also mobile and it can concentrate in the profile and re-oxidize, producing reddish or brown mottles. These features are collectively referred to as gley features, and the diagnostic criteria for gleysolic soils in the presence of well-developed gley features within 50 centimetres of the soil surface (University of Saskatchewan, 2021).

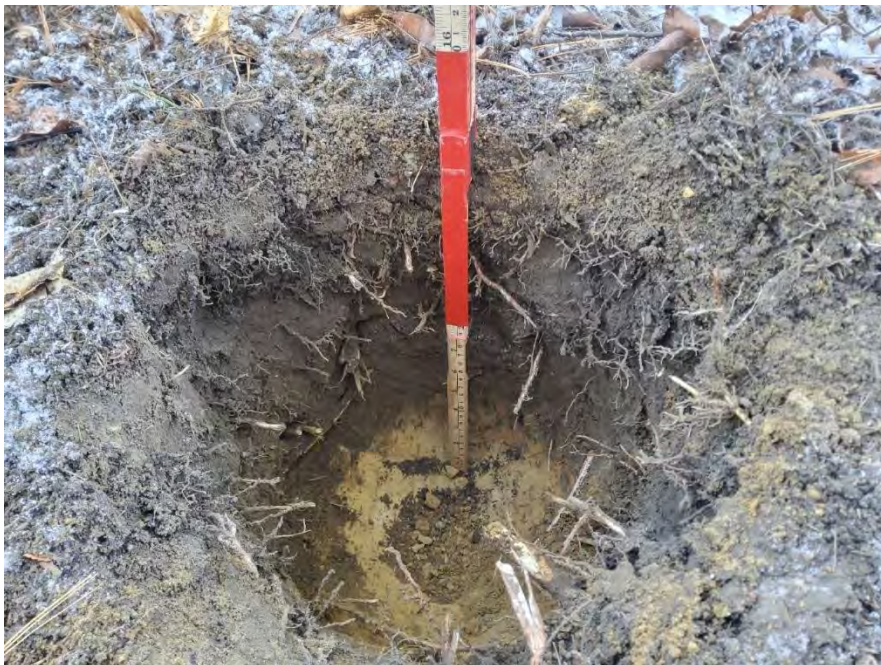
**Image 18: Test pit demonstrating intact topsoil (A-horizon).**

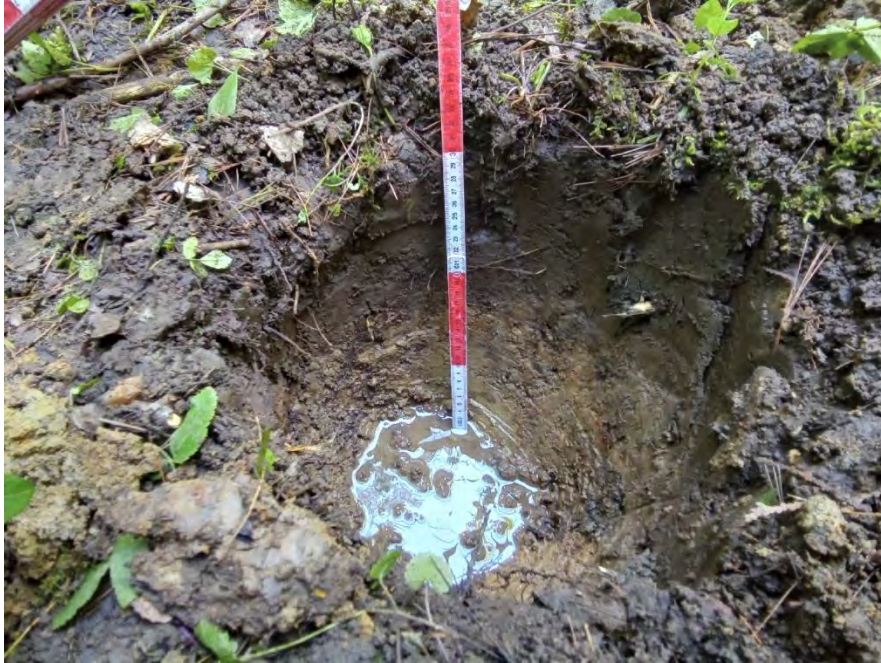
**Image 19: Test pit demonstrating gleysolic soil conditions and water table.**

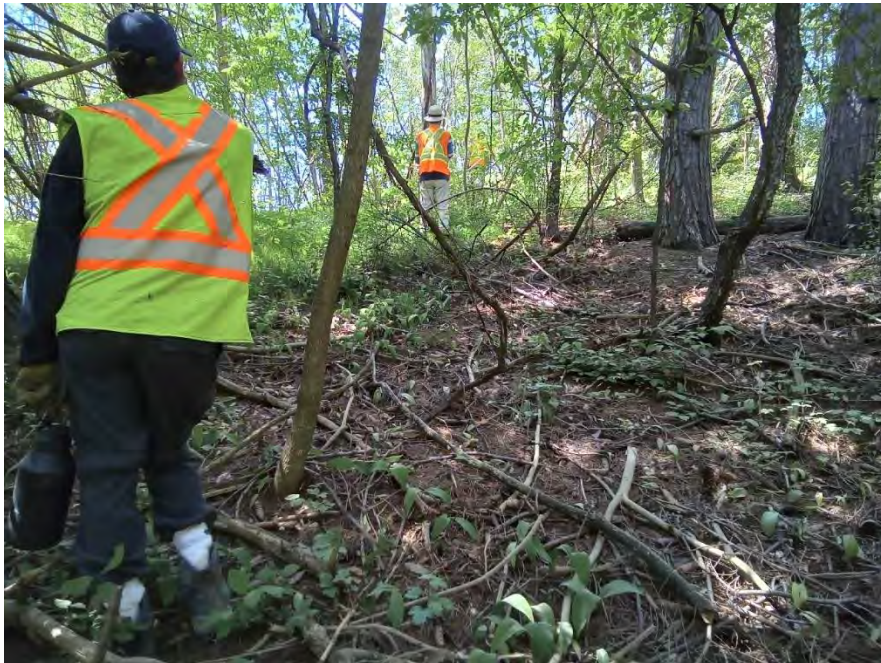
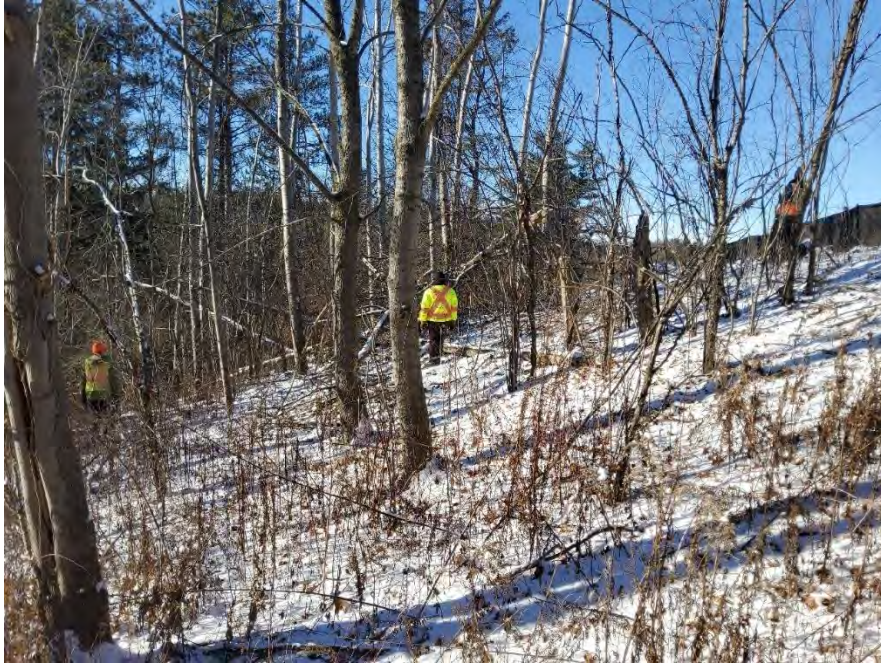
**Image 20: Sloping valley lands associated with a tributary of the Don River; no potential.**

**Image 21: Sloping valley lands associated with a tributary of the Don River; no potential.**

Approximately 2.2 percent of the Study Area (0.39 hectares) was documented as having naturally sloped conditions in excess of 20 degrees and not subject to Stage 2 survey, as per S & G Section 2.1, Standard 2.a.iii. The areas documented as being naturally sloped have no archaeological potential and include valley lands associated with a tributary of the Don River (Figure 6; Image 20-Image 21).

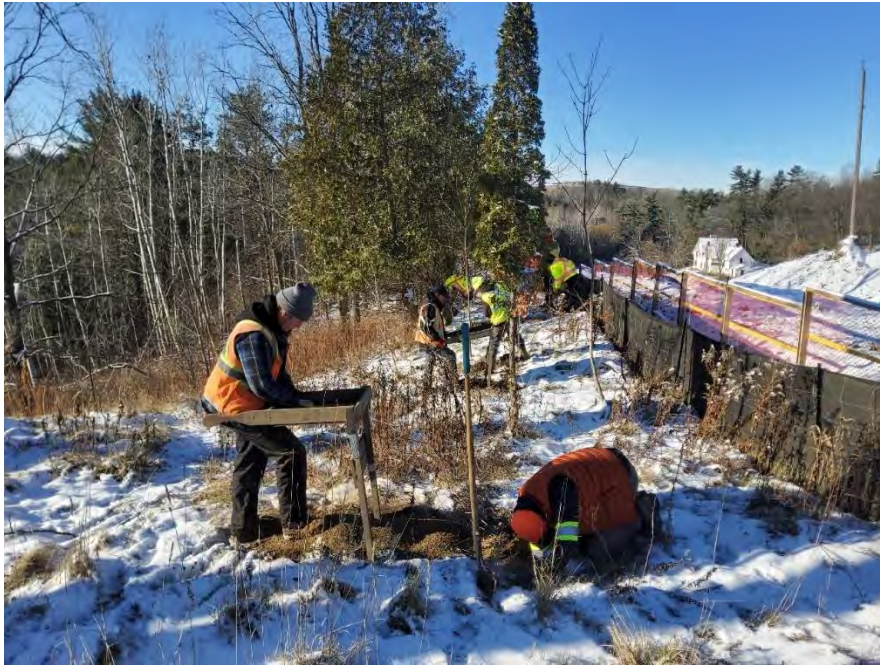
**Image 23: Test pit survey at five metre intervals.**

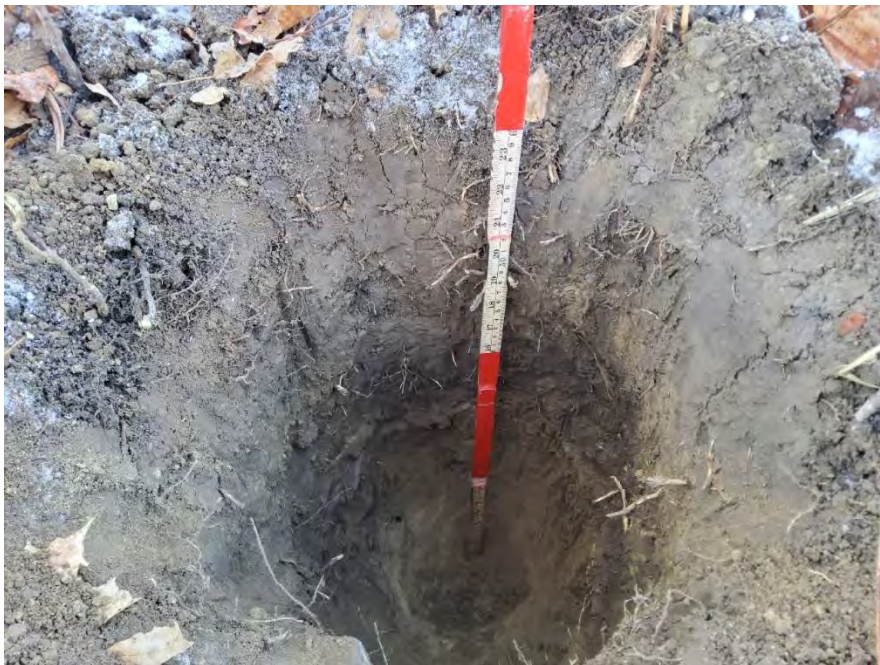
**Image 24: Test pit demonstrating an absence of intact topsoil (A-horizon).**

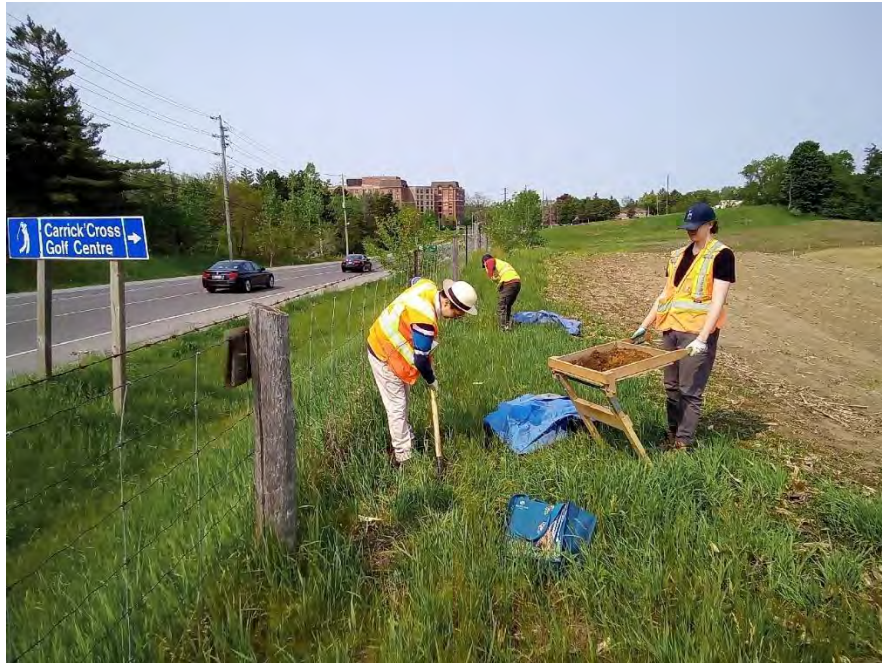
**Image 27: Test pit survey at five metre intervals.**

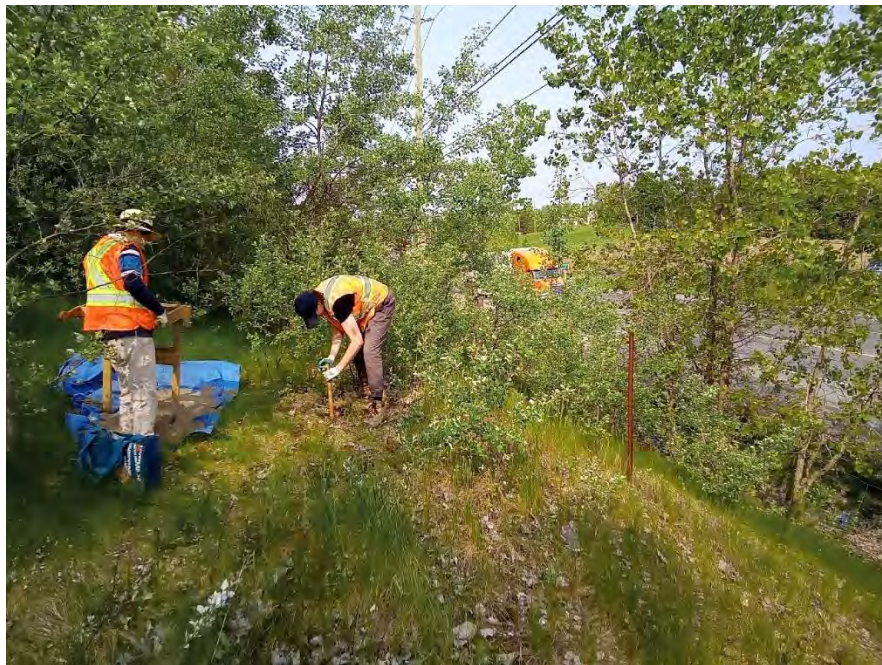
**Image 28: Judgmental test pit survey at 20 metre intervals.**

Approximately 1.5 percent of the Study Area (0.26 hectares) did not contain natural topsoil (A-horizon) and was subject to judgmental test pit survey at 10 metre intervals, and 2.4 percent (0.42 hectares) at 20 metre intervals to confirm previous disturbance following S & G Section 2.1.8, Standards 1-2 or gleysolic soil conditions following S & G Section 2.1, Standard 2.a.i. The areas subject to judgmental test pit survey include a berm associated with the former Keele Valley Landfill (Figure 5; Image 13), gleysolic soils associated with a tributary of the Don River (Figure 6), and portions of manicured lawns within the Teston Road right-of-way (Figure 7-Figure 8; Image 28 and Image 32).

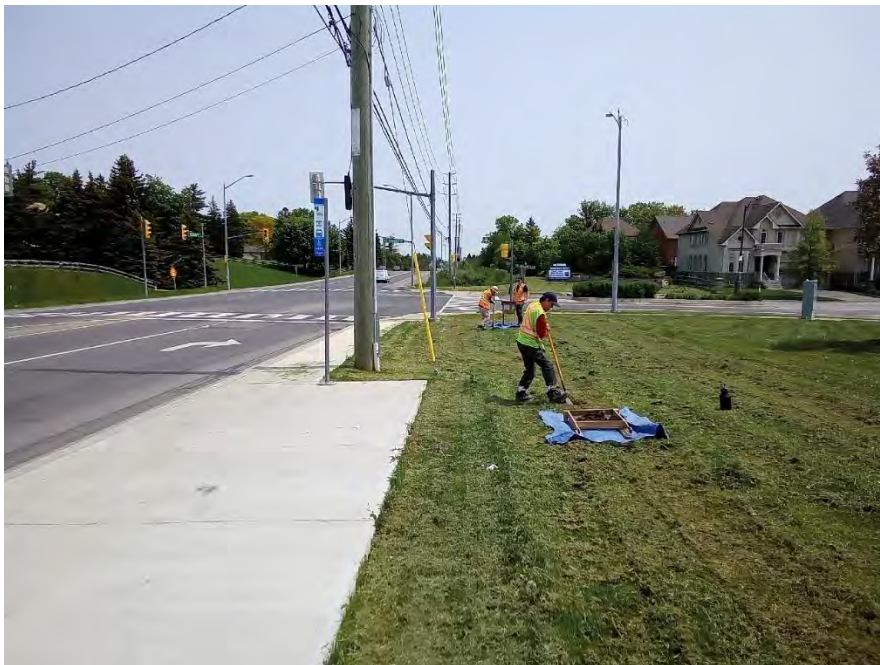
**Image 32: Judgmental test pit survey at 10 metre intervals.**

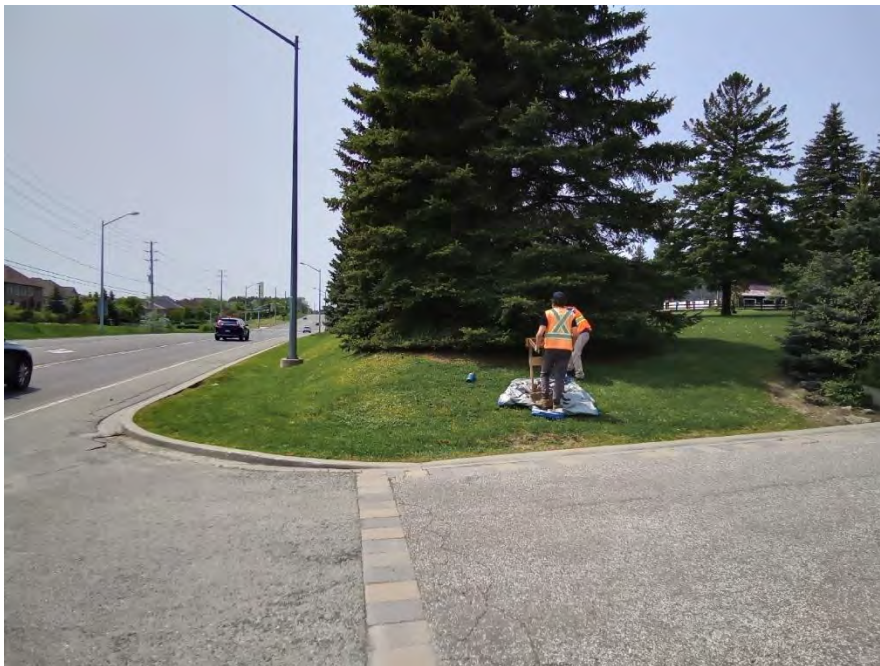
**Image 33: Test pit survey at five metre intervals (disturbed soils).**

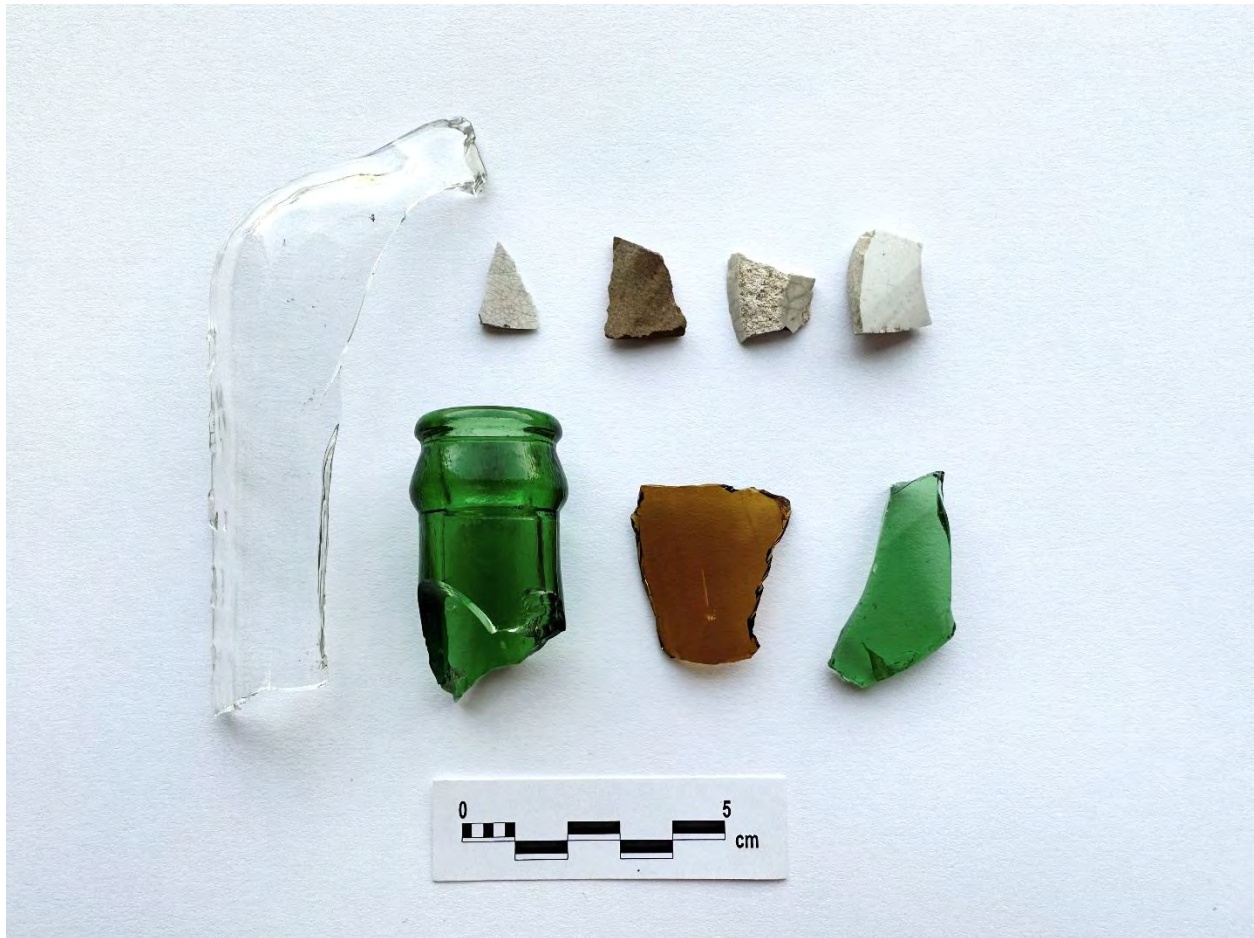
**Image 42: Select glass and ceramic artifacts from the Oliver Site, from left to right in a clockwise direction: colourless glass fragment of a Gilbert Bros. & Co. medicine container (Cat. 15), undecorated ironstone (Cat. 3), glazed coarse red earthenware (Cat. 4), undecorated ironstone (Cat.55), undecorated ironstone (Cat. 56), green container glass (Cat. 32), amber container glass (Cat. 31), green glass crown cap finish (Cat. 47).**

The kitchen and food related artifact sample of the Oliver site contains only 15 ceramic sherds (Image 42; Table 6). A complete catalogue of all collected ceramics from this site can be found in Appendix A: Artifact Catalogue.

As ceramic ware types changed through time, so did ceramic decorative styles. Decorative motifs documented in the Oliver site ceramic sample that are useful in providing temporal information can be found below in Table 7 (Image 42).

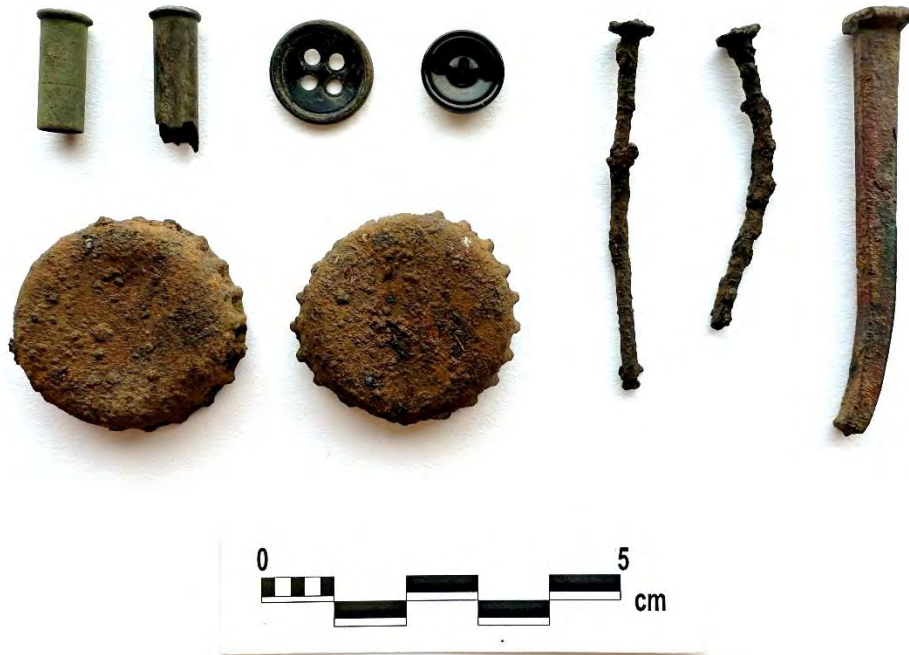
**Image 43: Select artifacts from the Oliver Site, from left to right, top to bottom: two 0.22 caliber cartridge cases (Cat. 14 and 33), black painted metal button (Cat. 41), black glass button (Cat. 61), two wire nails (Cat. 24), machine cut nail (Cat. 8), two metal crown bottle caps (Cat. 48).**

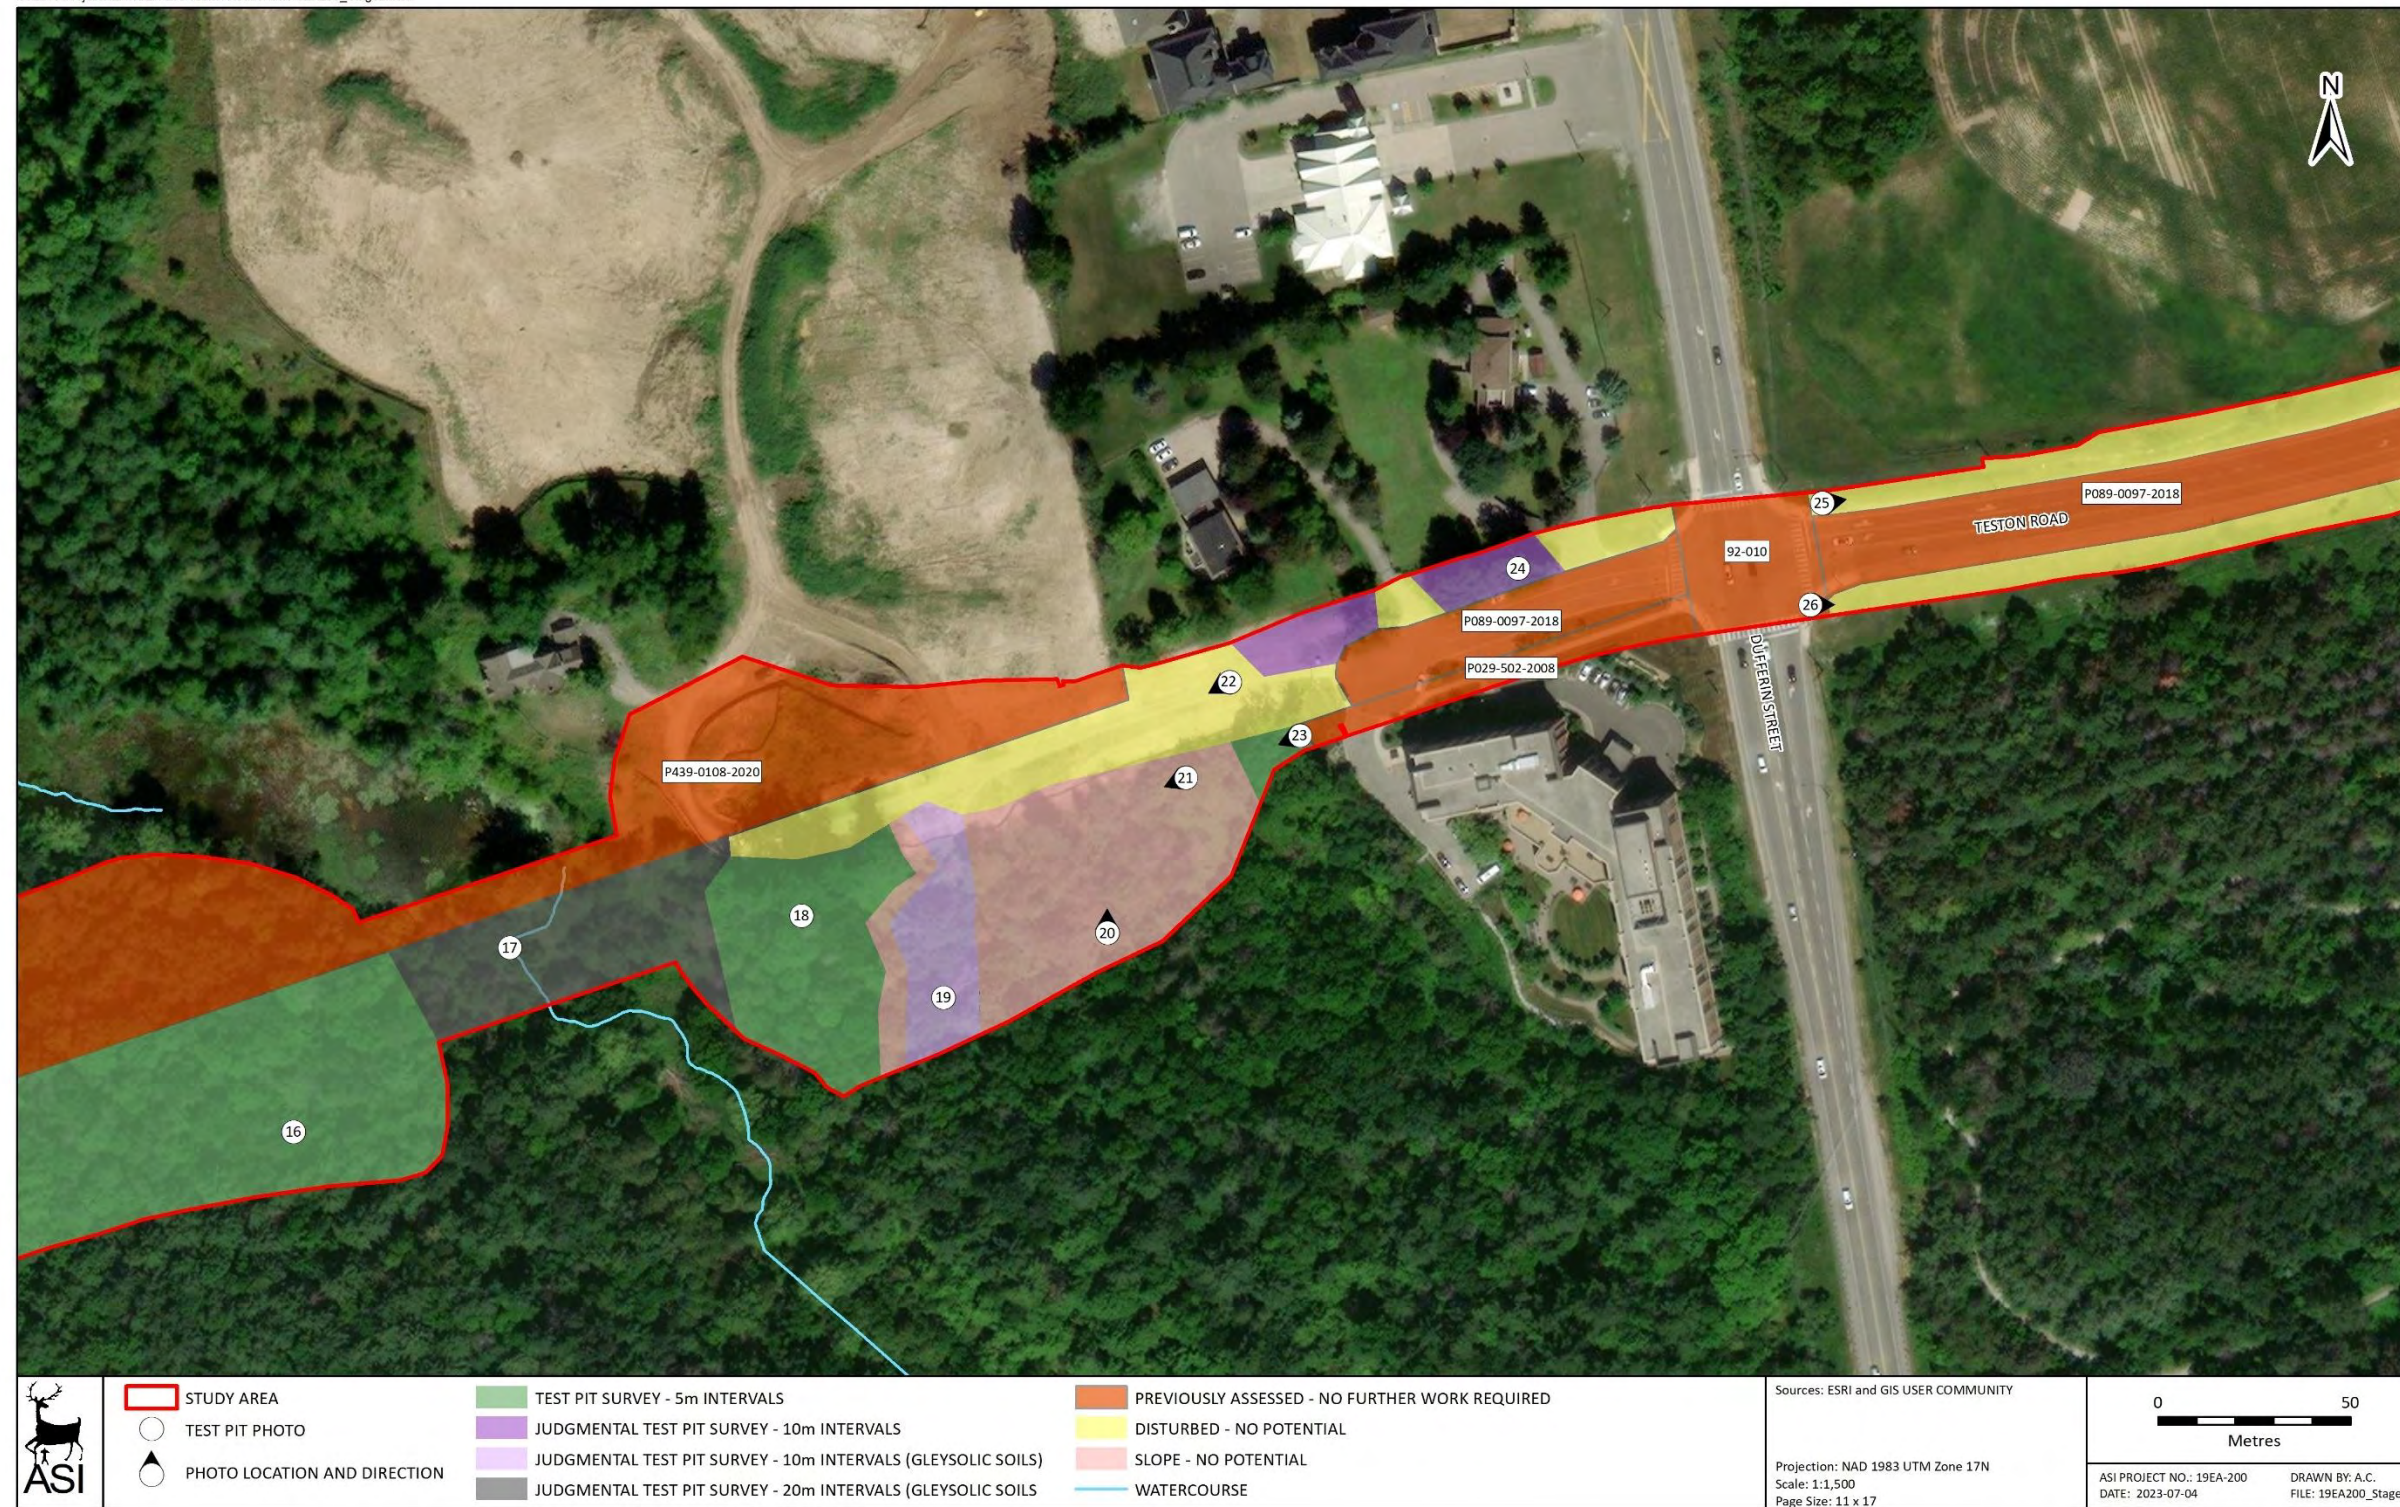
Figure 6: Stage 2 Archaeological Assessment Results for the Teston Road Individual Environmental Assessment – Sheet 4

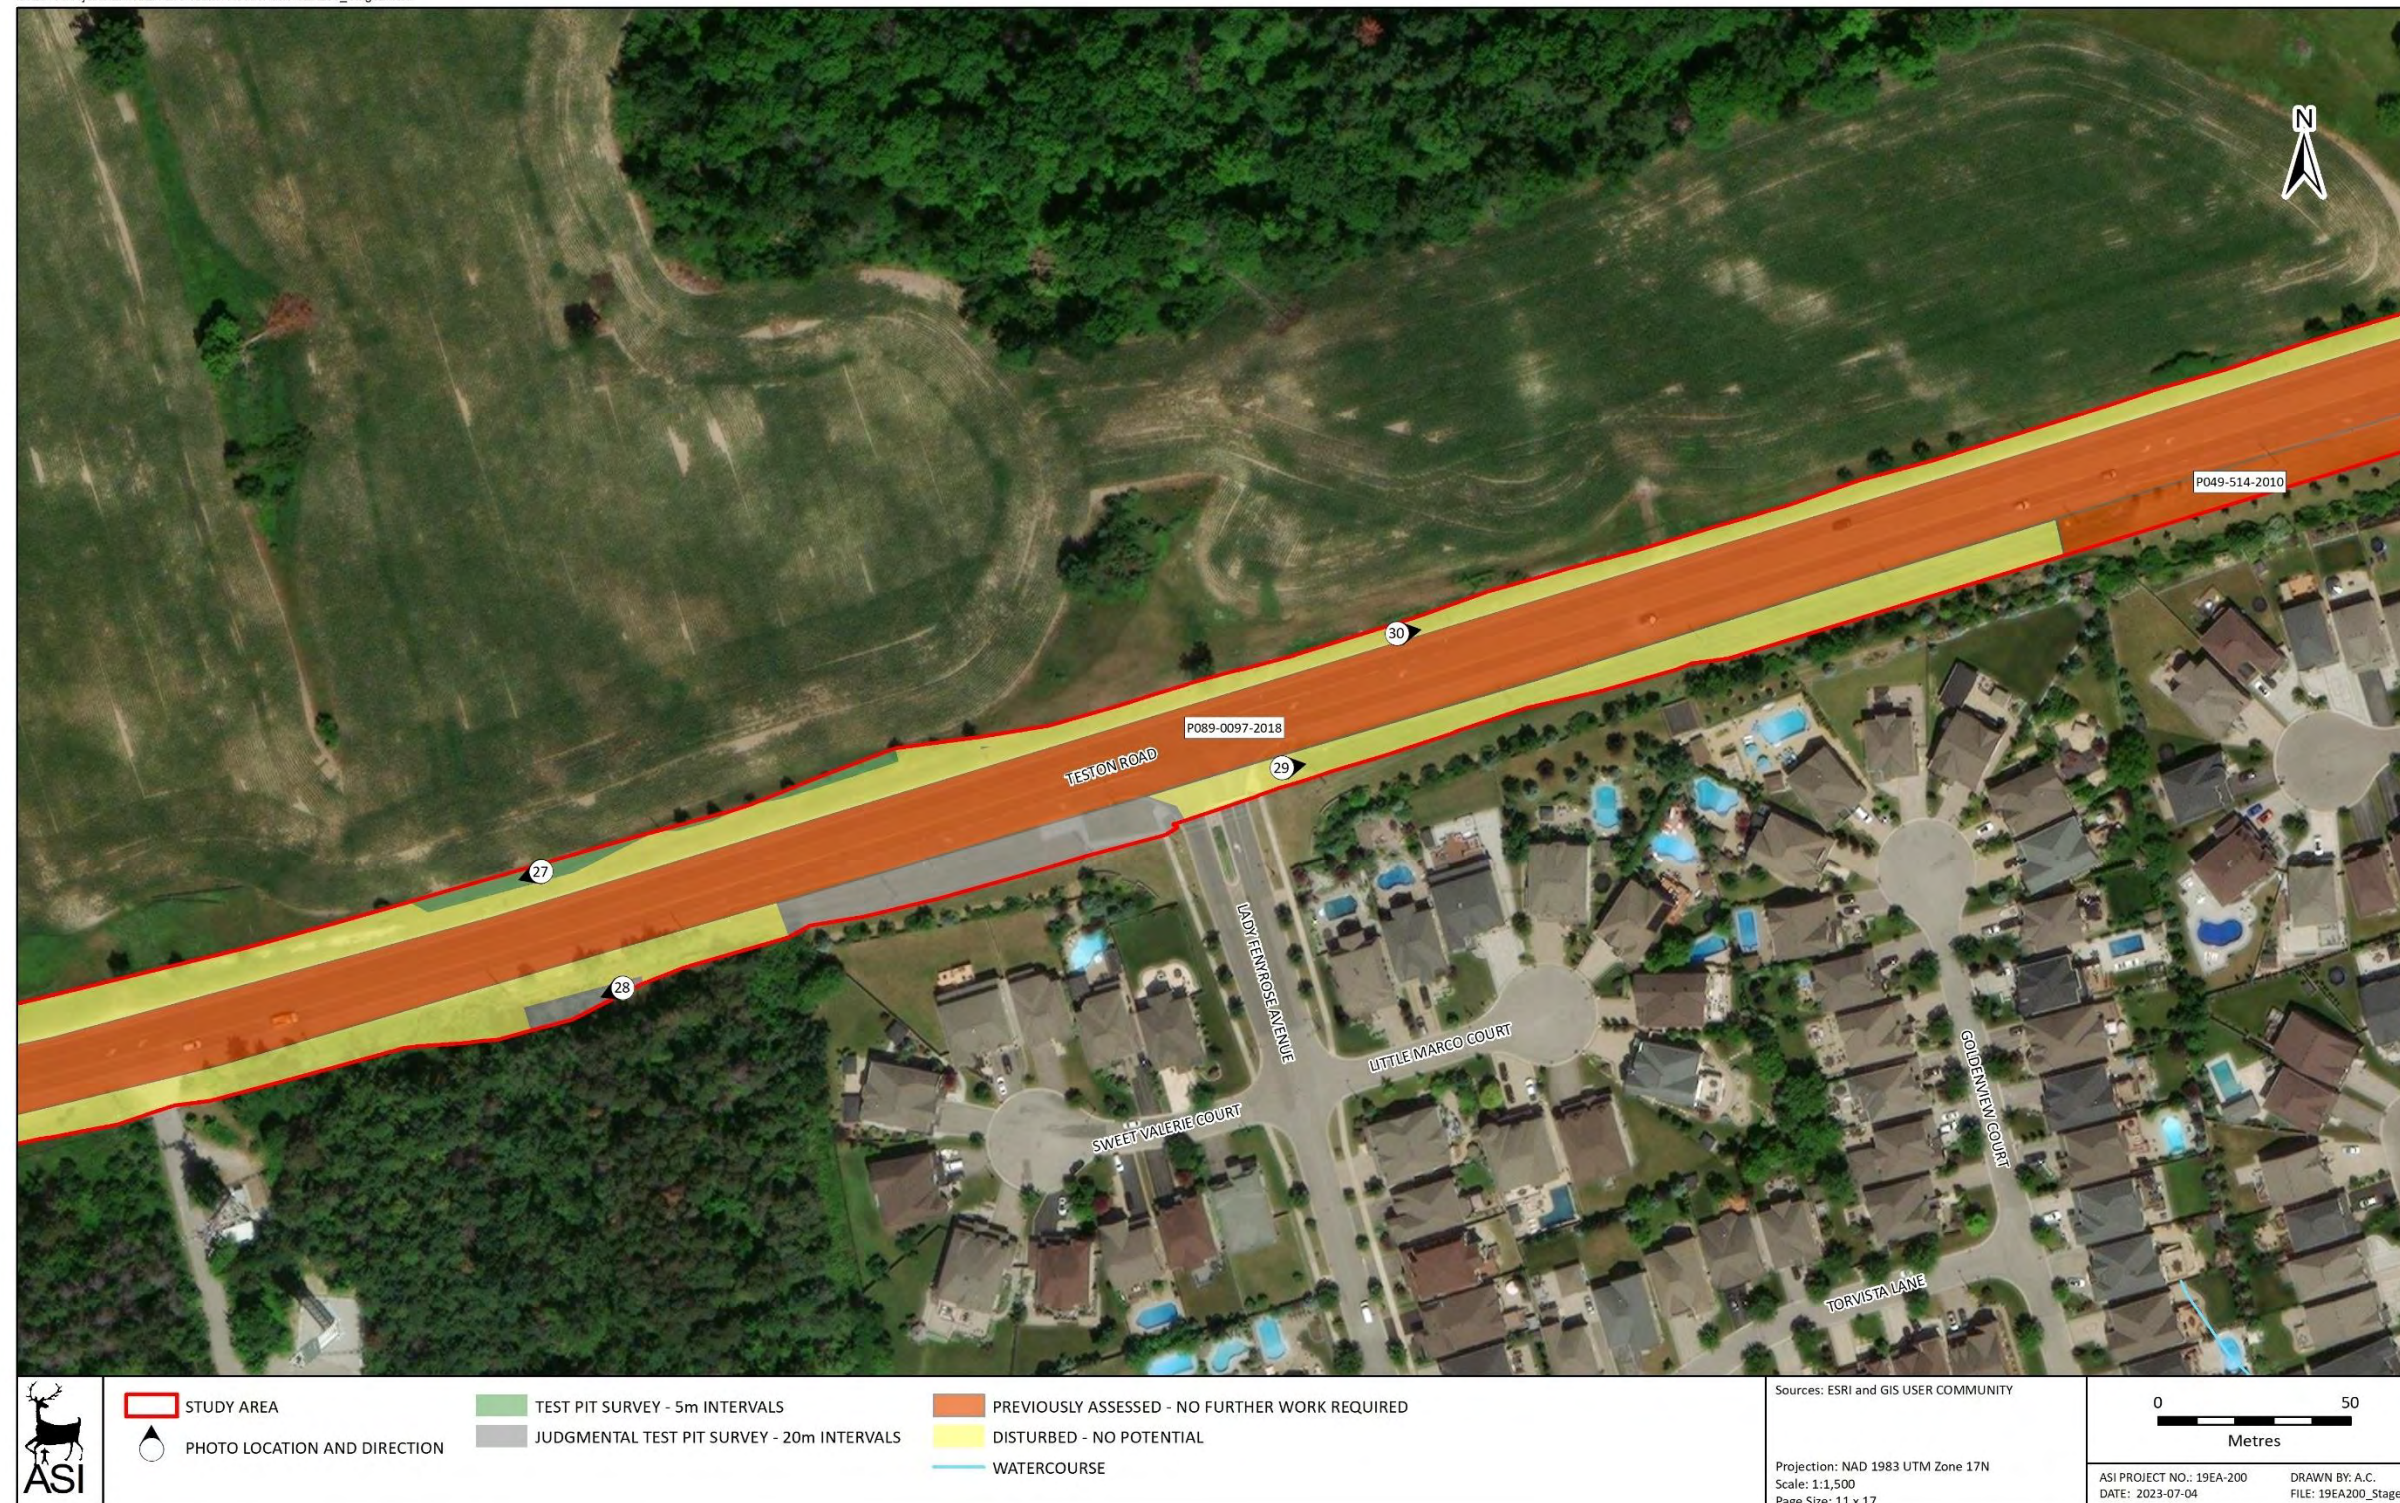
Figure 7: Stage 2 Archaeological Assessment Results for the Teston Road Individual Environmental Assessment – Sheet 5
