**Stage 2 Archaeological Assessment  
Teston Road - Highway 400 to Bathurst Street  
Individual Environmental Assessment  
Part of Lots 25 and 26, Concessions 2 and 3,  
and Part of Lot 26, Concession 4  
(Geographical Township of Vaughan, County of  
York)  
City of Vaughan, Regional Municipality of York**

**Original Report**

Archaeological Services Inc. File: 19EA-200

11 March 2024

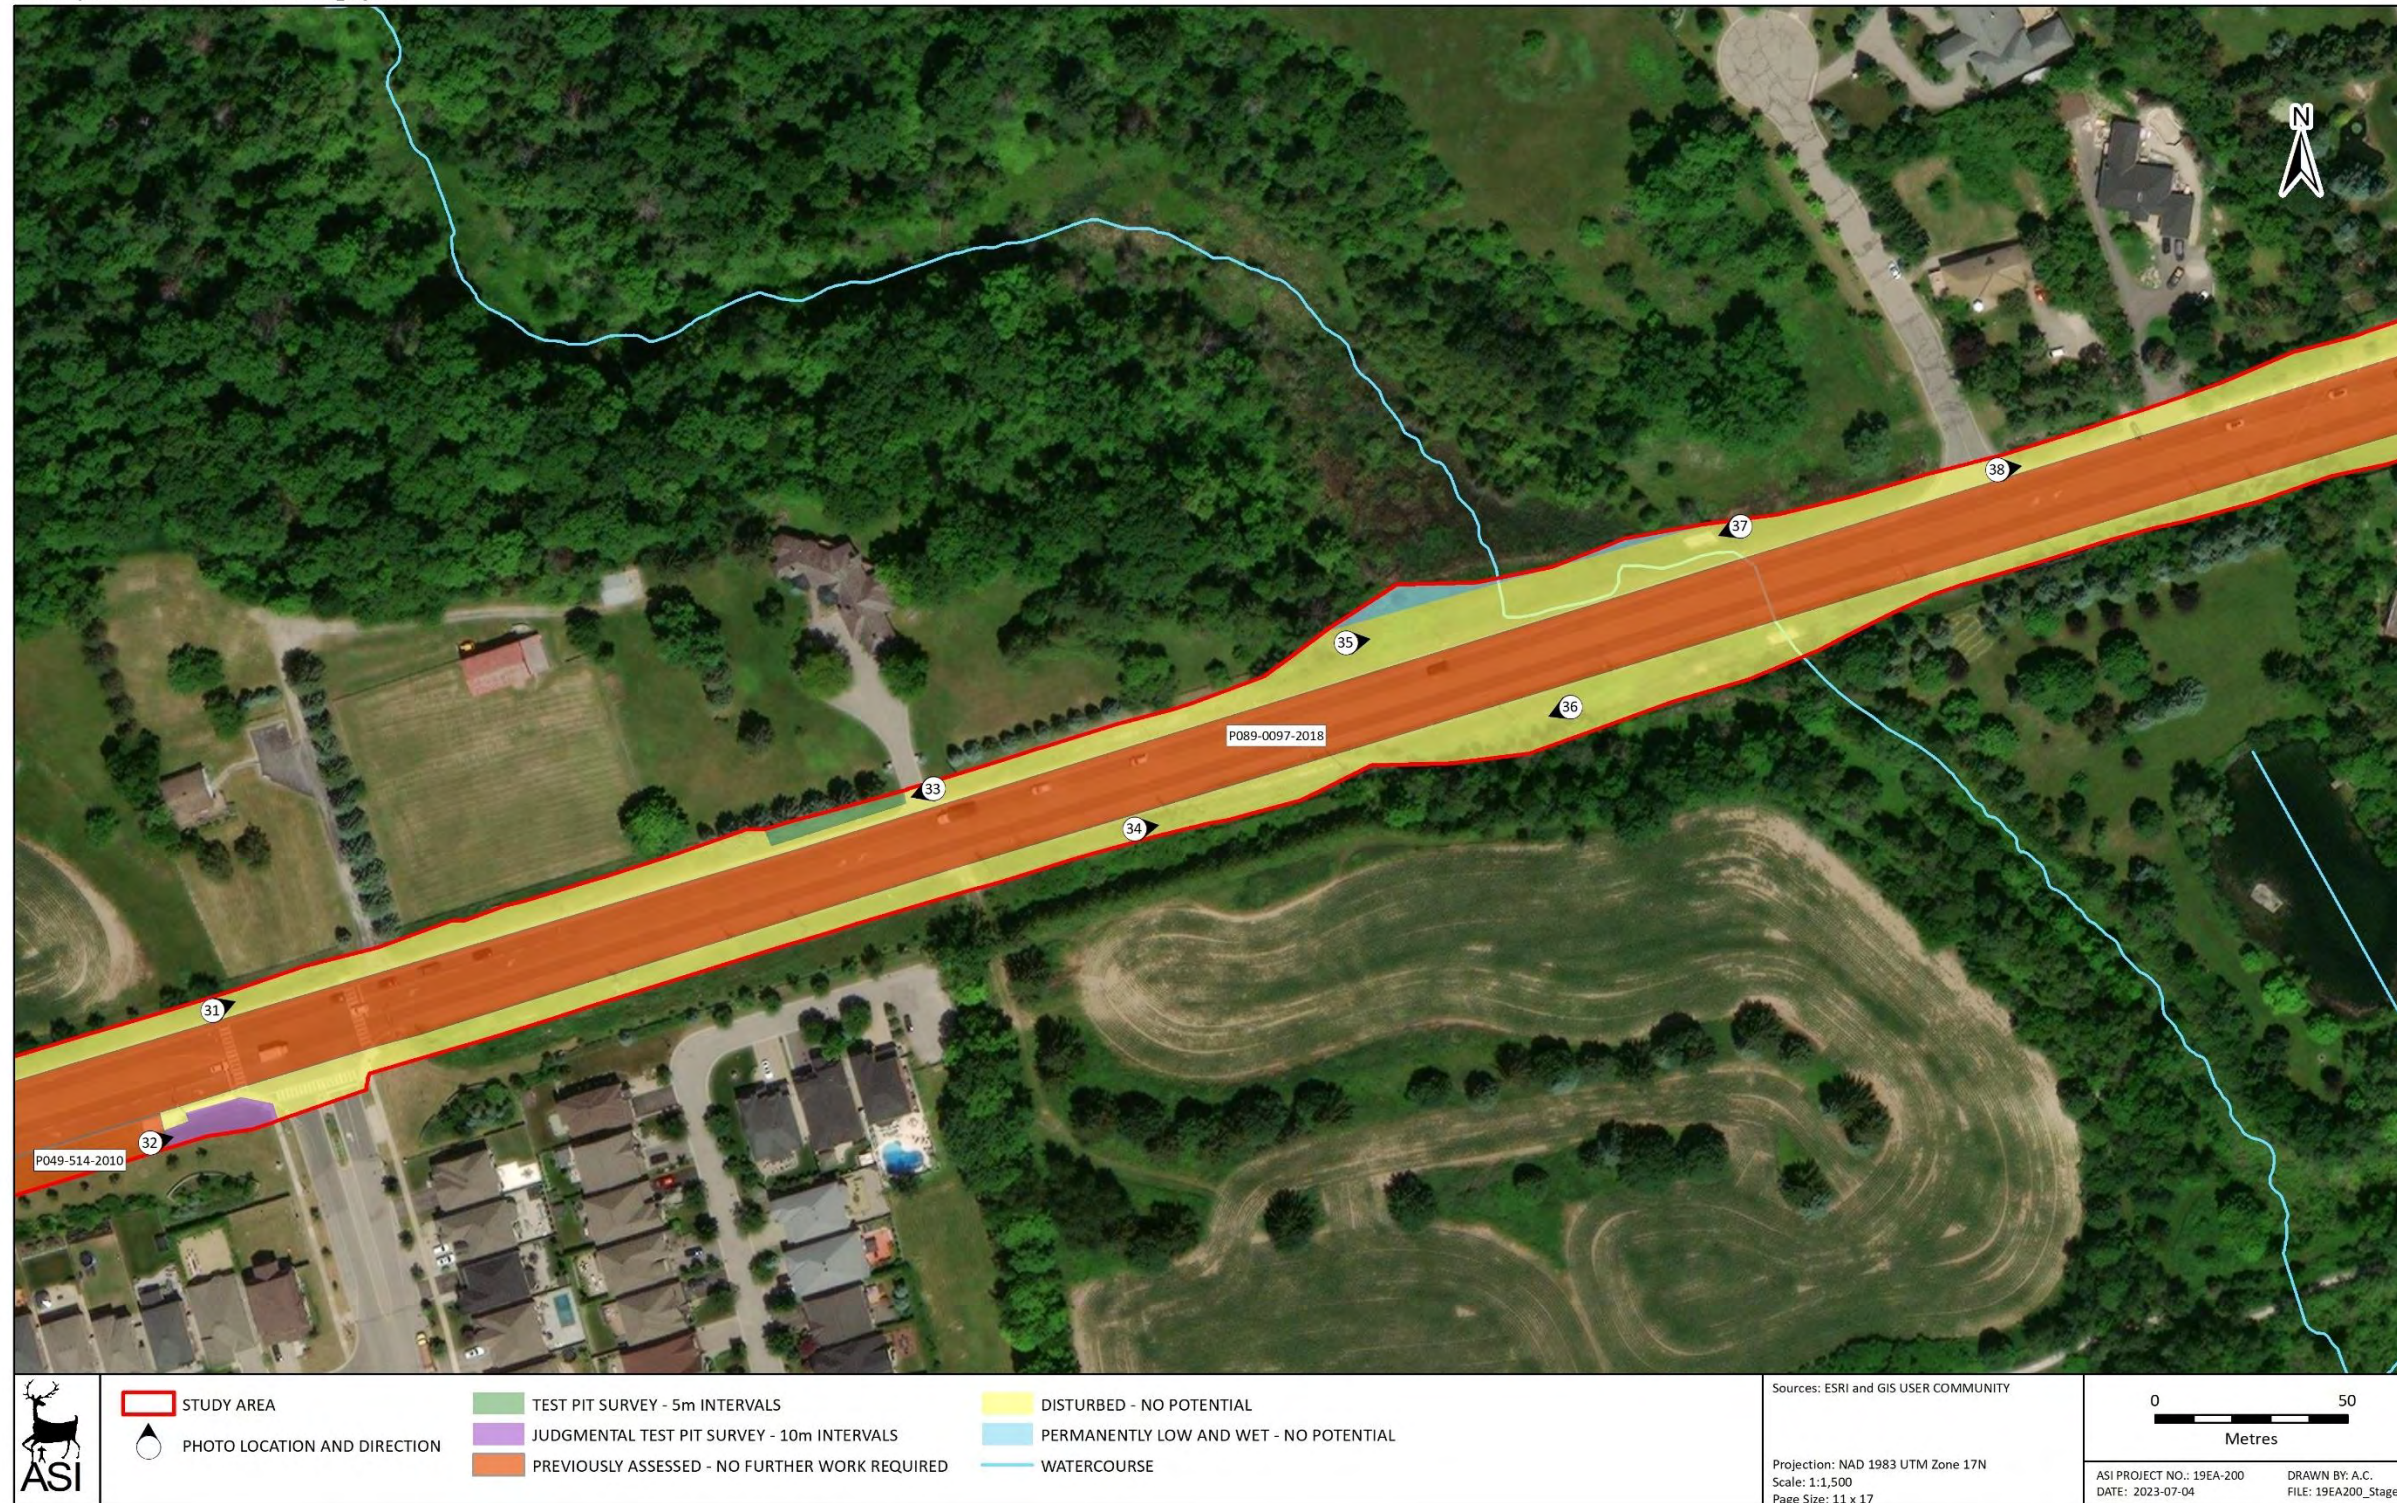
Figure 8: Stage 2 Archaeological Assessment Results for the Teston Road Individual Environmental Assessment – Sheet 6

Approximately 1.5 percent of the Study Area (0.26 hectares) did not contain natural topsoil (A-horizon) and was subject to judgmental test pit survey at 10 metre intervals, and 2.4 percent (0.42 hectares) at 20 metre intervals to confirm previous disturbance following S & G Section 2.1.8, Standards 1-2 or gleysolic soil conditions following S & G Section 2.1, Standard 2.a.i. The areas subject to judgmental test pit survey include a berm associated with the former Keele Valley Landfill (Figure 5; Image 13), gleysolic soils associated with a tributary of the Don River (Figure 6), and portions of manicured lawns within the Teston Road right-of-way (Figure 7-Figure 8; Image 28 and Image 32).
