# Teston Road Extension IEA Fluvial Erosion Hazard Study

DRAFT REPORT

Project No. P2021-597

# York Region Teston Road IEA – Meander Belt Width Final Report

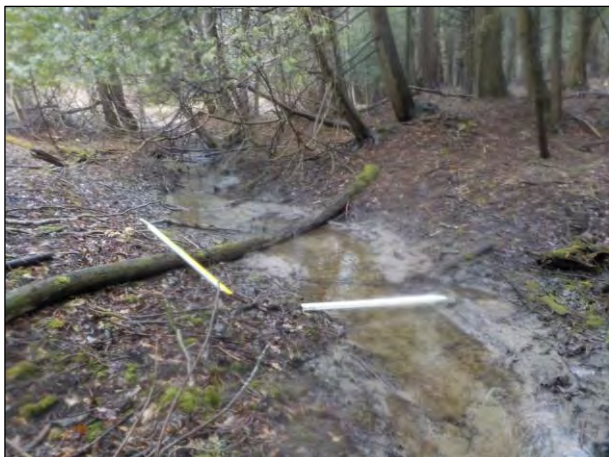
*Photo 1: View of Reach 1, upstream of the pond*

At the upstream extent of Reach 1, there is a steep valley wall present on the northeast side of the channel and a berm separating an offline pond is located along the southwest side of the channel. The valley subsequently transitions to a more expansive, unconfined setting. The Reach 1 channel is a low gradient, parabolic-shaped swale having poorly defined banks and stability controlled by vegetation. The channel bottom is primarily muck and detritus. The floodplain is readily connected to the channel due to the low profile banks. The backwater and low gradient impact of the existing pond (at the downstream limit of Reach 1) is likely contributing to the channel form here. This reach includes a section where the channel transitions into the pond/wetland, having substantial cattail growth. There are no indicators of systemic instability in Reach 1.

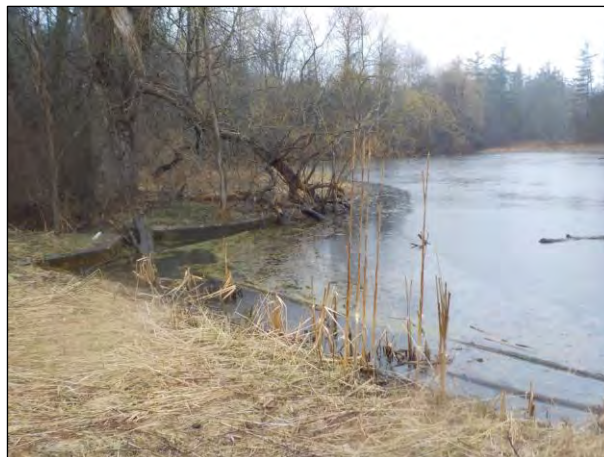
*Photo 2: Dam creating the in-line pond and delineating the reach break*

GeoProcess completed a geomorphological reconnaissance of the study area on April 21<sup>st</sup>, 2022. The unconfined valley setting was verified (per Section 2) and an online pond, having an outlet structure in disrepair, was documented. The study area was subsequently divided into two reaches, illustrated in Figure 5, with the pond being the divide. The upstream extent of the study reach is the confluence of the main tributary channel with a smaller ephemeral channel. The downstream extent is a historical (remnant) flow structure that may have been a culvert or low-head dam. Two offline ponds contribute flow to the channel near the upstream extents of the study reach.

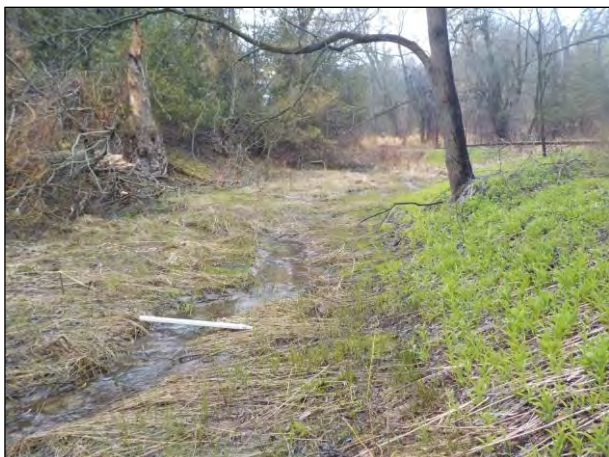
*Photo 3: View of Reach 2, looking downstream from pond perimeter berm*

Reach 2 flows out of the existing pond, and is within the footprint of a remnant pond, terminating at the historically failed outlet structure. The nature of this outlet is not clear (dam or culvert crossing). The channel in Reach 2 is a very low gradient and its slope is maintained by the rock outlet, which provides grade control. The form of the channel is almost indistinguishable from the floodplain at some locations, except for localized instances of scour where the channel intersects the valley wall (near the discharge from the existing pond). There are also no indicators of systemic instability in Reach 2.

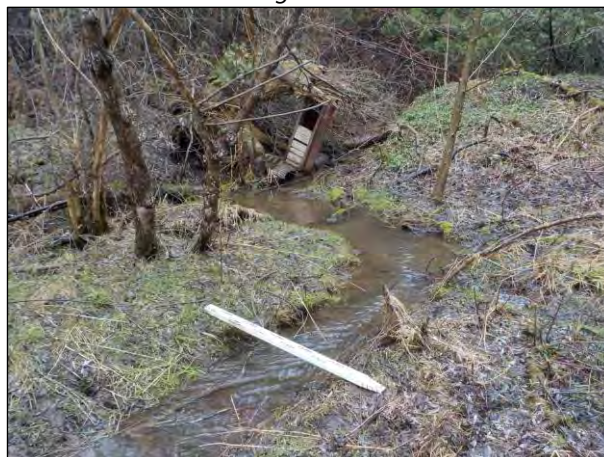
*Photo 4: Downstream extents of Reach 2*

Downstream of Reach 2, outside of the proposed road corridor, the channel definition increases and there are indicators of geomorphic instability by way of undercut vegetation and downcutting. This condition may be related to the past failure of the historical pond's flow conveyance structure, but the detailed history of this feature could not be ascertained. The channel incision downstream of Reach 2 is not predicted to propagate upstream, owing to the generally low flows (minimal energy) and presence of the historical rock outlet structure at the downstream extent of Reach 2, which provides grade control.

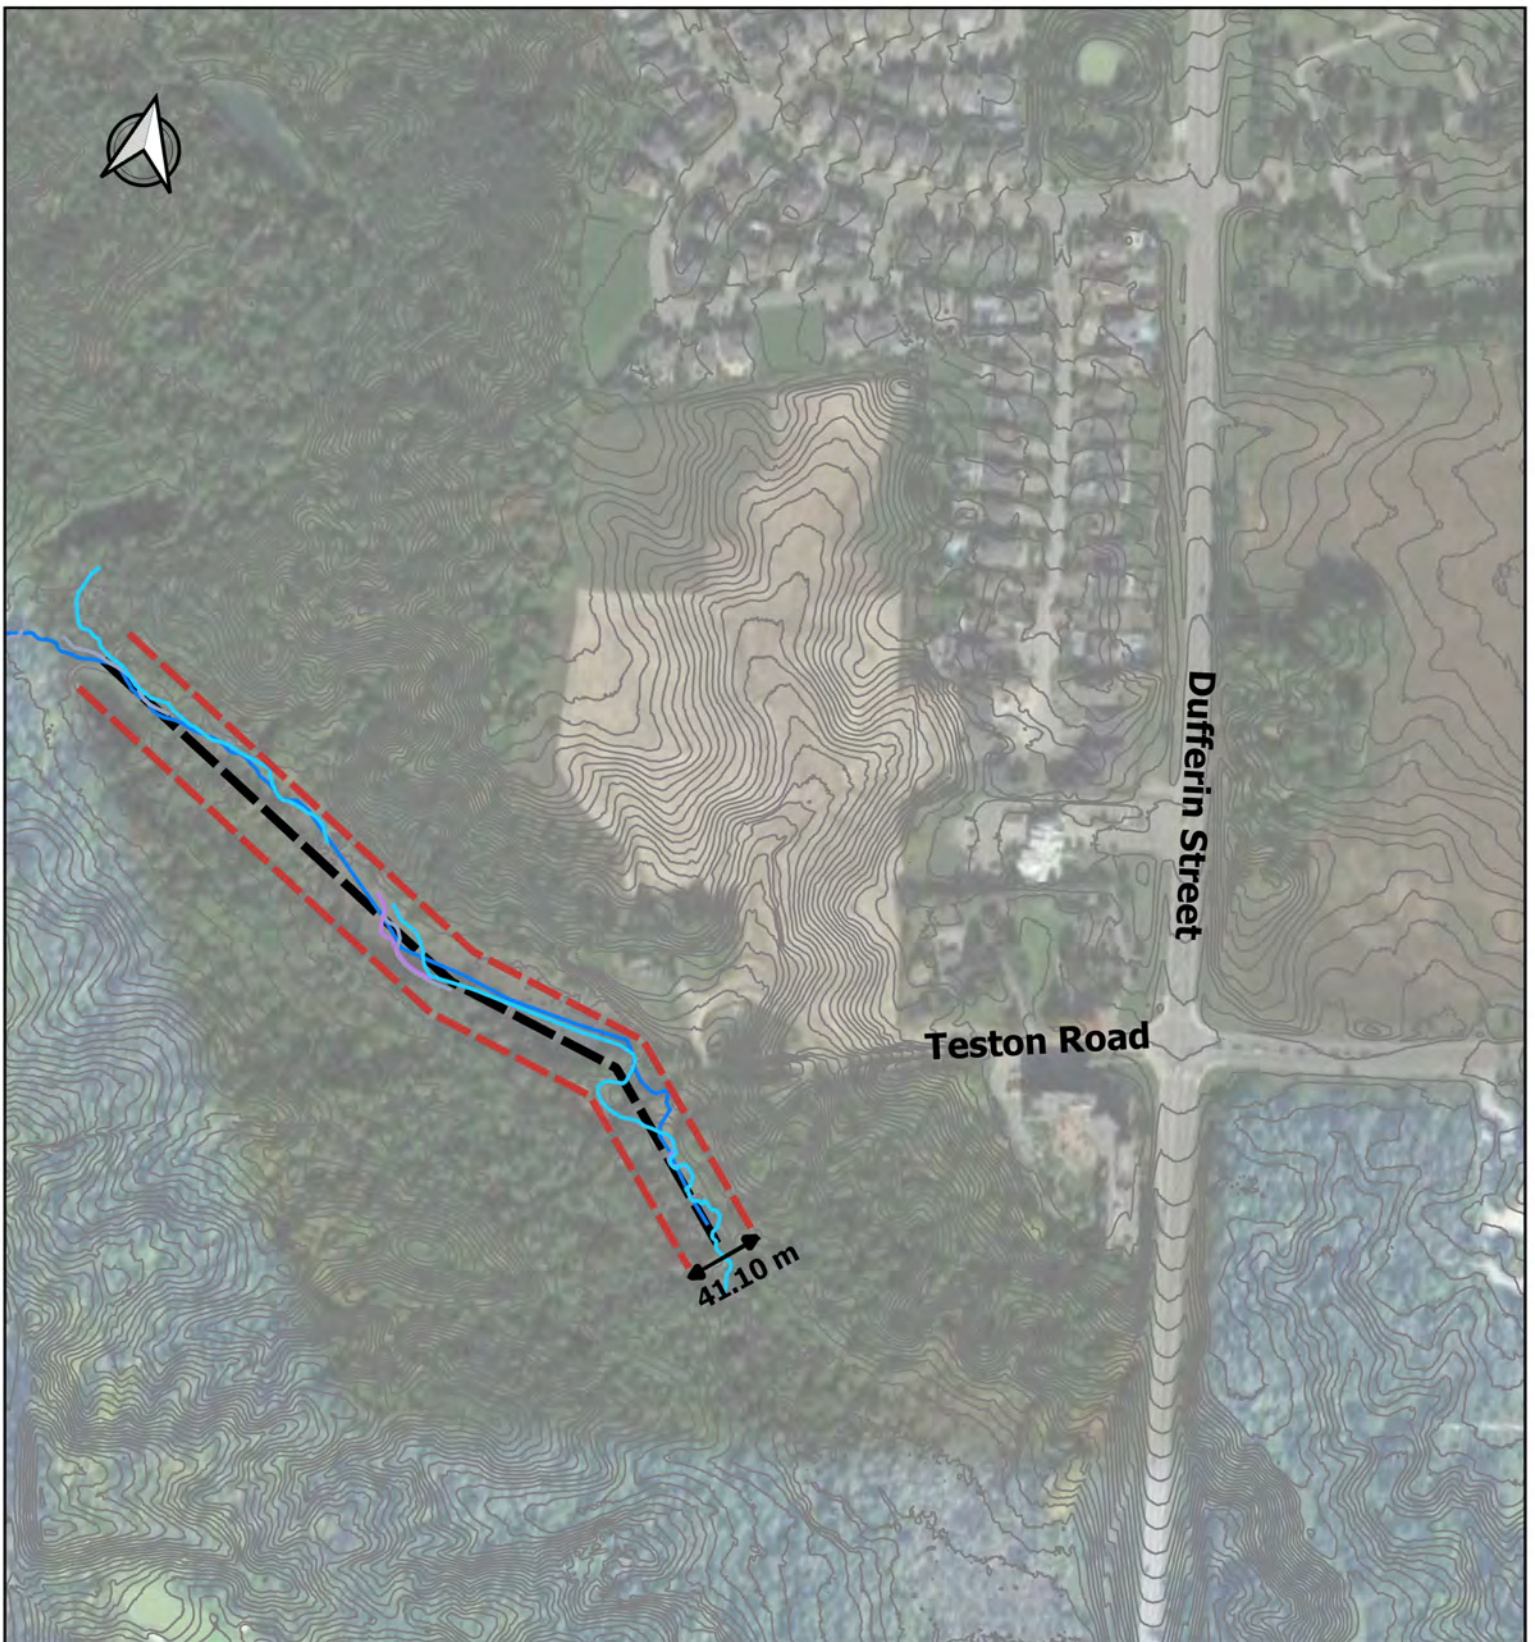
**Figure 6: Final Meander Belt**

- Final Belt Width
- Meander Axis
- 1 m contours
- 2021 centreline
- 2002 centreline
- 1988 centreline
- 1970 centreline

Preliminary Belt Width (m)	Source	Equation Standard Error	Final Belt Width (m)
25.8	TRCA, 2001	8.63	<u>43.1</u>

## 7. Conclusions
