RE: Conservation Authorities Moraine Coalition 2015 Report Card

Report Card on the Environmental Health of the Oak Ridges Moraine and Adjacent Greenbelt Lands

Report Card on the ENVIRONMENTAL HEALTH OF THE OAK RIDGES MORaine AND ADJACENT GREENBELT LANDS

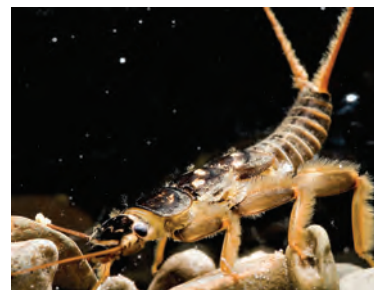
Stonefly nymph - indicative of good water quality

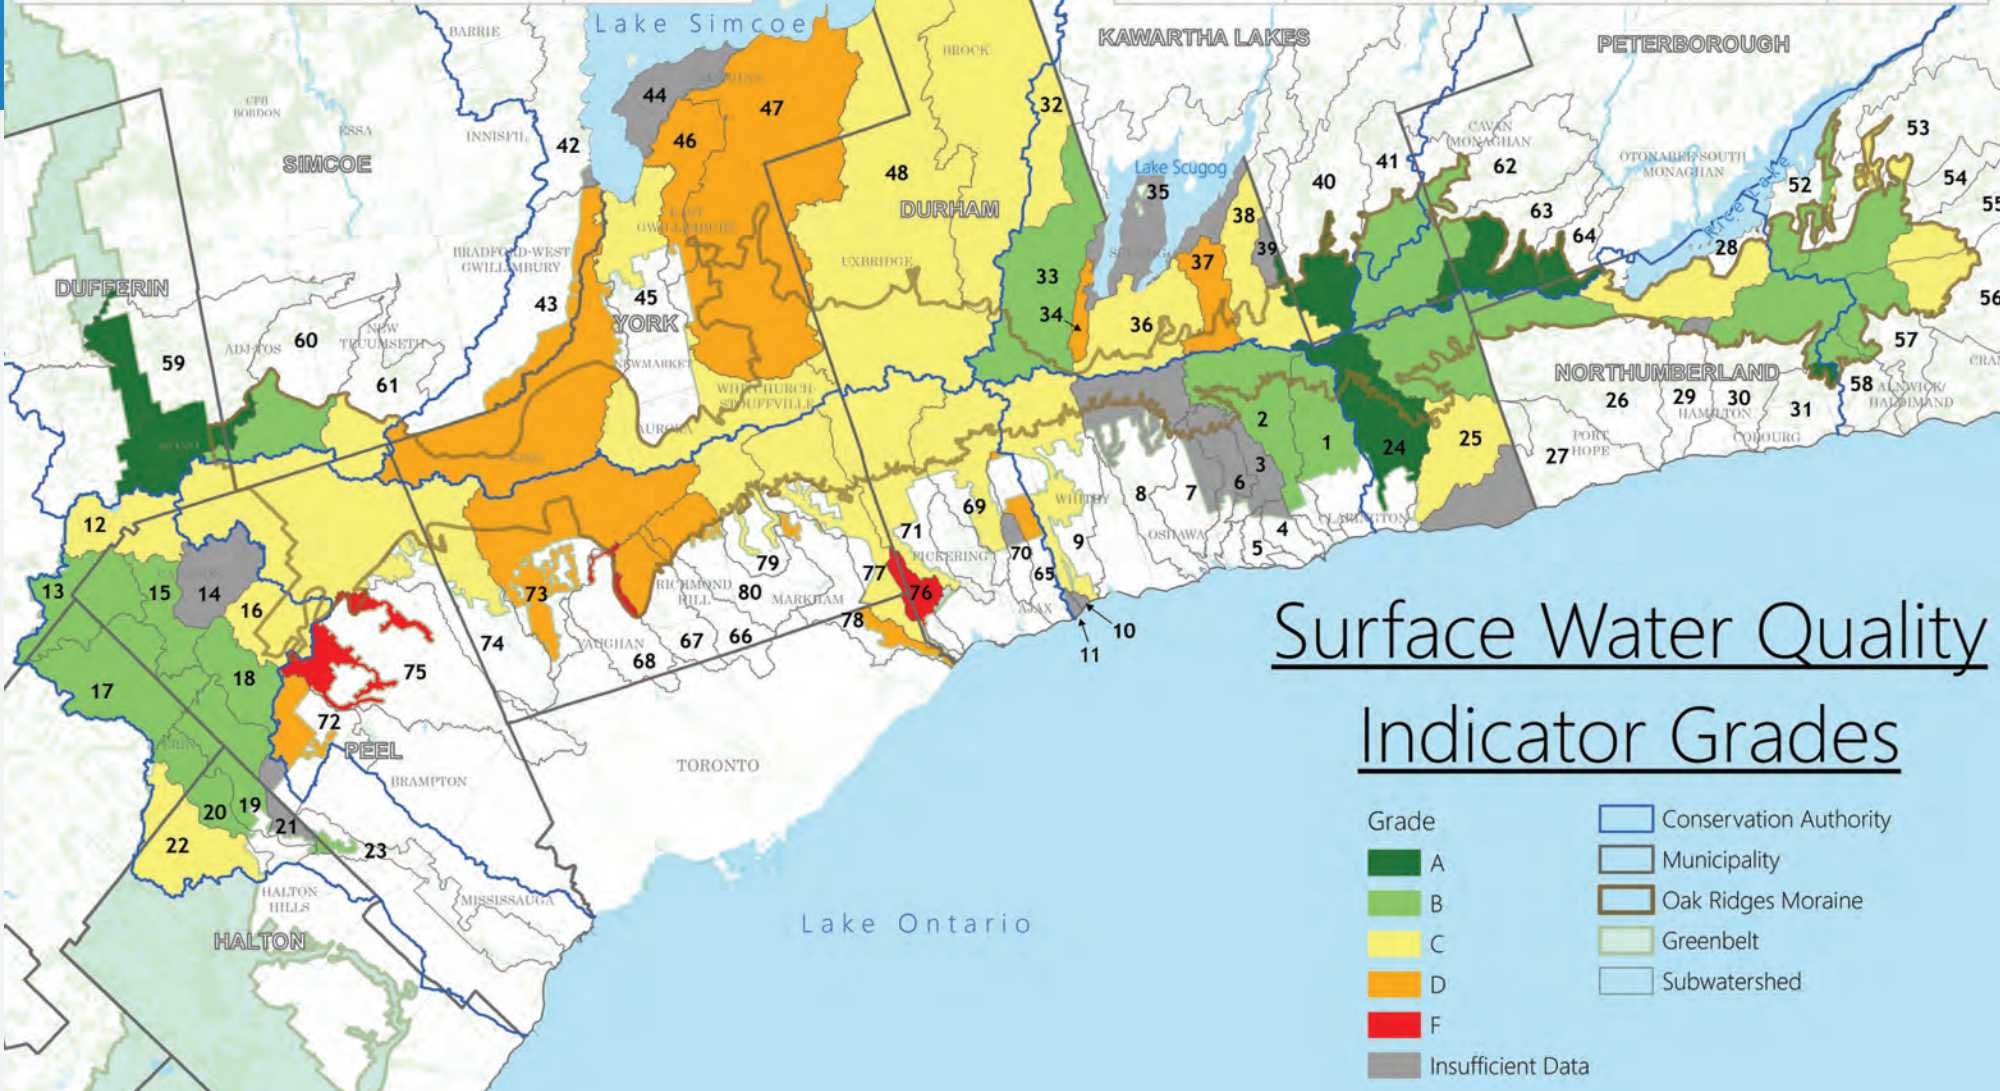
The map opposite shows Surface Water Quality grades by subwatershed. Subwatersheds that score “A” or “B” grades, appear to correlate well to lands with better forest conditions, more protective Plan designations and/or greater distance from urban influences. Subwatersheds that score “D” or “F” grades are likely impacted by settlement areas or countryside/agricultural uses where forest and/or riparian cover is lowest.

Table 2 shows that one third of subwatersheds in the Greenbelt have surface water grades that score as good (B) or very good (A) quality. One quarter have a grade of fair (C), while one fifth of subwatersheds grade as poor (D) or

very poor (F) quality. A further one fifth of subwatersheds had insufficient or inconclusive monitoring data available to grade them.

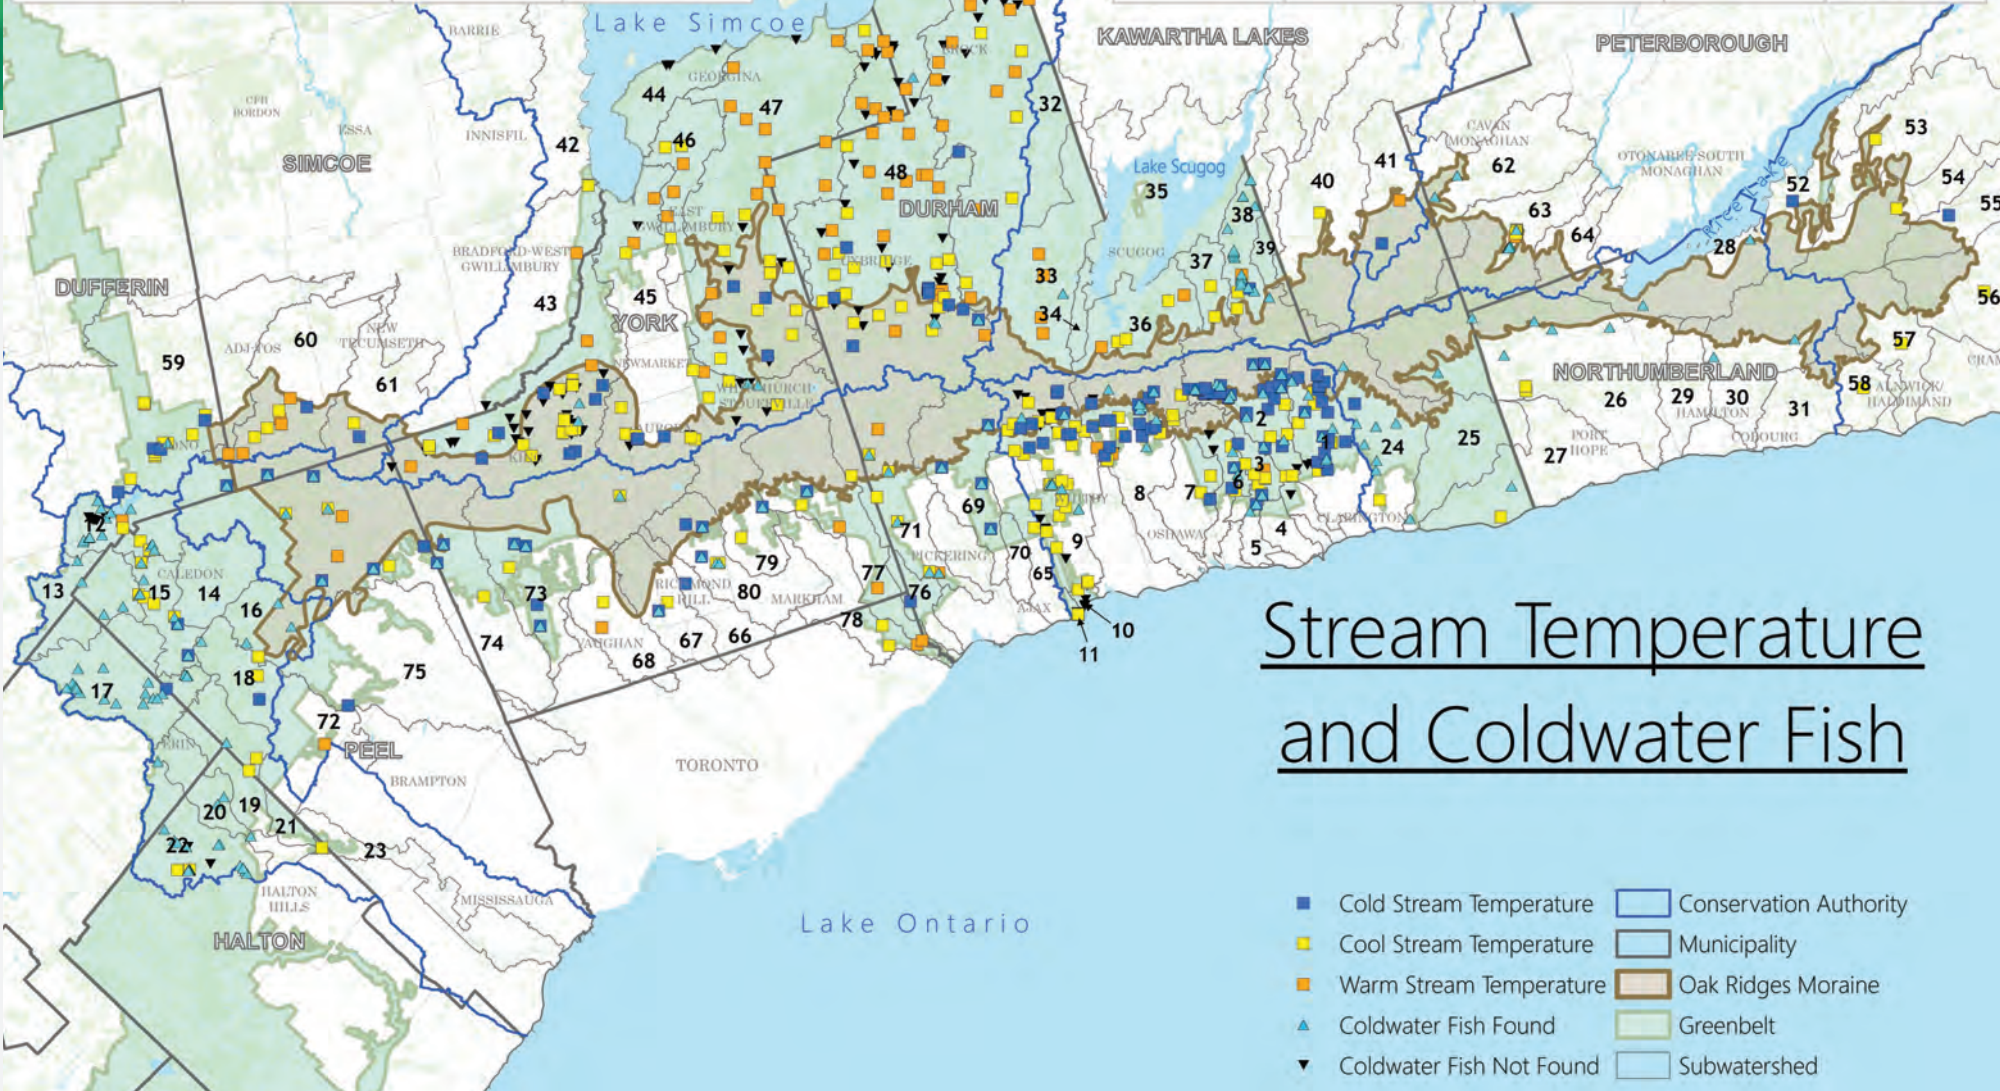
The map opposite shows the distribution of Stream Temperature and Coldwater Fish results. One Conservation Authority (Lower Trent) did not have data available for fish.

Coldwater temperature sites are widely distributed across the study area. Similarly, Brook Trout and Sculpin are also widespread across the study area, with a concentration in streams

Coldwater Fish are found at the majority (62%) of sampled fish sites. Given that only 29% of the Stream Temperature sites are coldwater, it is assumed that some of the coldwater fish are found in marginal habitats (e.g. coolwater). 71% of all temperature monitoring sites in the study area have cold or cool water temperatures available to these coldwater fish. Coolwater sites likely represent marginal habitats at greater risk of being impacted by climate change or land use changes. Land use mitigation and restoration efforts may offset such impacts.
