ANNUAL REPORT
MARCH 31, 2017

The Region and the local municipalities are demonstrating leadership in inflow and infiltration reduction within the water and wastewater industry.

2.0 2016 Inflow and Infiltration Reduction

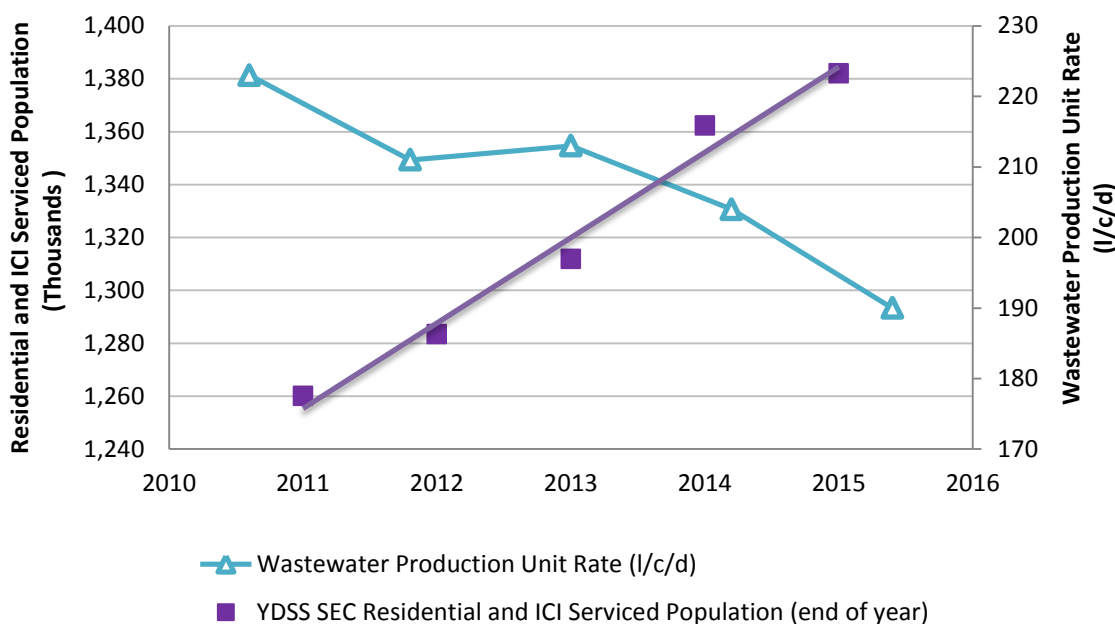
Figure 2 - York Region's Population Growth versus Wastewater Production Unit Rate

The DWF reduction by 2031 is expected to be even much higher as water conservation efforts increase and the use of water-efficient fixtures and appliances become the norm. A detailed methodology for the background calculations is provided in Appendix A.

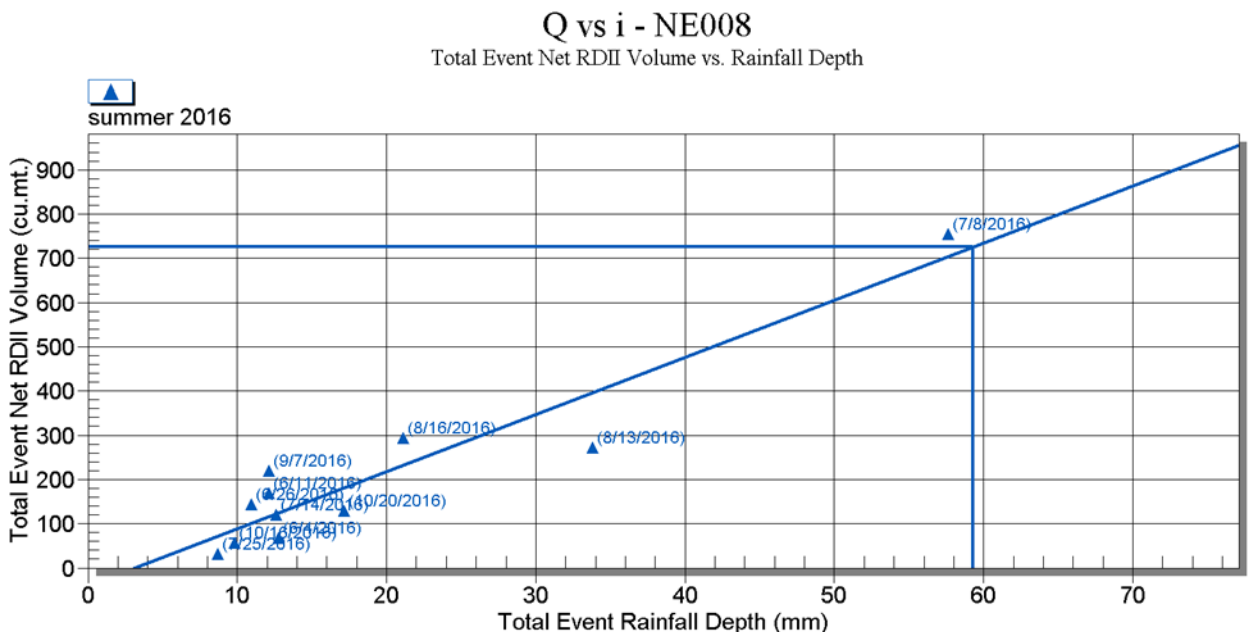
Figure 5 - RDII Volume Regression Prediction

All of the KPI figures are determined by regression analysis and all points are reviewed and outliers are investigated. Basins with an r^2 value less than 0.7 are studied more intensely before further SSES or repair activities are prescribed, because of the lower level of uncertainty in the prediction. The r^2 value for the prediction shown in Figure 5 below is 0.76, which is acceptable.

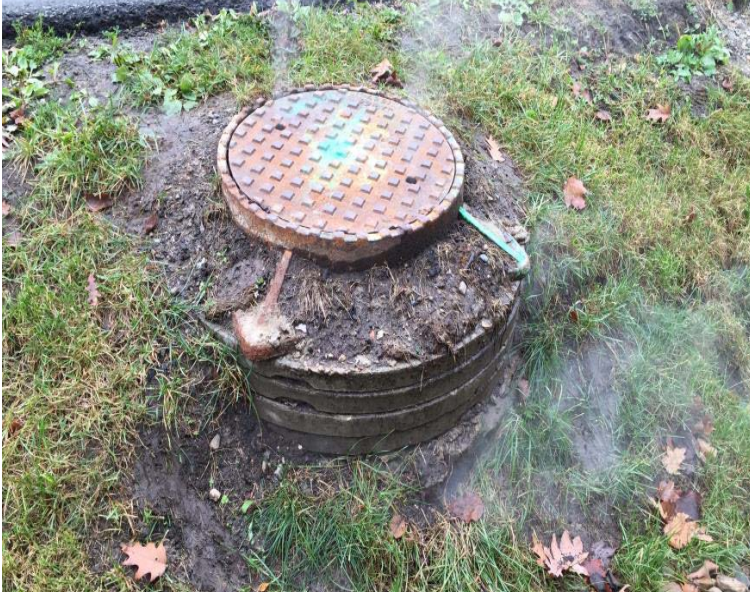
Figure 11 - Smoking Maintenance Hole through Chimney and Frame in Vaughan

In total, the Region tested nearly 25 km of local municipal sanitary sewer which revealed a total of 131 defects such as cross-connections, missing cleanout caps, and structural defects. In addition, maintenance hole inspections in the Village of Nobleton discovered 59 of them had active infiltration, with another 71 that had the potential for inflow during wet weather. The Region is working with local municipalities to address the defects as part of normal maintenance activities as well as through private programs with local developers. See Table 9

for a complete breakdown of the defects identified during SSES and Figure 11 and Figure 12 for smoking I/I sources.

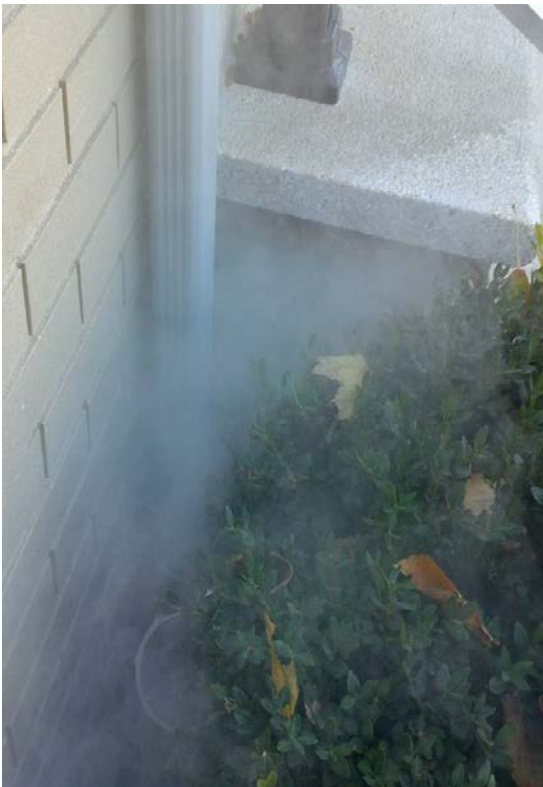
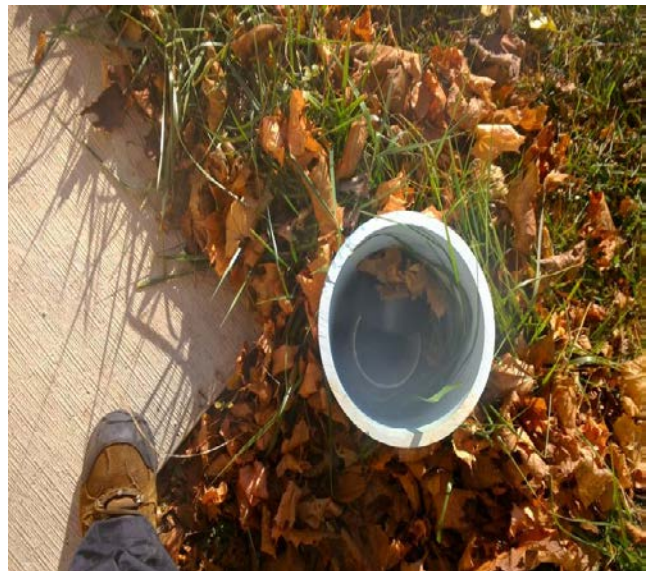
Figure 12 - Smoking Downspout and Open Sanitary Cleanout in Richmond Hill and Vaughan

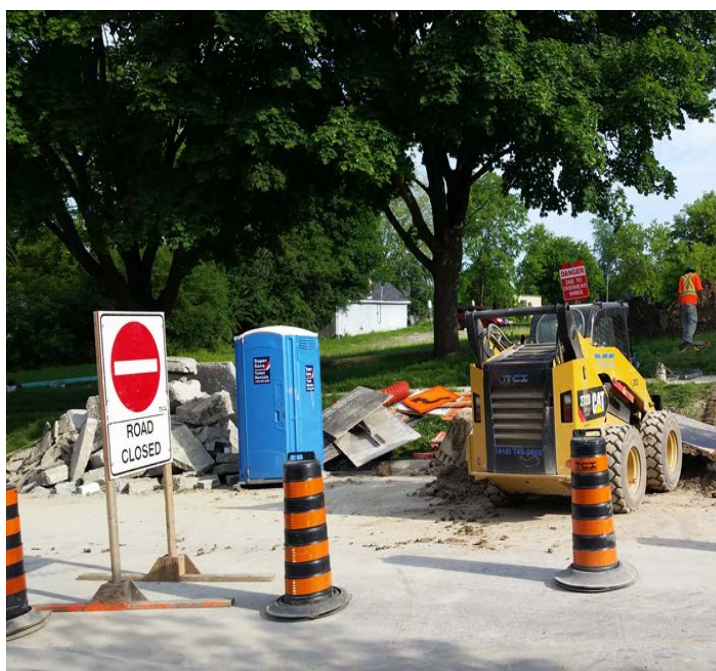
Figure 13 - Lateral Replacement in Aurora

As a continuation of Pilot I Rehabilitation project completed in 2012, the Region, in collaboration with the local municipalities have completed work in the private side of the majority of the catchments included as part of Pilot I. The project works for the Rehabilitation of Private Sanitary Sewer Laterals were located in catchments within five local municipalities – Aurora, East Gwillimbury, Georgina, Newmarket, and Vaughan – and focused on repairing or replacing damaged sanitary sewer laterals between the mainline and property line.

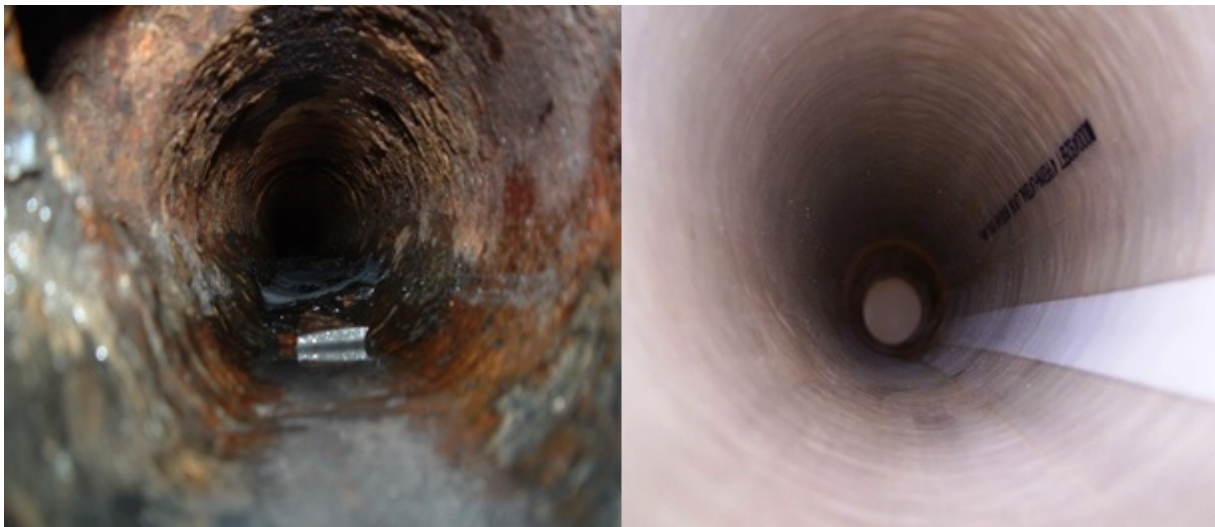
Figure 14 - Lateral Lining Before and After Rehab Illustration

Where possible, laterals were rehabilitated using full-length cured-in-place pipe (CIPP) or spot repairs. Laterals that were too damaged for rehabilitation were completely replaced or capped at the mainline sewer. Table 10 below summarizes the type and number of repairs completed and I/I reduction achieved in each of the catchments as a result of this pilot project and Figure 13 shows a lateral replacement in East Gwillimbury. Figure 14 compares a pipe before and after lateral lining.

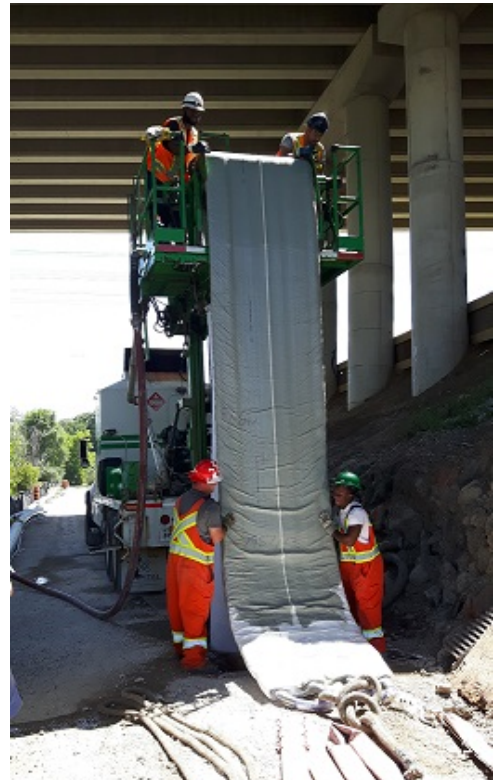
Figure 15 - CIPP liner prior to installation

Repair has taken place in the Aurora West Collector where a number of active infiltration points were discovered during a routine CCTV inspection. A weir was installed and the sewer flow diverted in order to quantify the amount of infiltration entering the sanitary sewer, which was determined to be 0.001 MLD. To address the infiltration, a 900 mm diameter CIPP liner approximately 225 m in length was installed (Figure 15), and rehabilitation was performed on three maintenance holes. A map of the project area is provided in Appendix D.

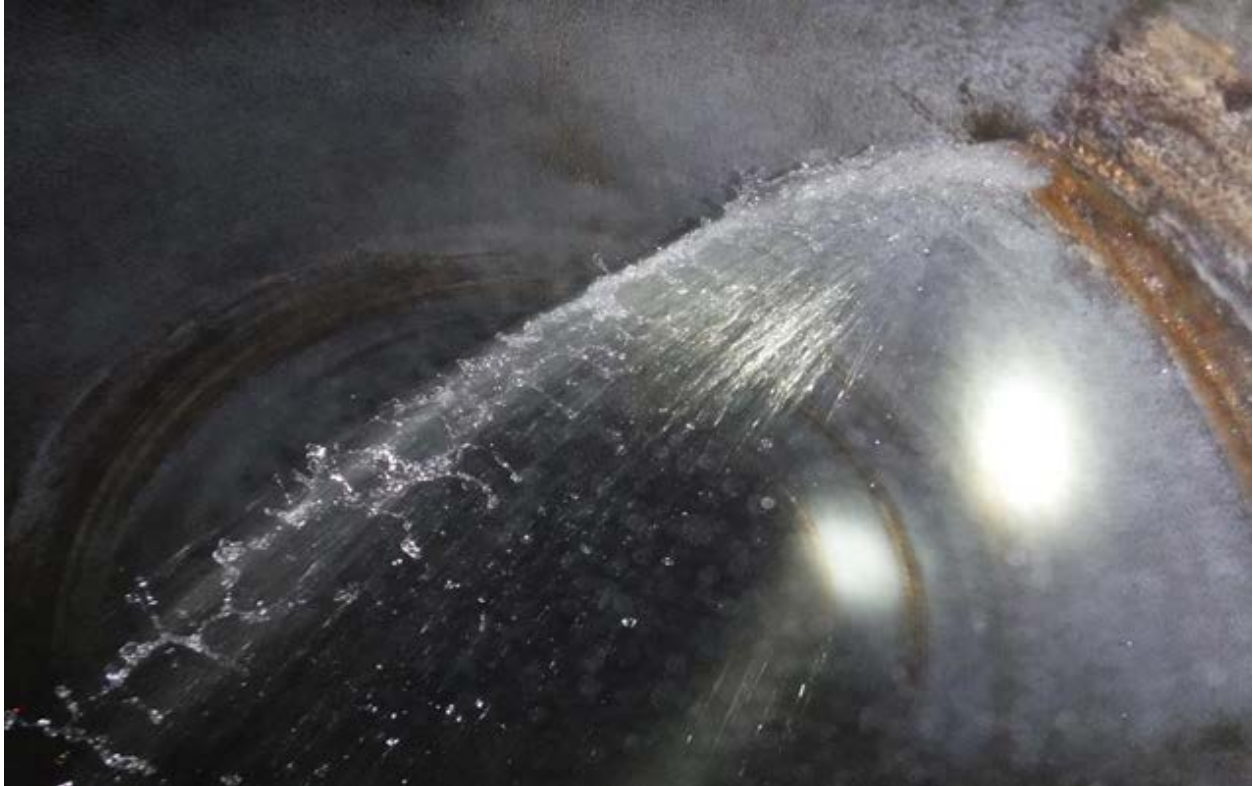
The two areas selected for the pilot have longitudinal cracks on their internal surface, and active, heavy infiltration (Figure 17), calculated to be 0.082 MLD via a tipping bucket test (see Table 11). This pilot enables evaluation of the method’s performance, and provides valuable information on its durability and how effective it will be at reducing inflow and infiltration. If proven successful under the pilot study, the Region will proceed with the design of the YDSS 16th Avenue Rehabilitation Project recommending the use of a geopolymer mortar lining as the specified method (Figure 18) and reductions will be reported next year.

Figure 17 - 16th Avenue Trunk Sewer Gusher Prior to Rehabilitation

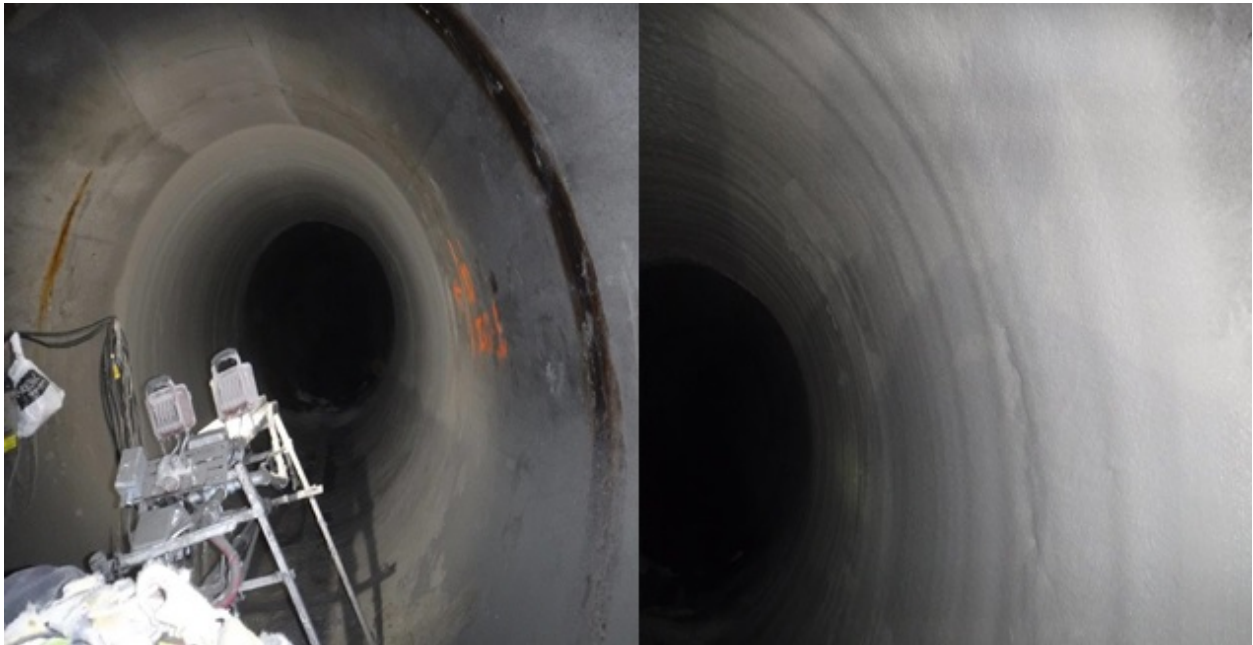
Figure 18 - 16th Avenue Trunk Sewer Gusher after Application of Geopolymer

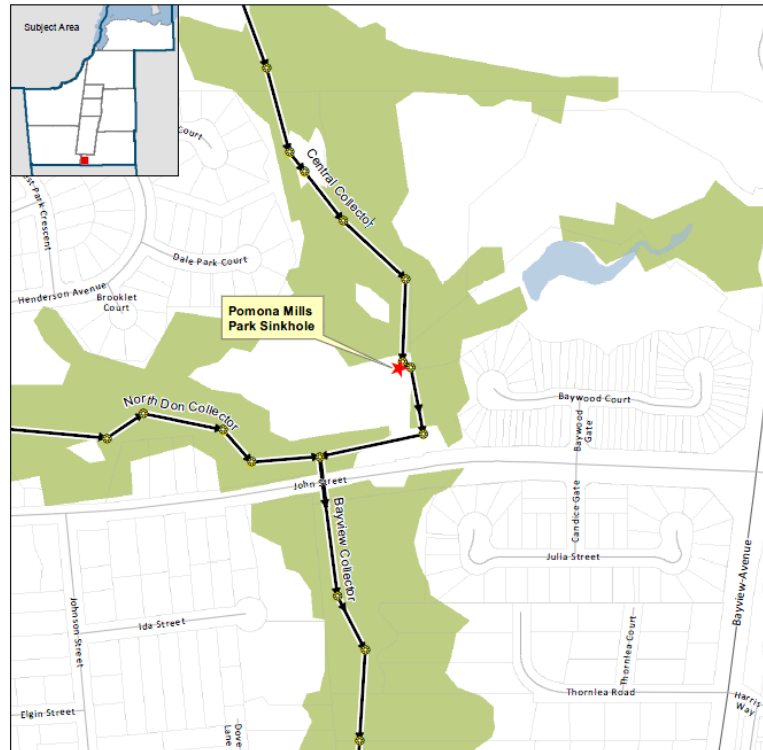
Figure 19 - Map Showing Pomona Mills Park Sinkhole location in York Central Collector

CCTV inspections of the sewer system were initiated, which identified the displacement of two maintenance holes and open pipe joints and emergency sewer repair was completed in the fall of 2016. The scope of work included installation of new sewer pipe and maintenance holes, decommissioning of the affected sewer infrastructure and ongoing operation of the sewage bypass system throughout construction activities.

While only 3 infiltration gushers/runners were observed in pre-remediation videos. If the line had been allowed to continue to sink, there could have been significant ground water infiltration quantification potential. Therefore the project circumvented potentially significant I/I that cannot be quantified. A reduction of 0.01 MLD is reported following the CCTV review and quantification of the infiltration runner.

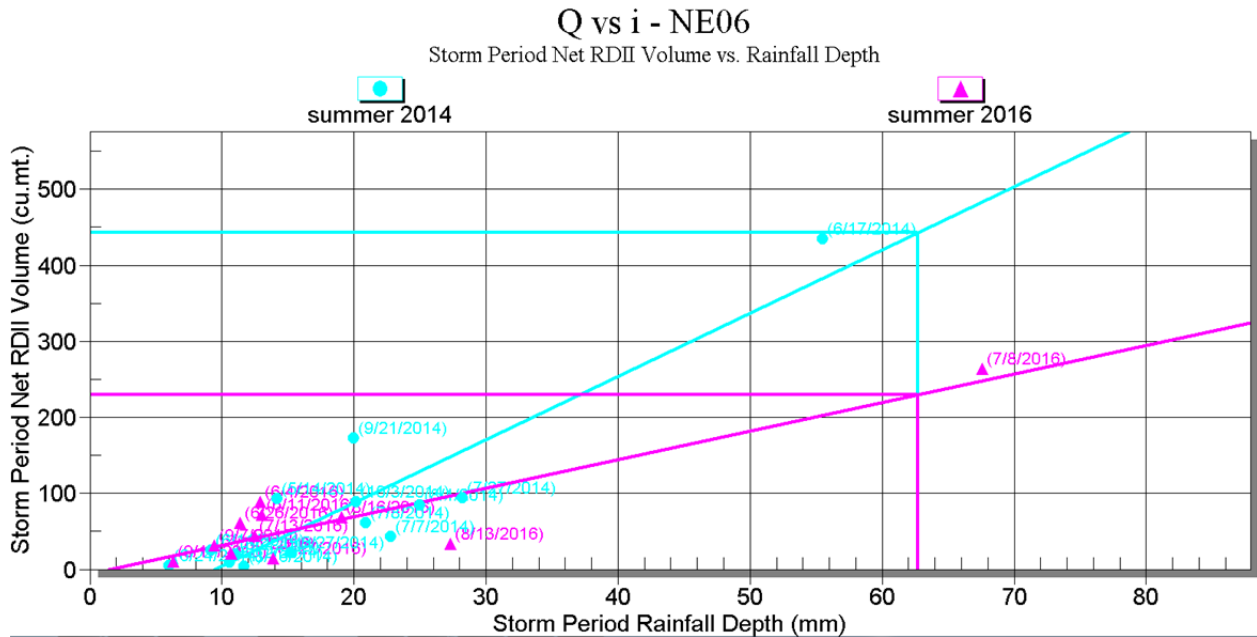
Town of Newmarket - Catchment NE06: RDII Volume versus Rainfall Depth

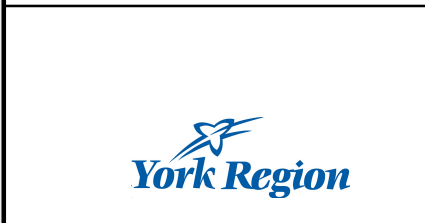
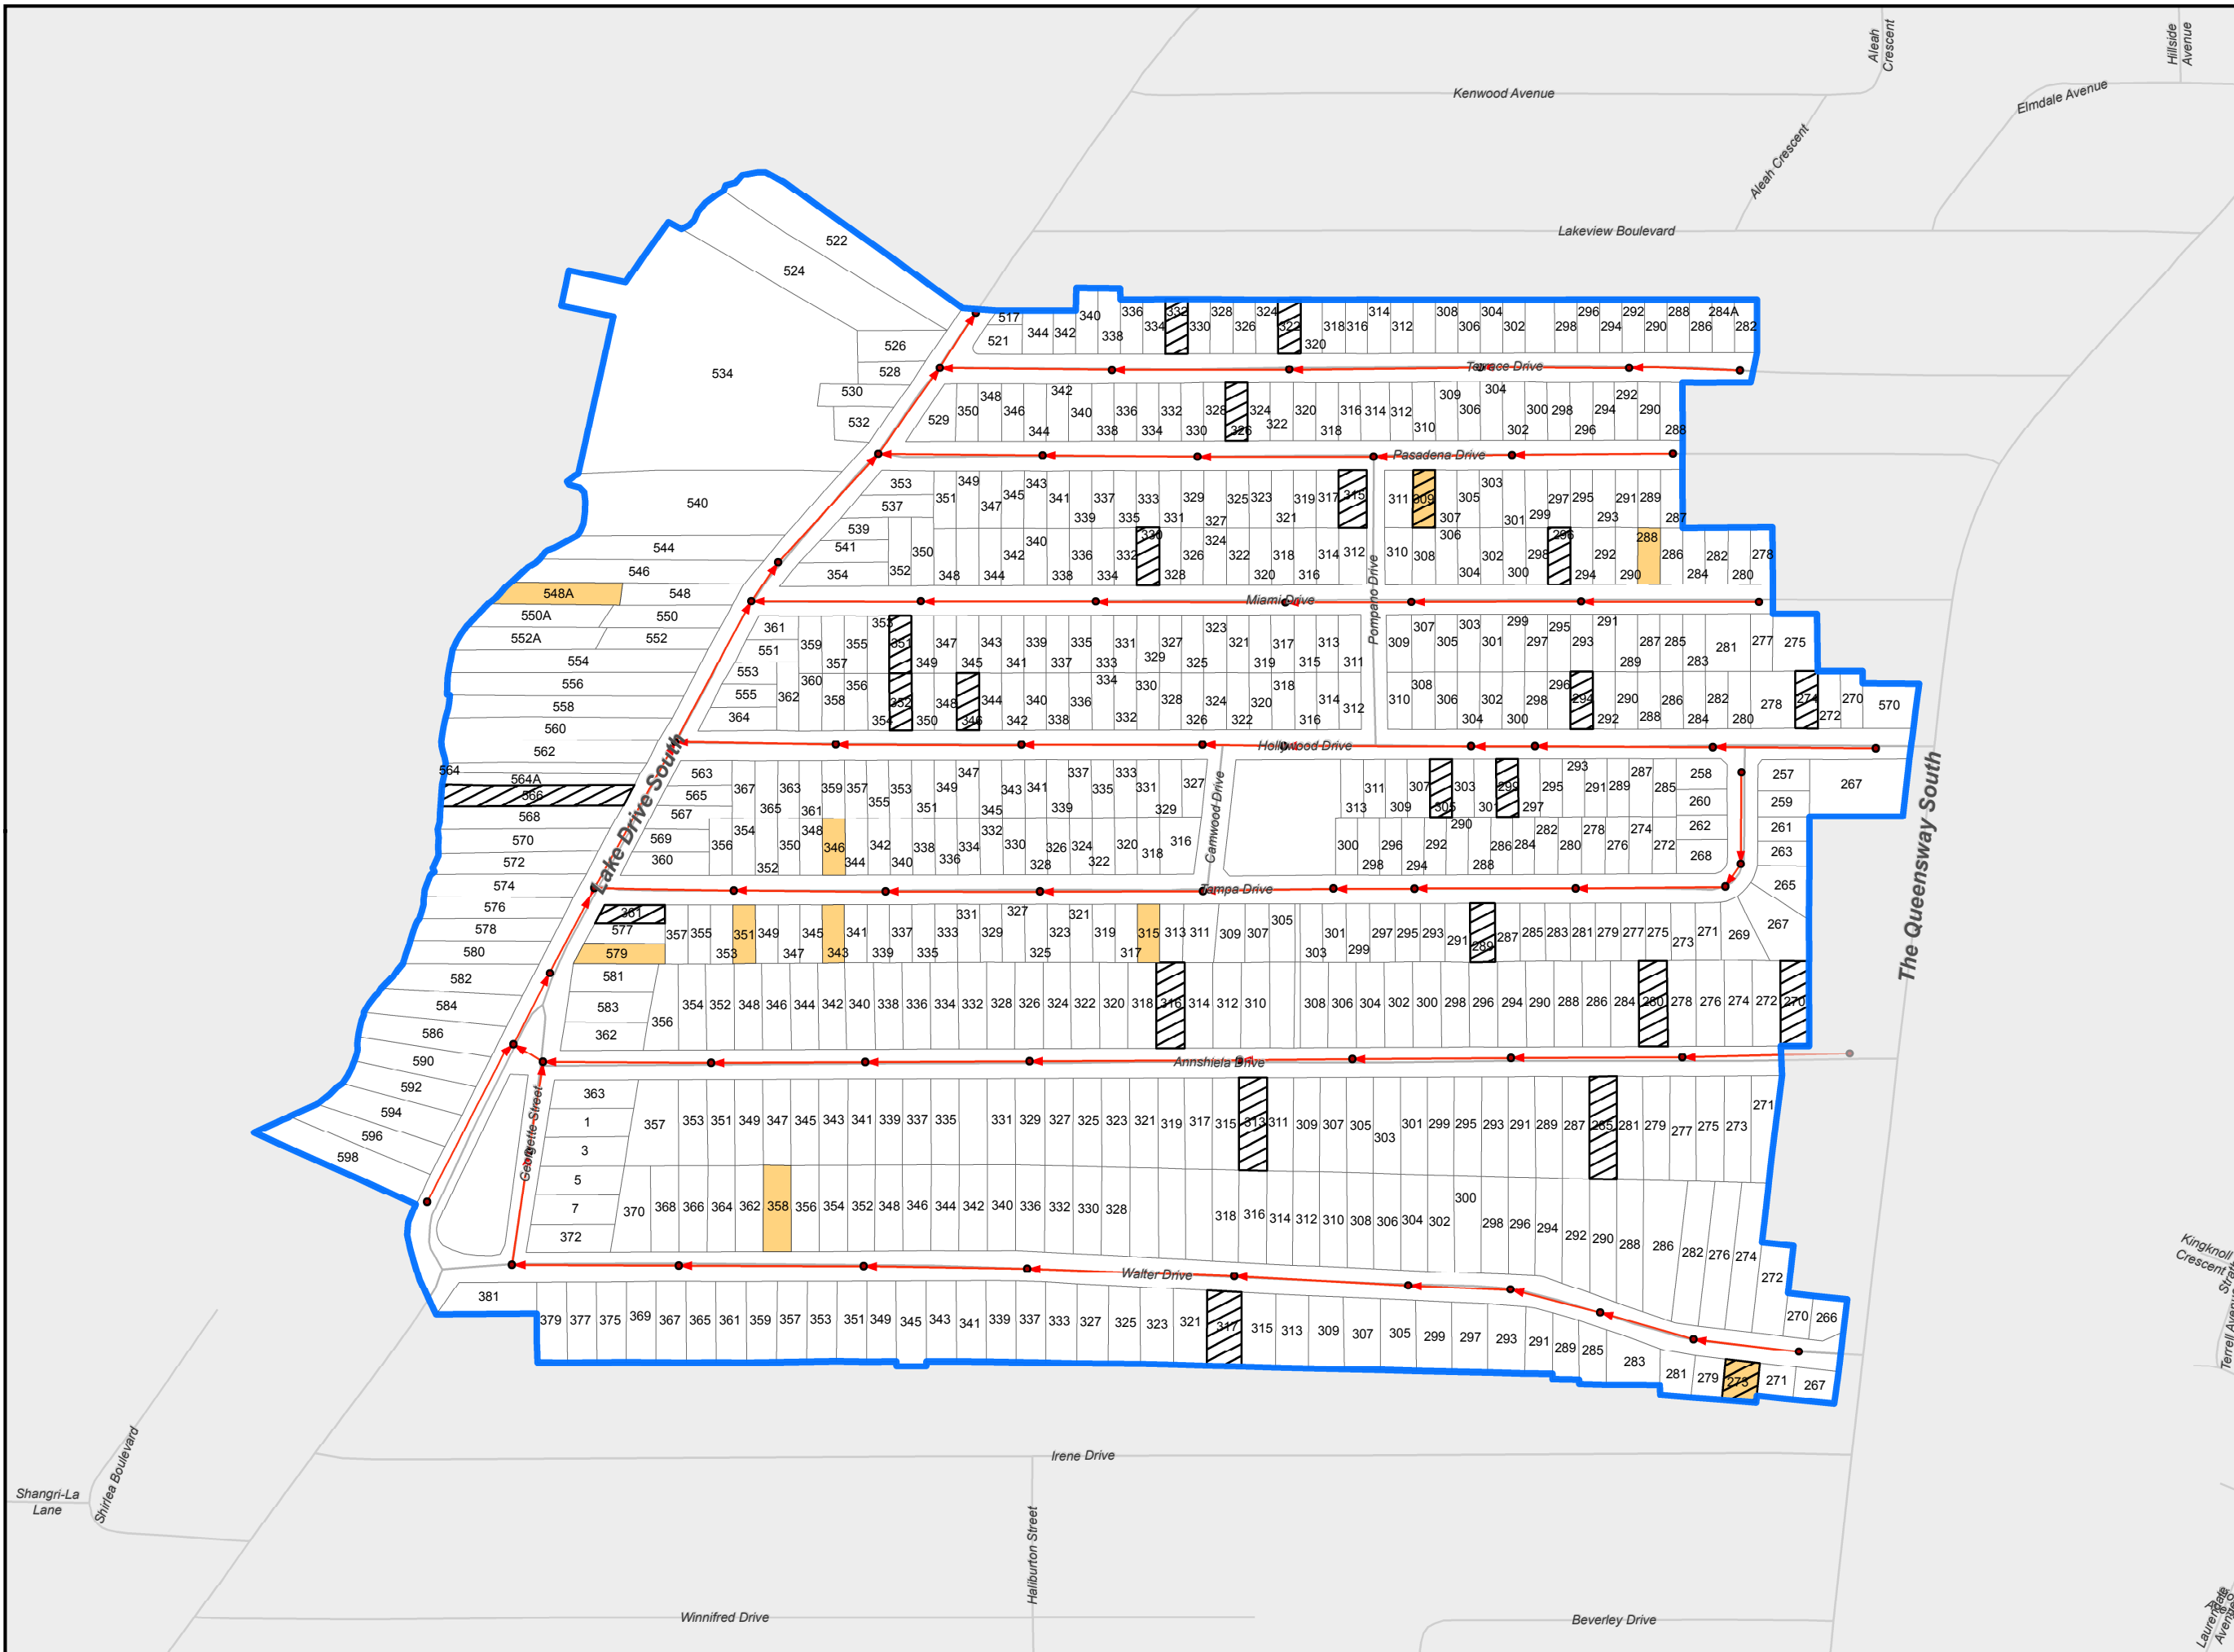
**East Gwillimbury - HL01
As-Built Lateral
Rehabilitation**

Rehabilitation of Private Property
Sanitary Sewer Laterals
The Regional Municipality of York

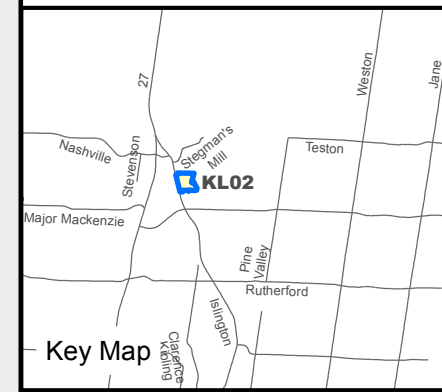
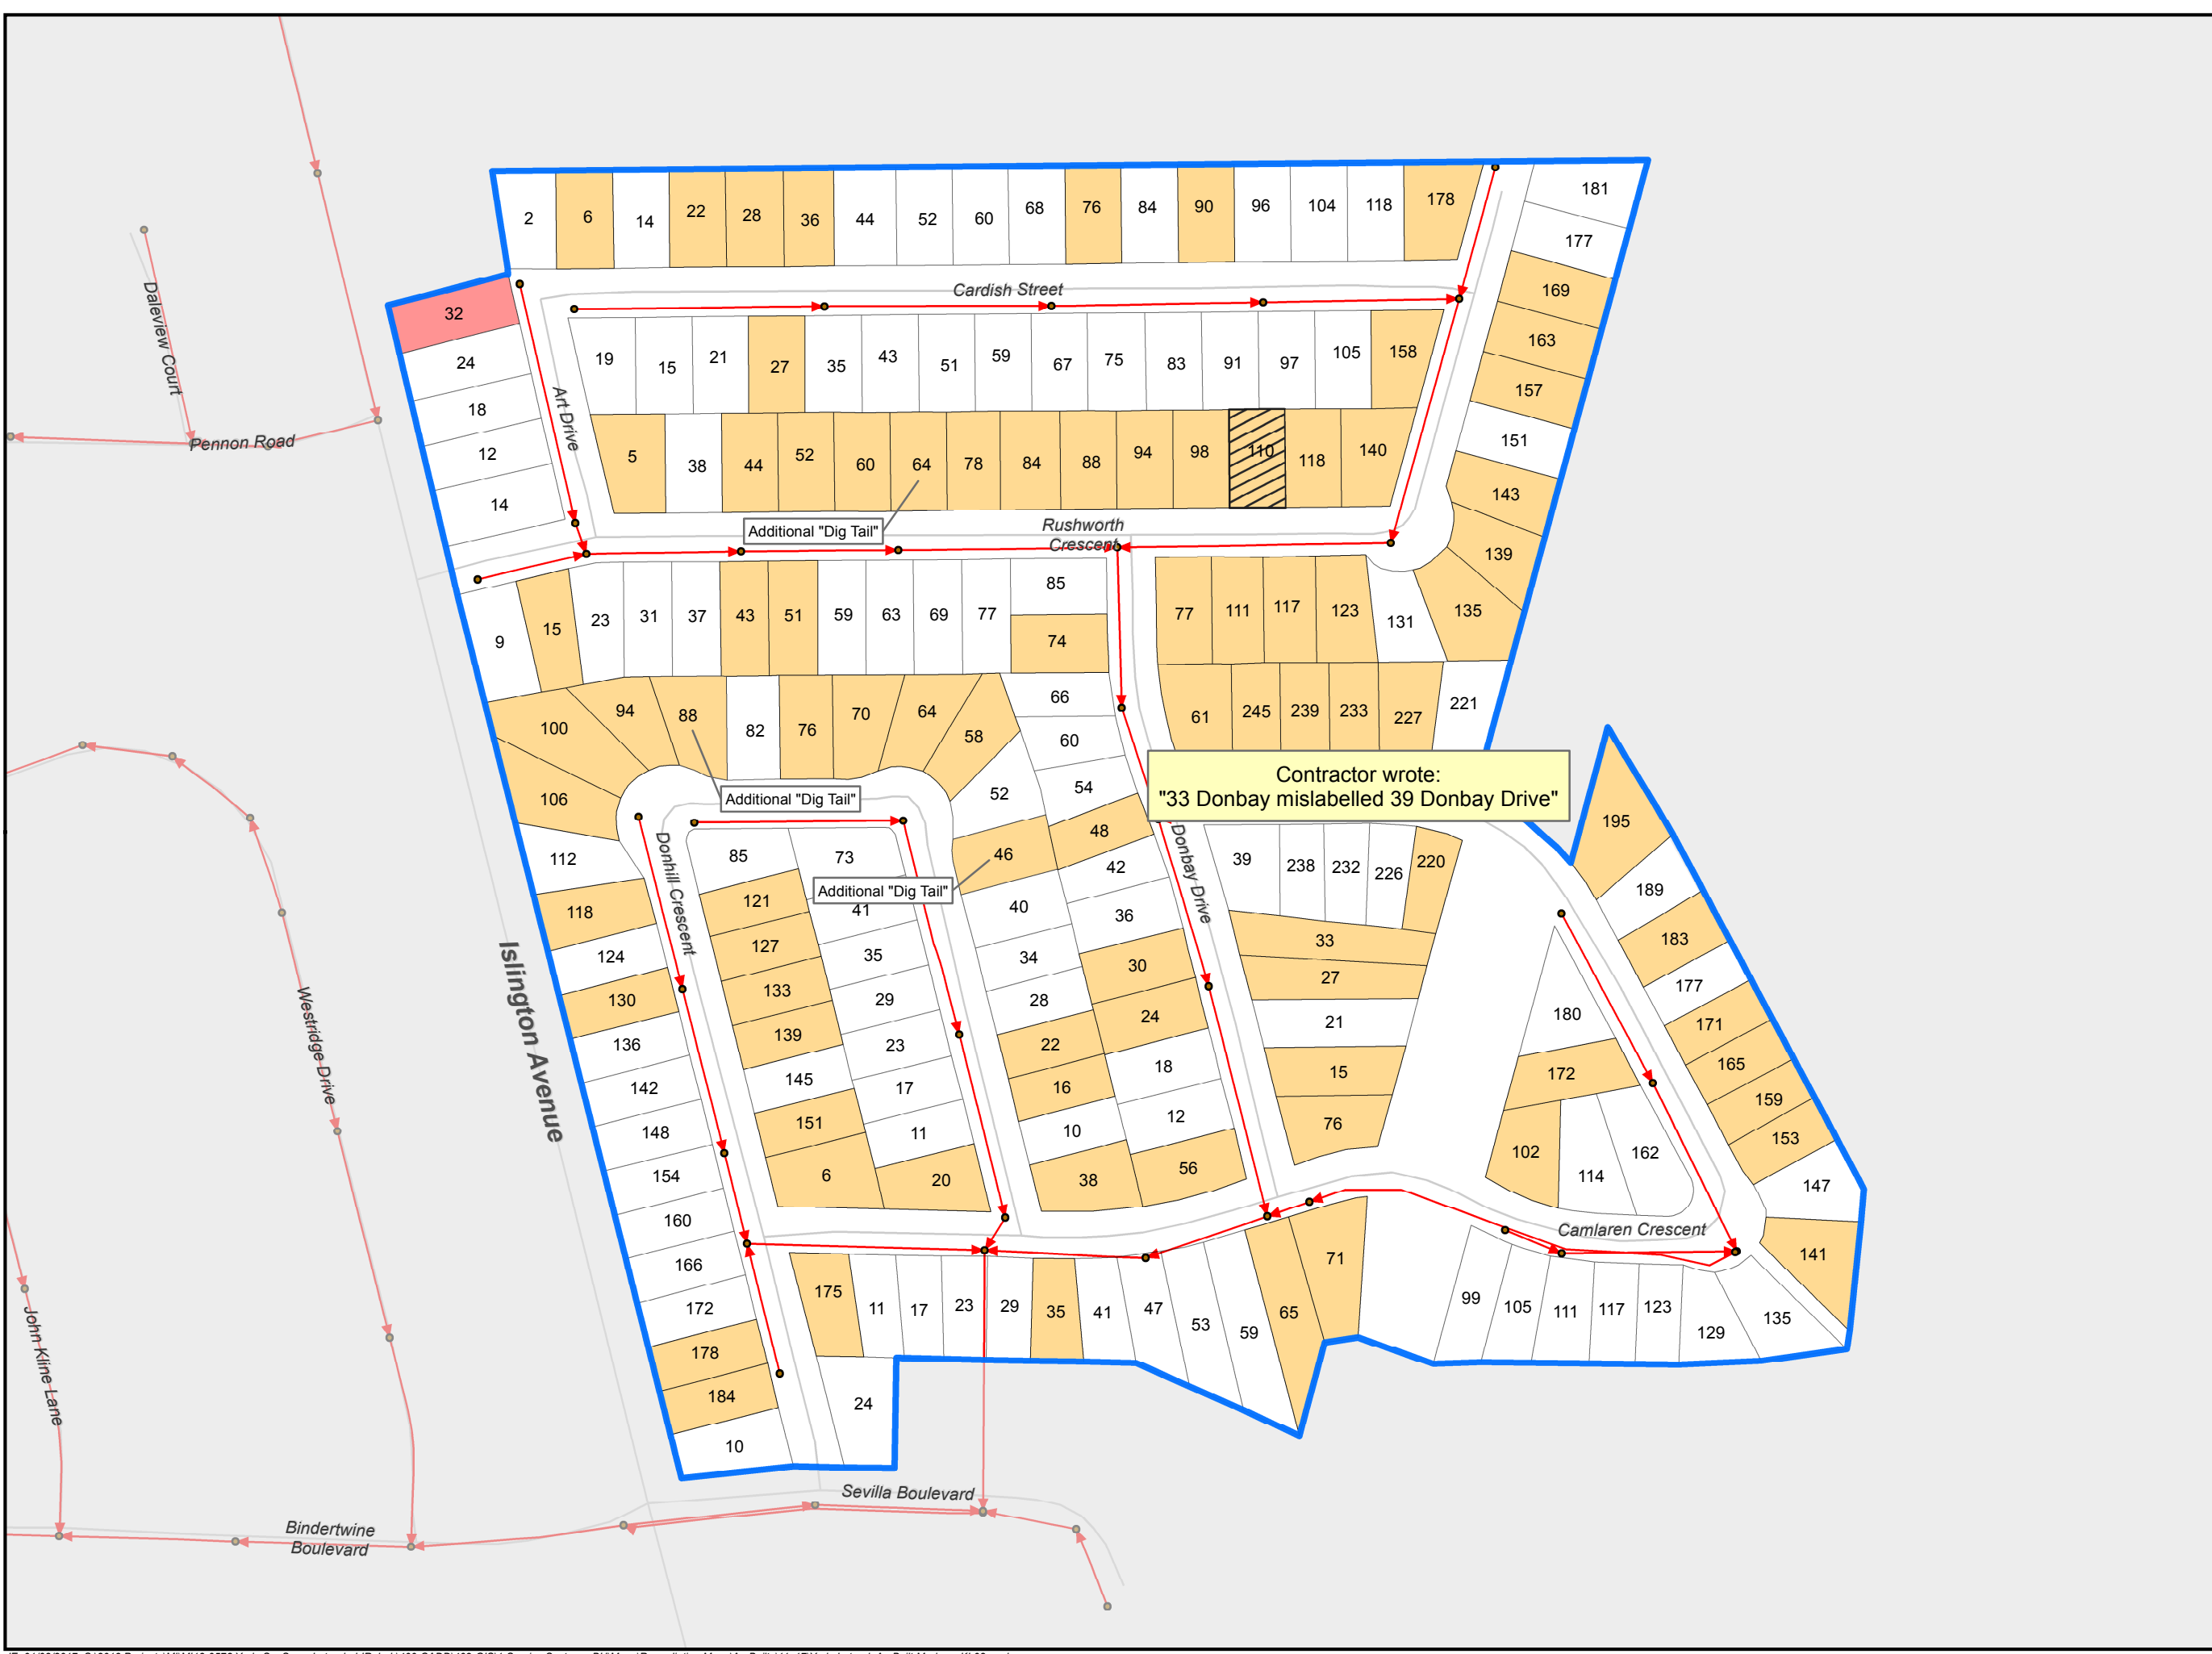
Rehabilitation of Private Property
Sanitary Sewer Laterals
The Regional Municipality of York
