Appendix U - Part 2

Contamination Overview Study Report

Project Property: *052314 Kennedy Road Study Area COS
Kennedy Road ROW from Elgin Mills to
Major Mackenzie
Markham ON*

Project No: *300052314.0000*

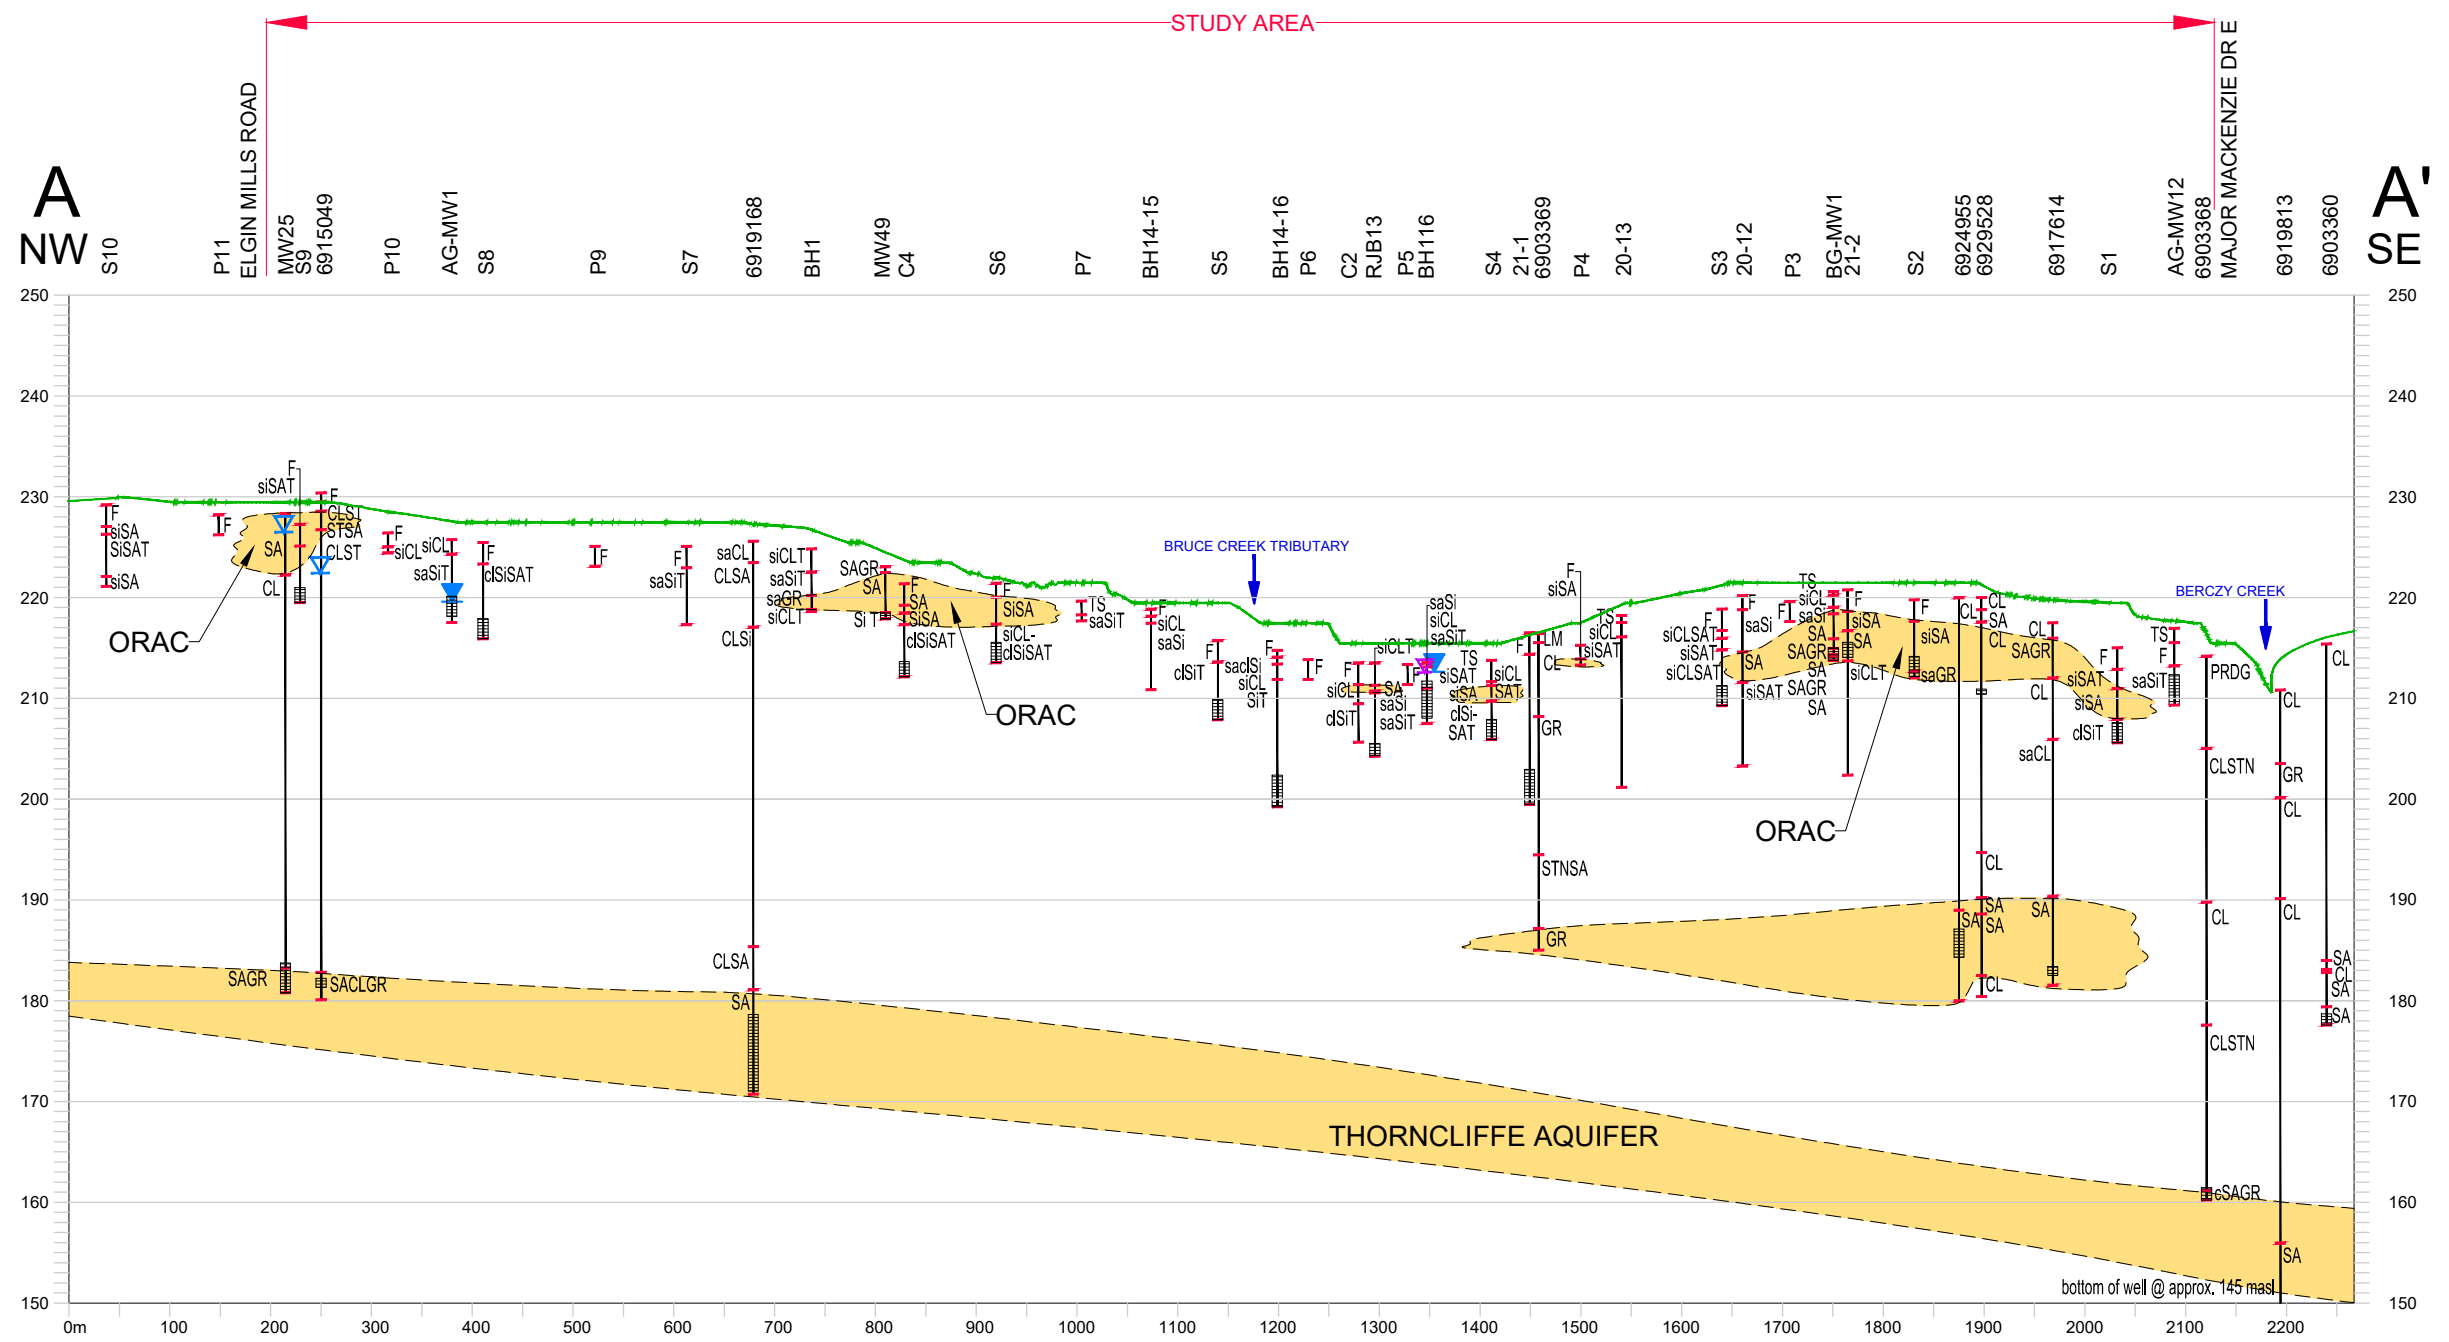
Drawn SK	Checked SC	Date FEBRUARY 2022	Figure No. 5
Scale 1:7,500	Project No. 300052314

Figure Title **INTERPRETED GEOLOGICAL
 CROSS-SECTION A-A'
 (WARDEN AVENUE)**

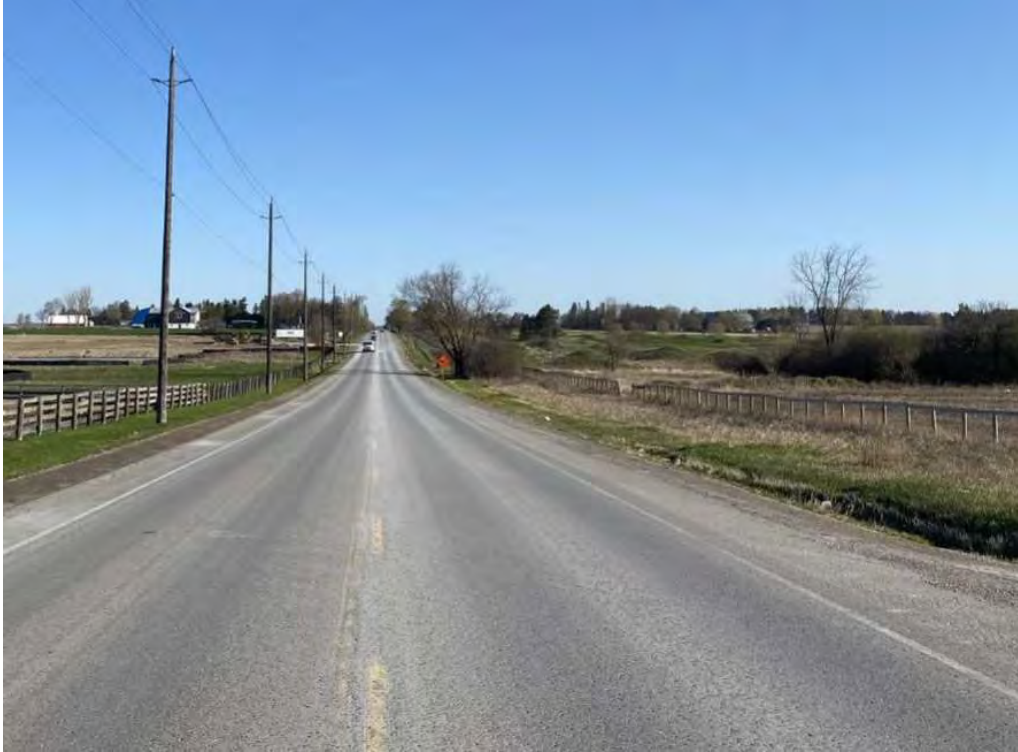
Photo 3: Provincially Significant Wetland (PSW) and golf course on east side of Warden Avenue.

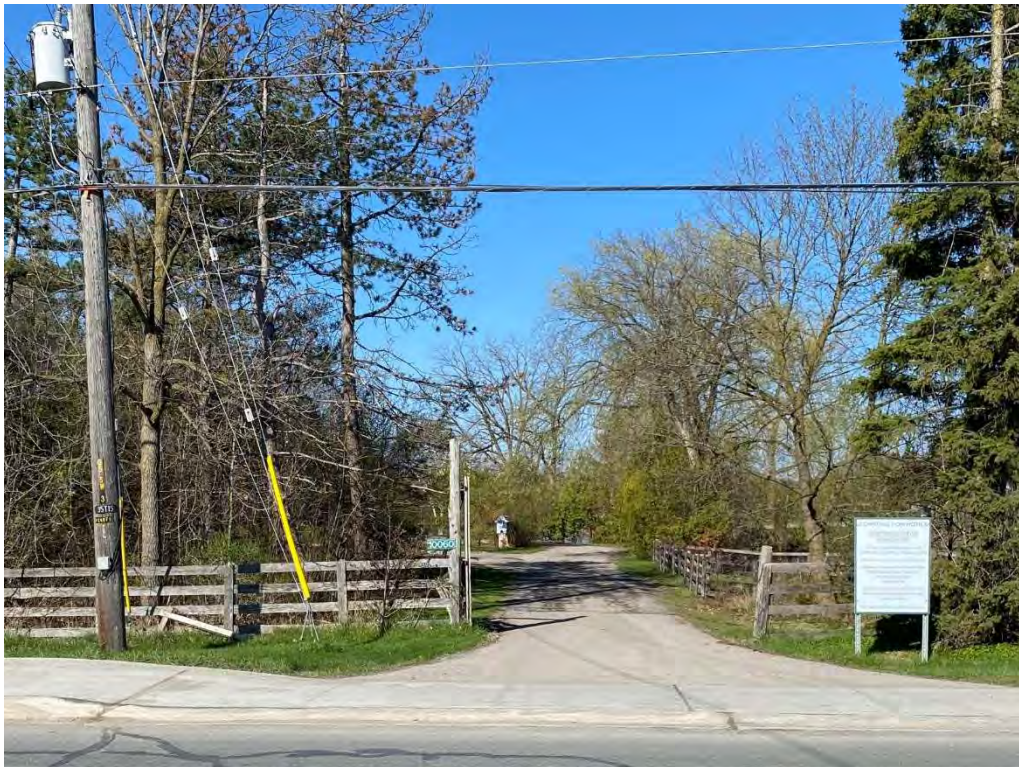
Photo 8: Entrance at 10060 Kennedy Road (golf course property) on west side of Kennedy Road.
